# Precipitation, Peak Streamflow, and Inundation in the Bynum Run and Winters Run Watersheds in Harford County, Maryland

Scientific Investigations Report 2021–5007

By Christopher W. Nealen and Edward J. Doheny

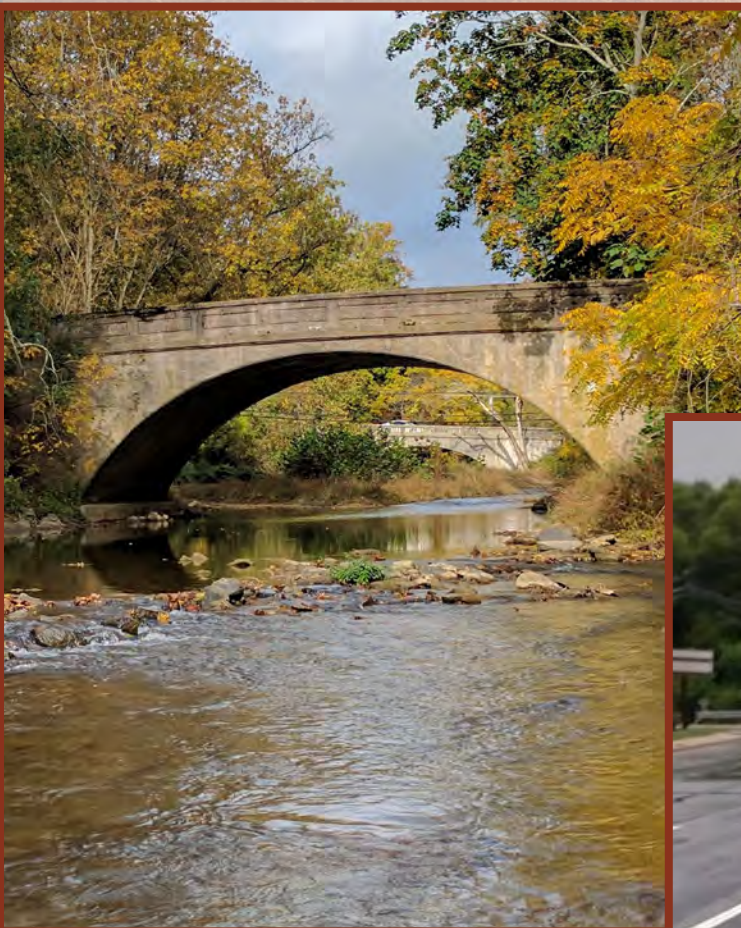
**Left photo:** Winters Run stream at Lake Fanny Road bridge taken on October 21, 2016 by Christopher Nealen from U.S. Geological Survey.

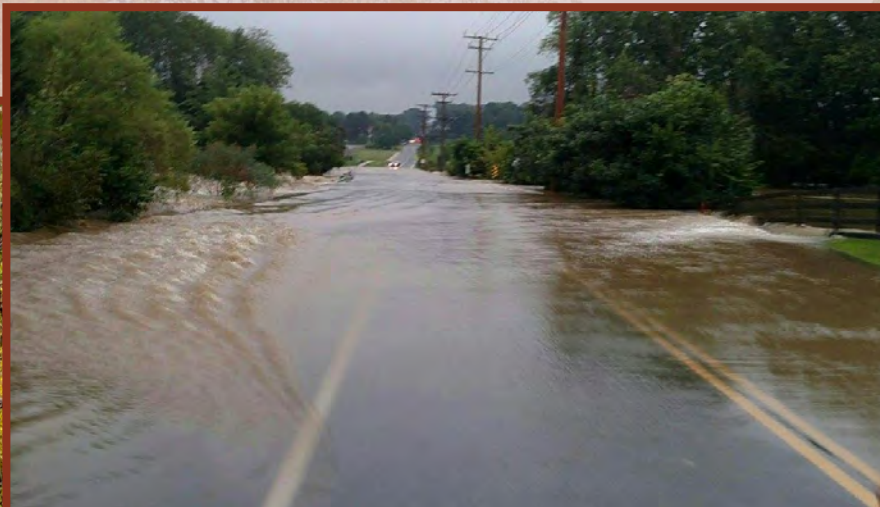
**Right top photo:** Bynum Run at Moores Mill taken on August 20, 2015. Photograph by Harford County Department of Public Works.

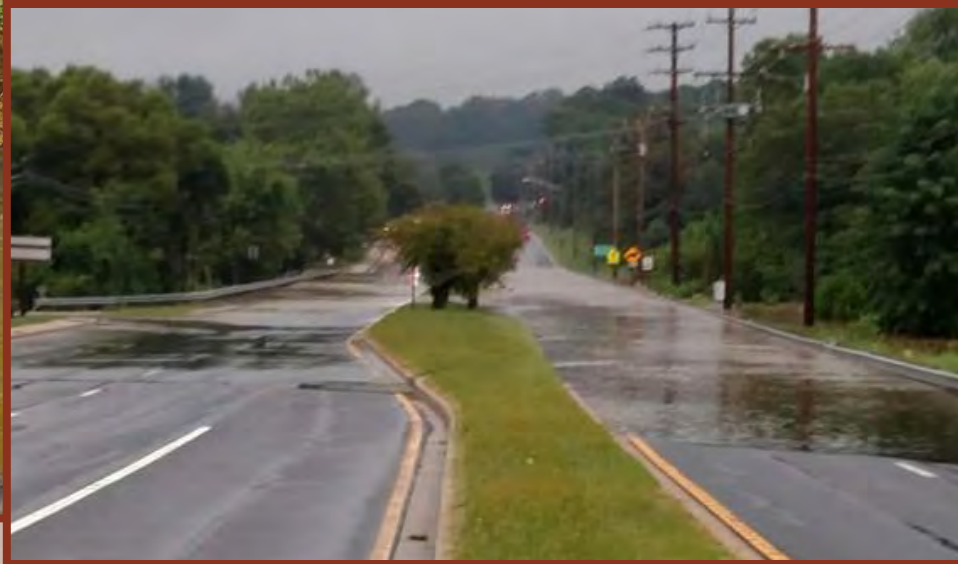
**Right bottom photo:** Bynum Run at Rt. 22 taken on August 20, 2015. Photograph by Harford County Department of Public Works.

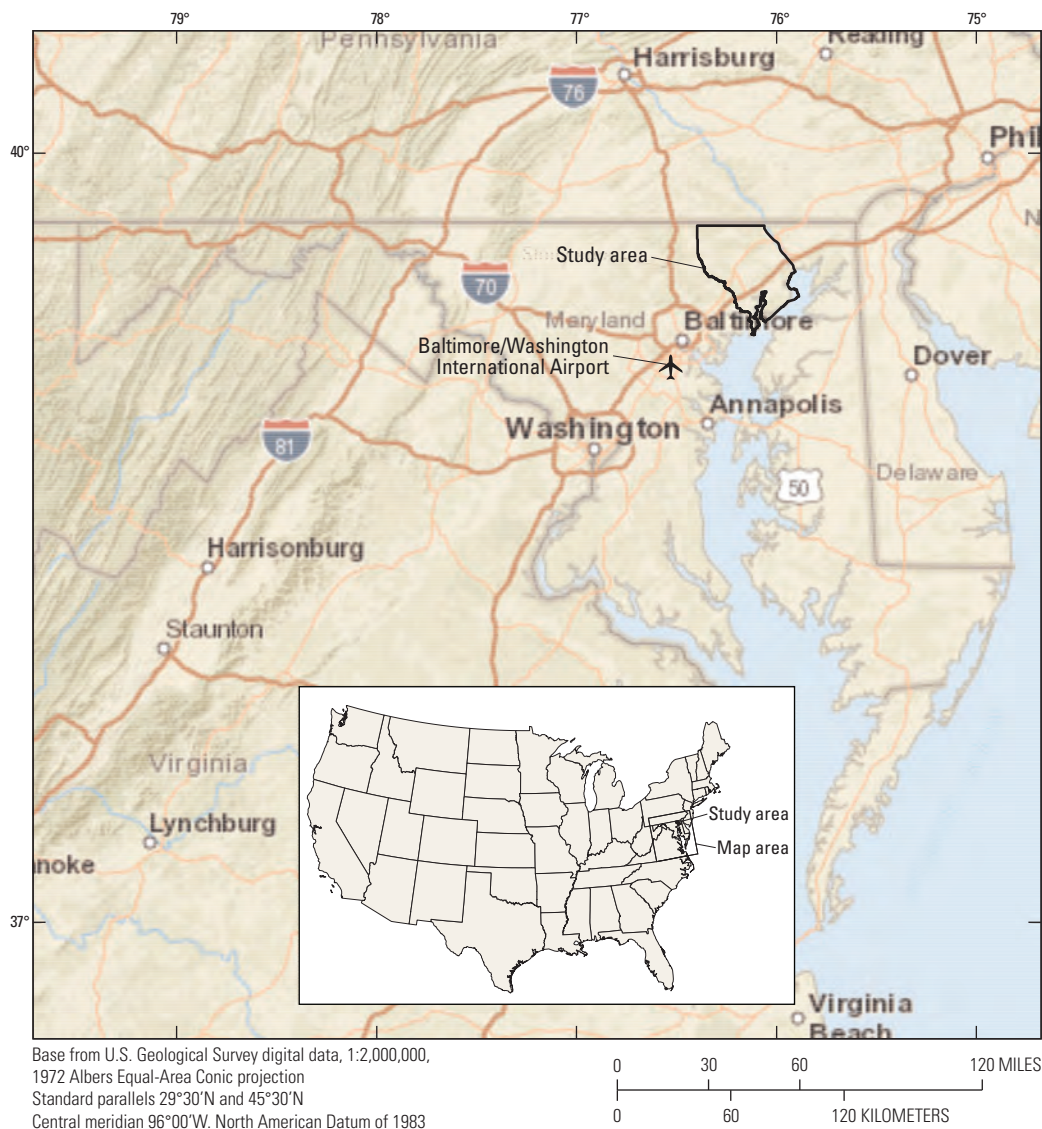
**Figure 1.** Map showing location of study area, Harford County, Maryland.

in Harford County, Maryland (fig. 1). USGS operates a streamgauge (01581500) on Bynum Run, which drains an area of 8.52 square miles. USGS also operates two streamgages on Winters Run; one streamgauge (01581700) drains an area of 34.8 square miles, and another a little downstream (01581750) drains an area of 36.8 square miles. USGS also operates two rain gages in the study area—Rain Gage in Winters Run Basin at Fallston, Md. (gage 393126076244301), hereafter Fallston Rain gage, and Atkisson Reservoir near Bel Air, Md. (gage 01581753), hereafter Atkisson Reservoir gage. (fig. 3).
