# Assessment of the Hydraulic Connection Between Ground Water and the Peace River, West-Central Florida

U.S. Geological Survey

Water-Resources Investigations Report 97-4211

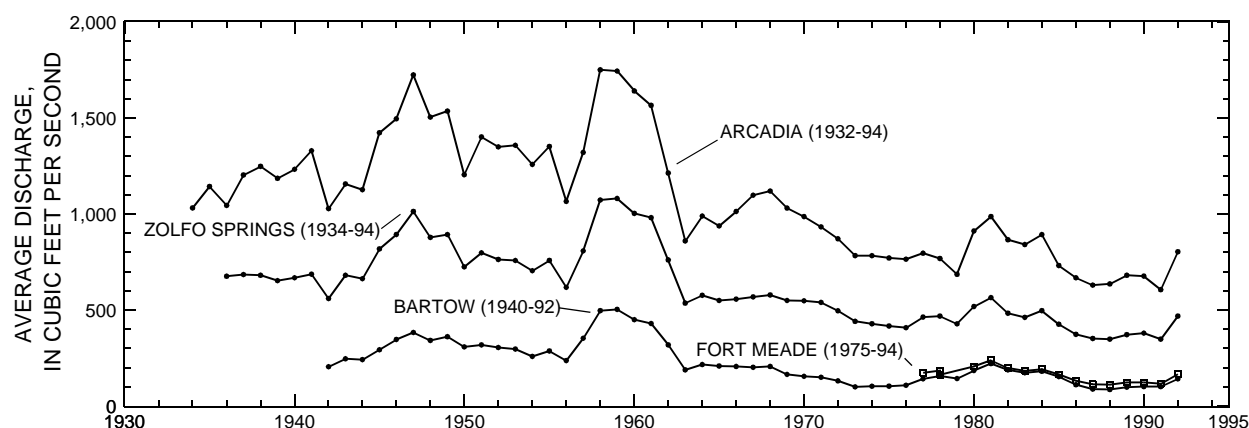
**Figure 10.** Five-year moving averages of annual mean discharge for the Peace River at Bartow, Fort Meade, Zolfo Springs, and Arcadia streamflow gaging stations. (Modified from Hammett, 1990.)

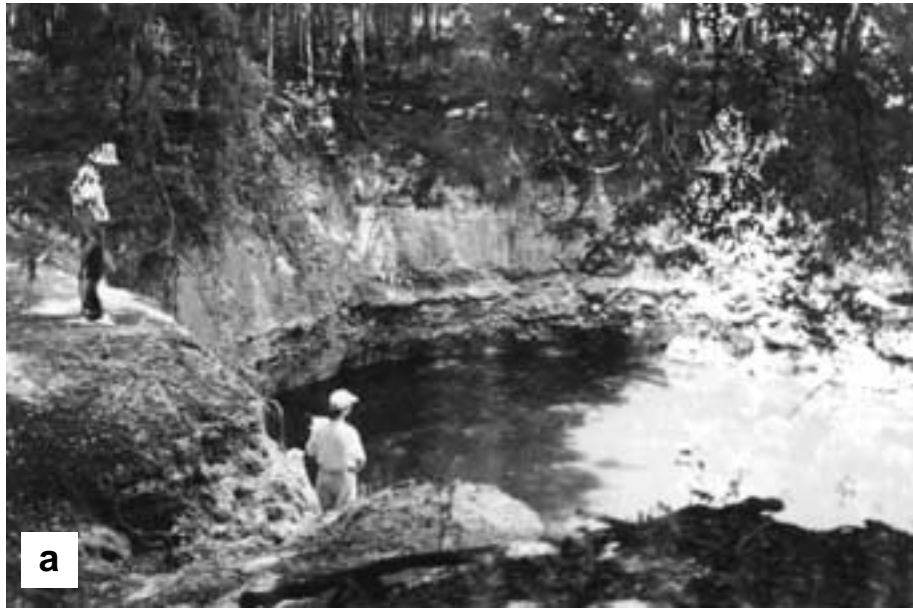
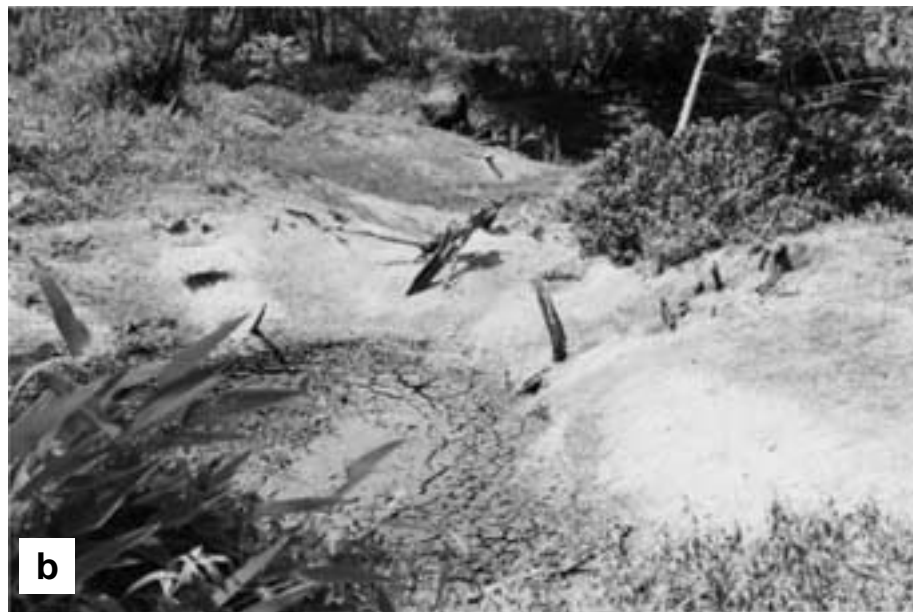
**Figure 22.** Examples of subsidence features observed in the upper Peace River floodplain: (a) large collapse feature with steep walls and (b) small sand-filled depressions. (Location of subsidence features are shown in figure 18.)

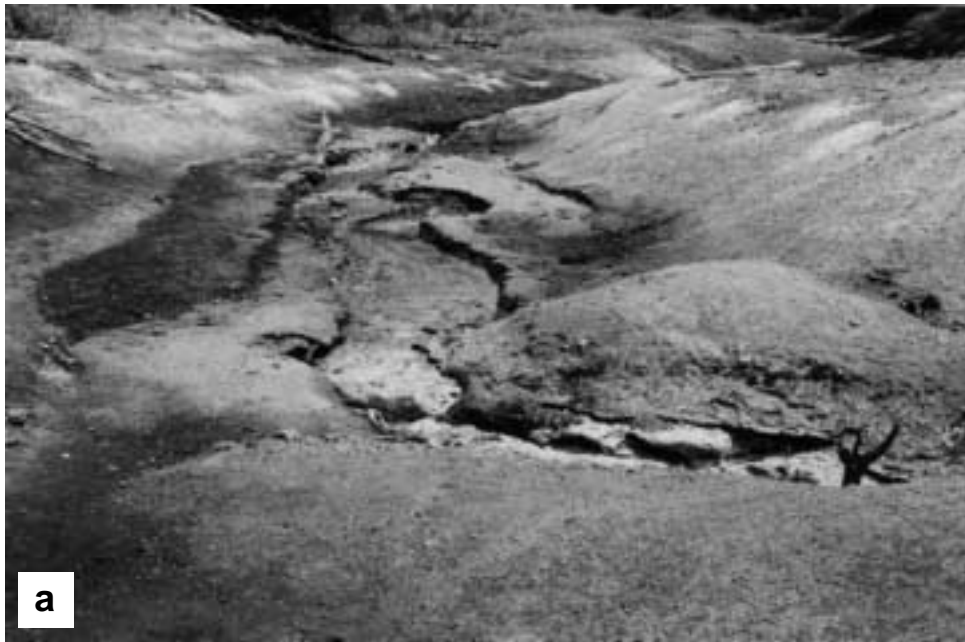
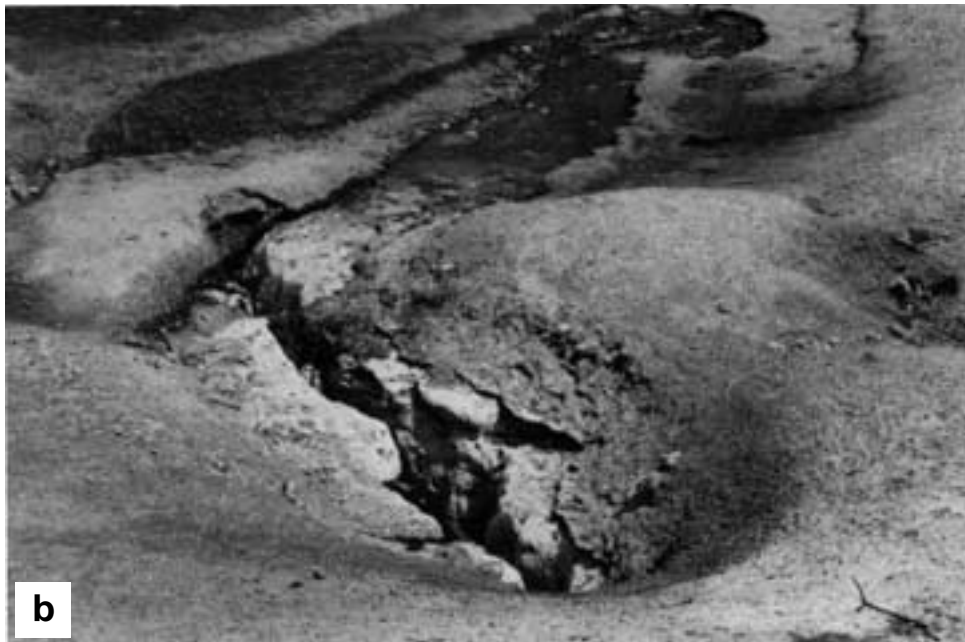
**Figure 23.** Example (a and b) of an enlarged linear solution feature capturing Peace River flow during low base-flow conditions, May 1995. (Location of solution feature is shown in figure 18.)

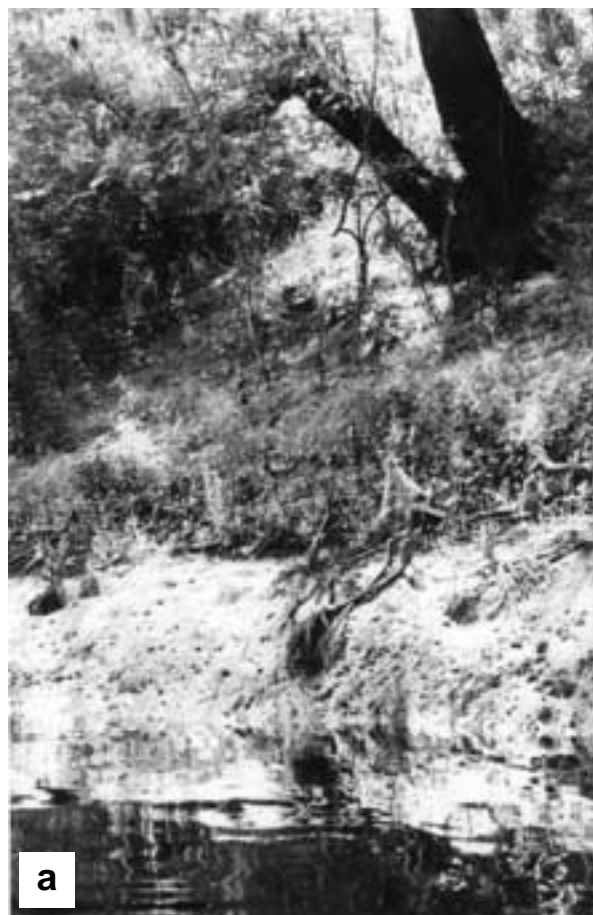
**Figure 28a.** Example of exposed geologic units along the banks of the lower Peace River.

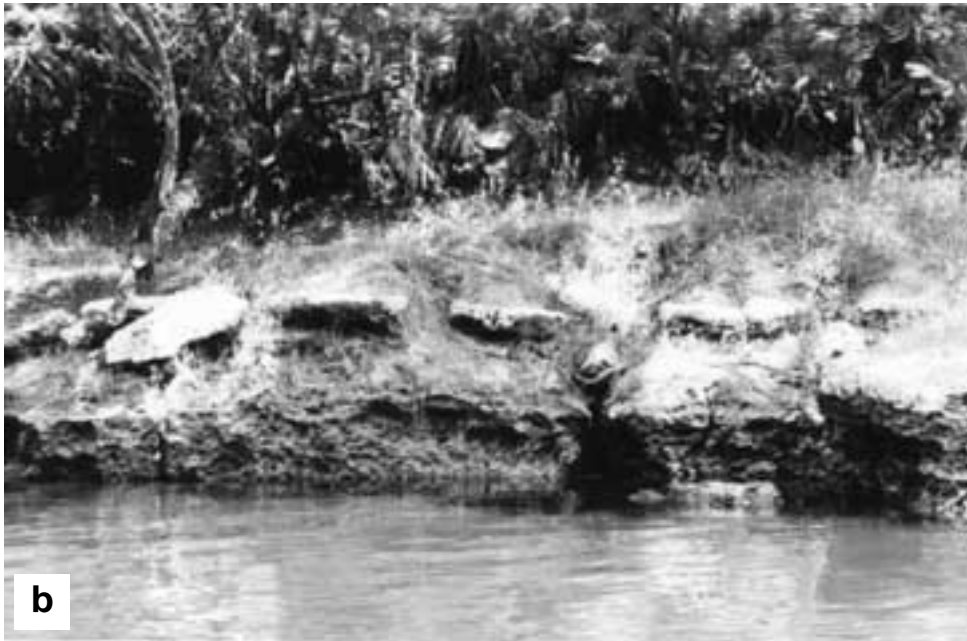
**Figure 28b.** Example of exposed geologic units along the banks of the lower Peace River.

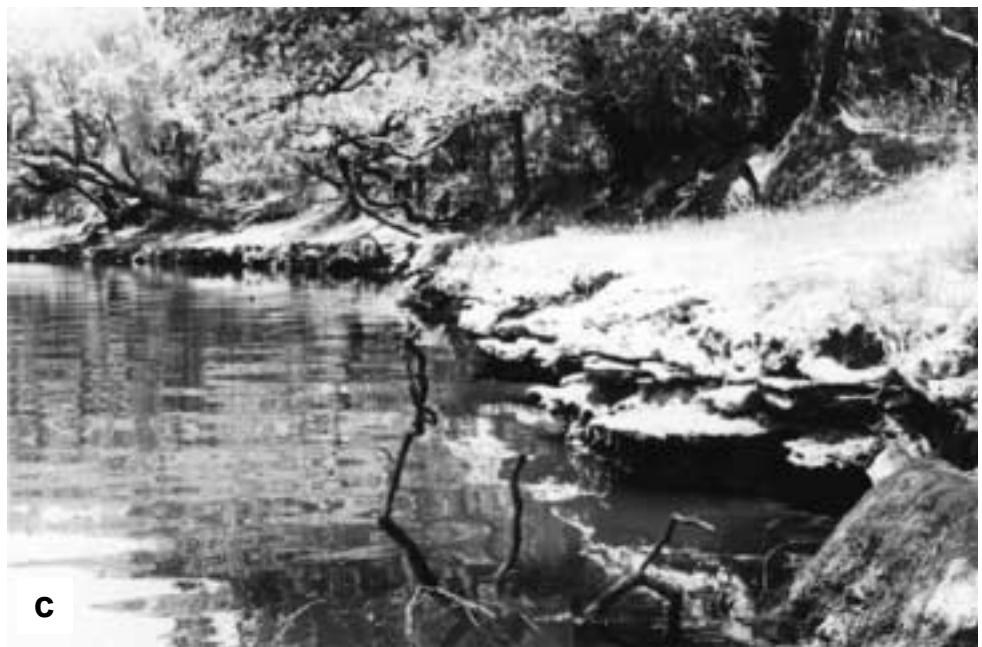
**Figure 28c.** Example of exposed geologic units along the banks of the lower Peace River.

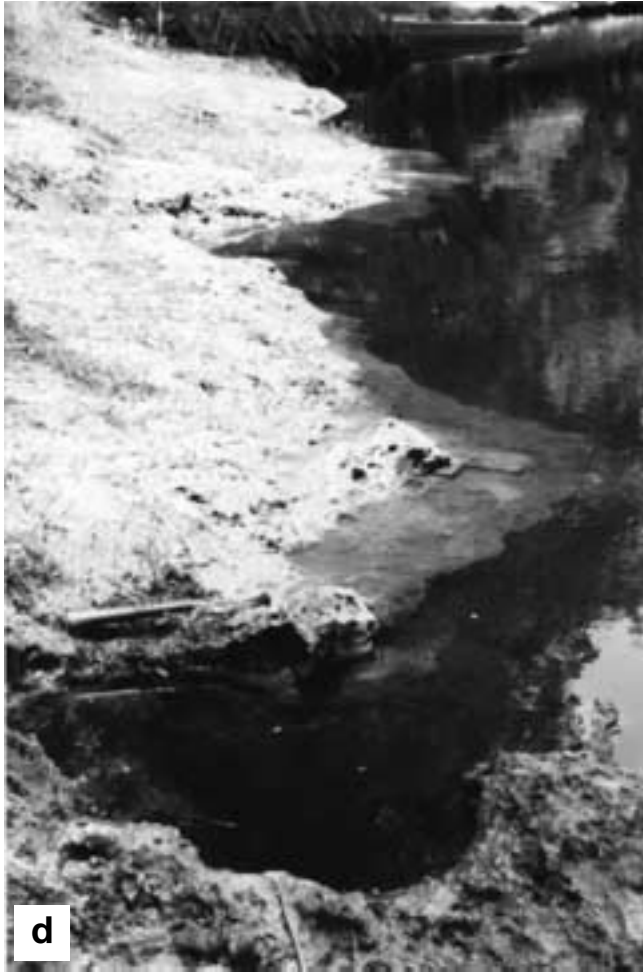
**Figure 28d.** Example of exposed geologic units along the banks of the lower Peace River.

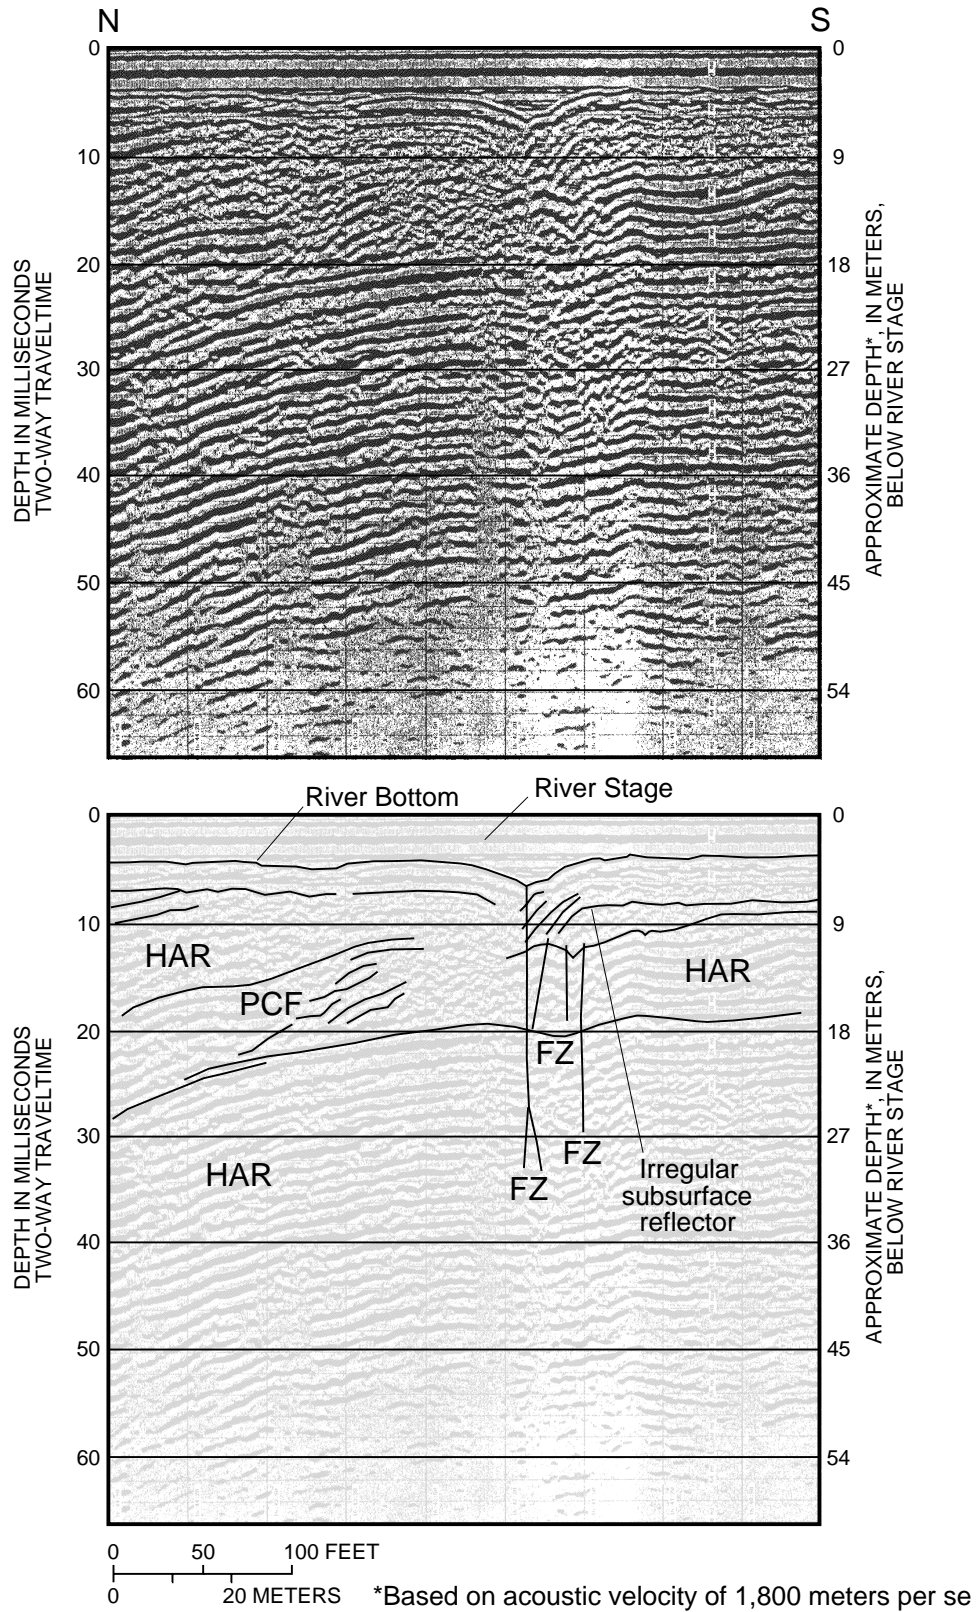
**Figure 32a.** Seismic-reflection profile and interpretation along the lower Peace River north of Arcadia. (See figure 26 for location.)
