CHAPTER VI

THE OLD CAPITOL AS COMPLETED

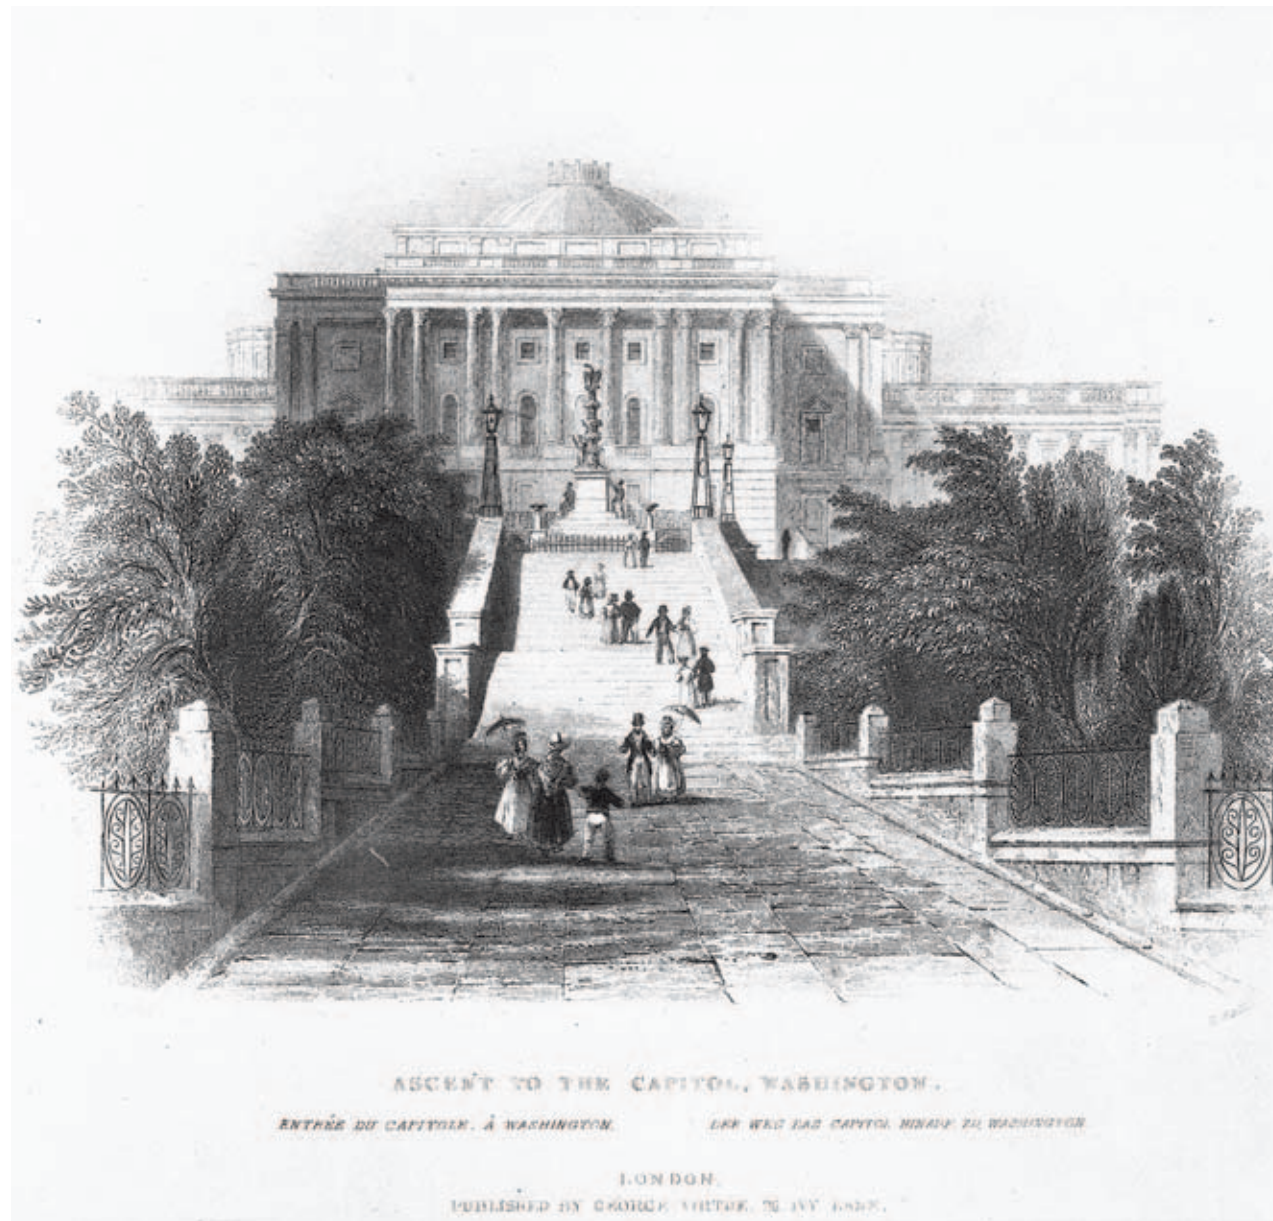
STEPS AND ENTRANCE TO WEST FRONT OF OLD CAPITOL.

Engraving published by George Virtue, ca. 1840.

On entering the grounds by the western gates, passing by a fountain, one ascended two flights of steps to the “Grand Terrace” [Plate 88].

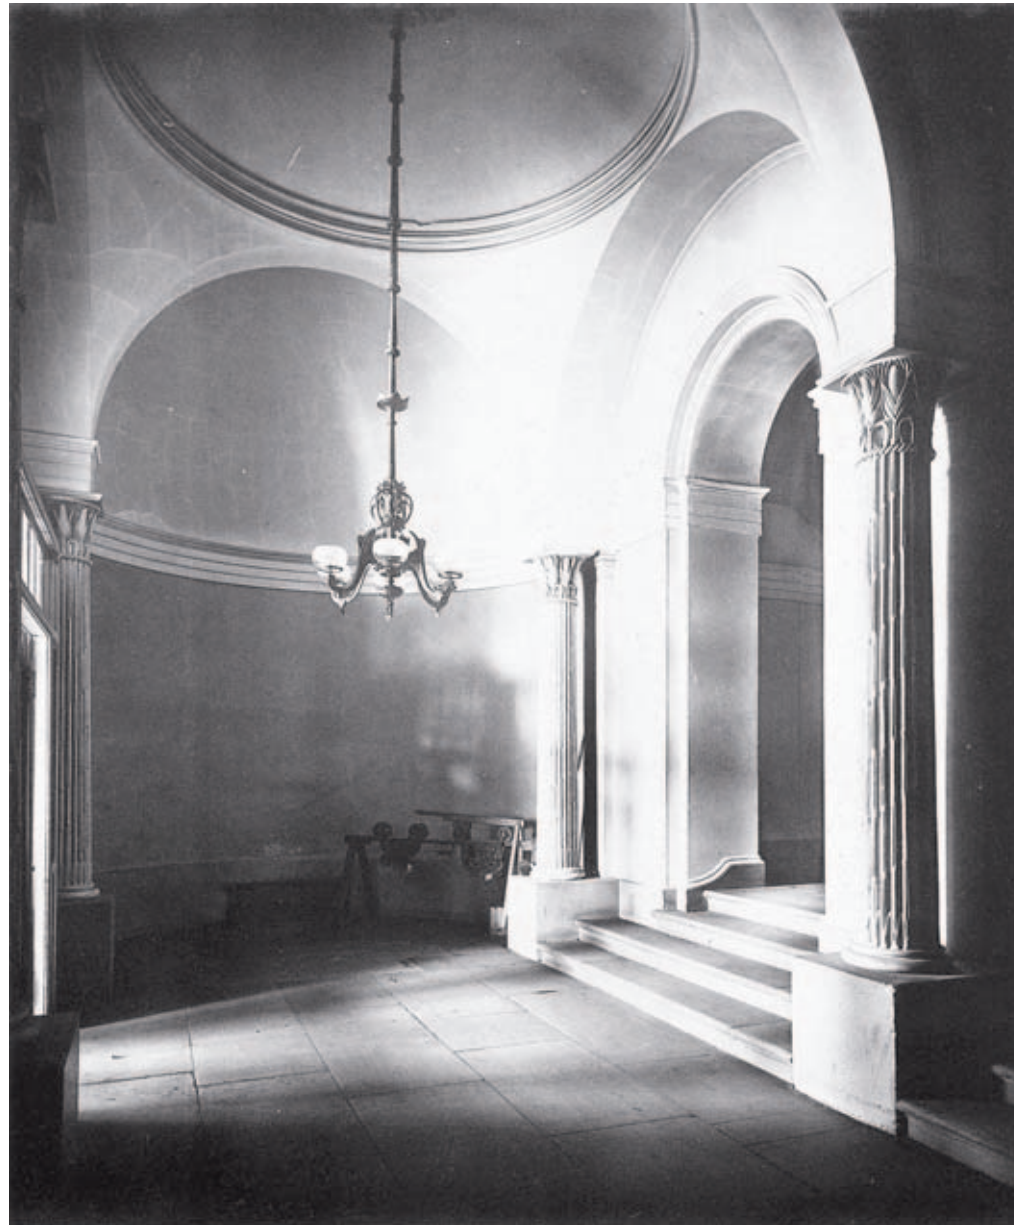
VESTIBULE BASEMENT, NORTH WING.

The exterior door became an interior door when the east front extension was built between 1958 and 1962.

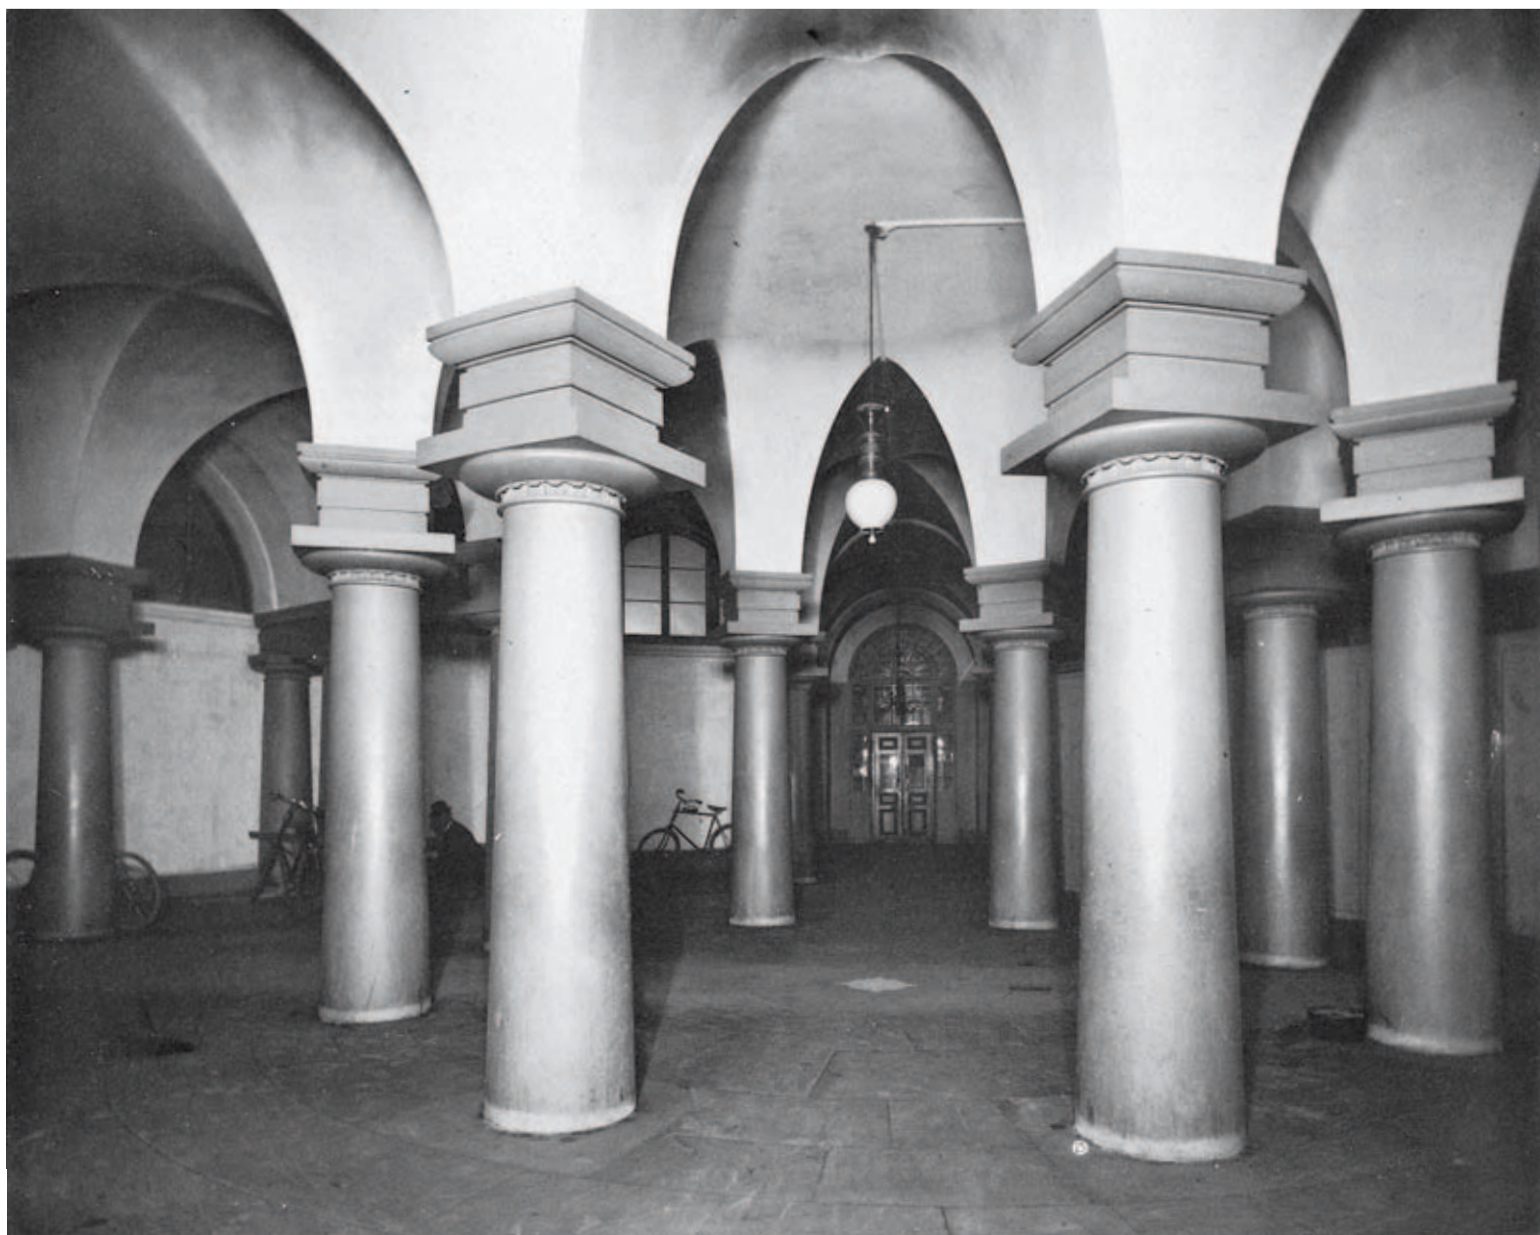
THE CRYPT, OLD CAPITOL.

The crypt, which now houses exhibitions and sculpture, was once an informal storage space where bicycles were parked.

The central portion of the basement is the crypt—a circular room beneath the Rotunda. The floor of the apartment above is supported on groined arches resting upon Doric columns modeled after those of the

Temple of Paestum [Plate 93]. Leading north from the crypt is a passageway to a central hall lighted from above. This was originally intended for the stairway. The brickwork surrounding it has remained through all the changes. Latrobe removed the stairway which led to the Senate above and placed it in the hall to the east, in a particularly out-of-the-way position, where only those familiar with the plan can find it. From this confined hall one doorway led into the Supreme Court, the other into the marshal’s office. On the west side of the elliptical passageway was a door leading to the Law Library. Farther north, on the west side, were the entrances to the apartments of the clerk of the Supreme Court. Near the north entrance were the rooms of the Attorney-General and judges, west and east of the hall, respectively. The entrances to the court room were from the Senate stairway hall and from the lobby in the center of the building. This room is semicircular in plan, with an arched recess on the west, through which an arcaded passageway ran, and on which the groined-arch ceiling, which covered the whole room, rested. On the east of the room is a colonnade, through which the chamber is lighted [Plate 94]. At the present time the room is used as the Supreme Court library. The columns were modeled on the Doric order. The construction of the walls and supports is particularly massive, as the first domed ceiling of the room failed for want of proper abutments. Complaints were made of the lack of light and ventilation in this room. The floor, as late as 1847, was below the general level. On the south of the crypt a passageway led directly to the southern entrance. The stairway to the House of Representatives is a little to the west of this hall; the space was occupied by committee rooms.⁵ A furnace room was in the cellar below for heating the House. The principal story [Plate 95] of the Capitol was reached by the broad

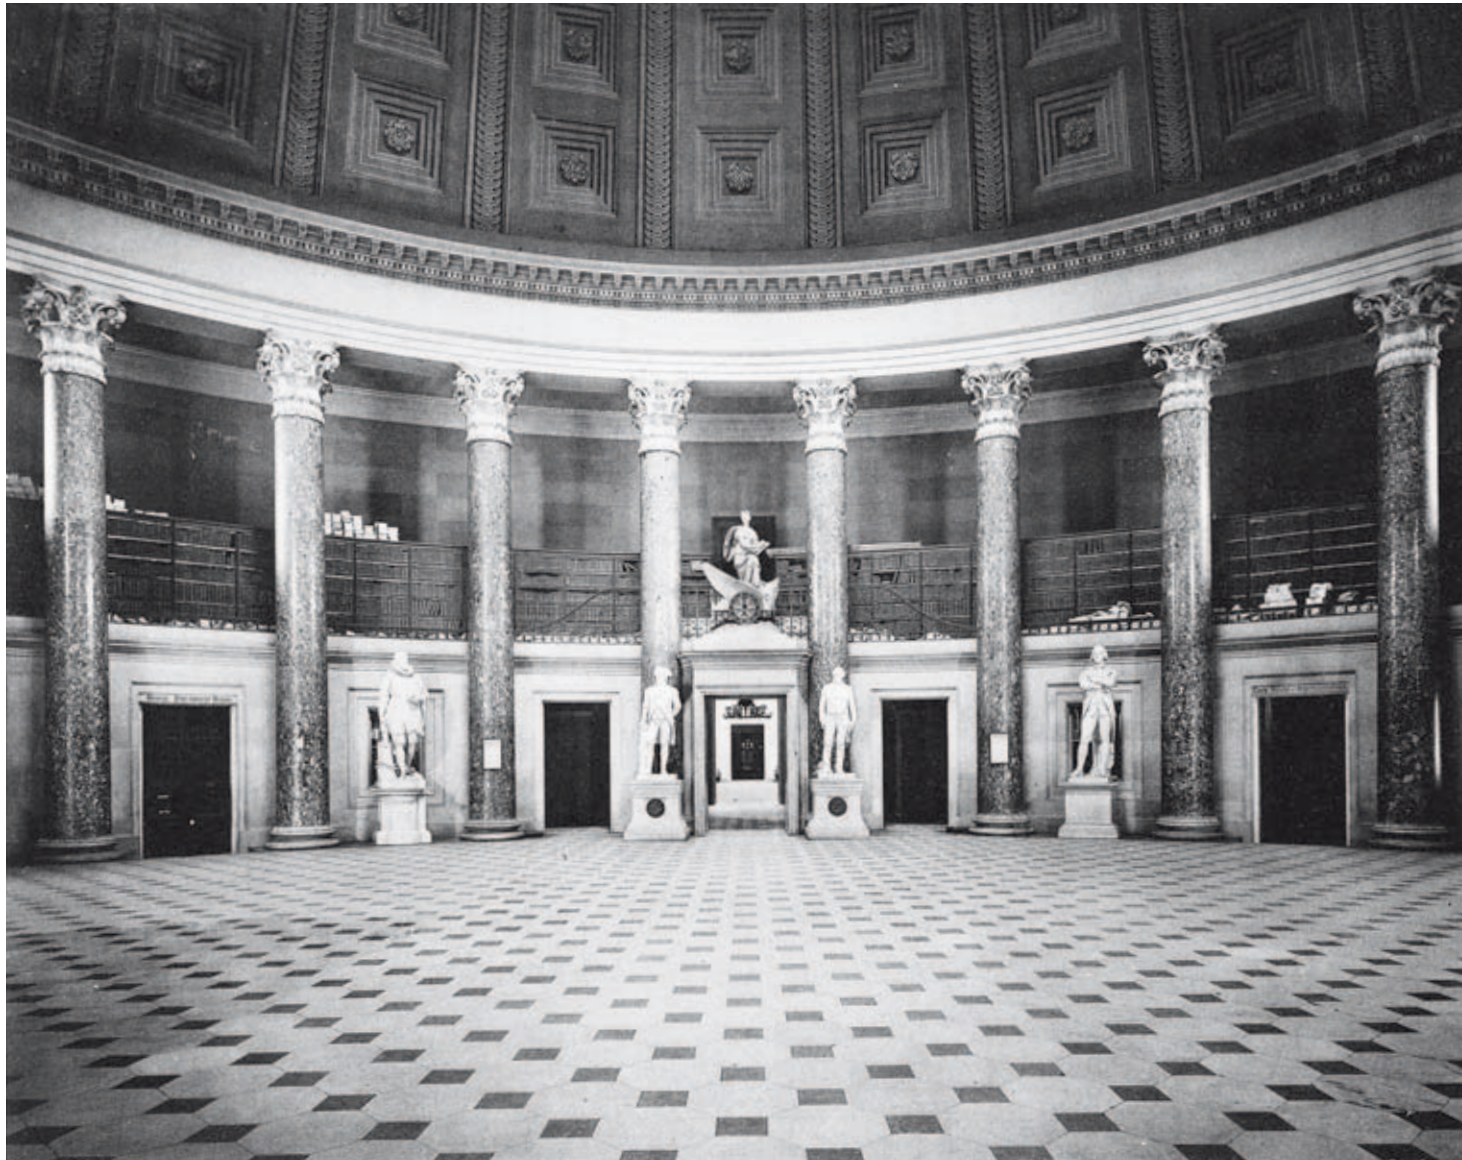
VIEW OF OLD HALL OF REPRESENTATIVES, 1900 A. D. HALL OF STATUARY.

Photograph showing the gallery fitted with shelves for books and documents.

The wooden ceiling, painted to appear coffered, was removed in 1901.

²⁰ This painted wooden ceiling was removed and replaced with a superstructure of cast steel in 1901. *Annual Report of the Superintendent of the Capitol* (Washington: Government Printing Office, 1902).

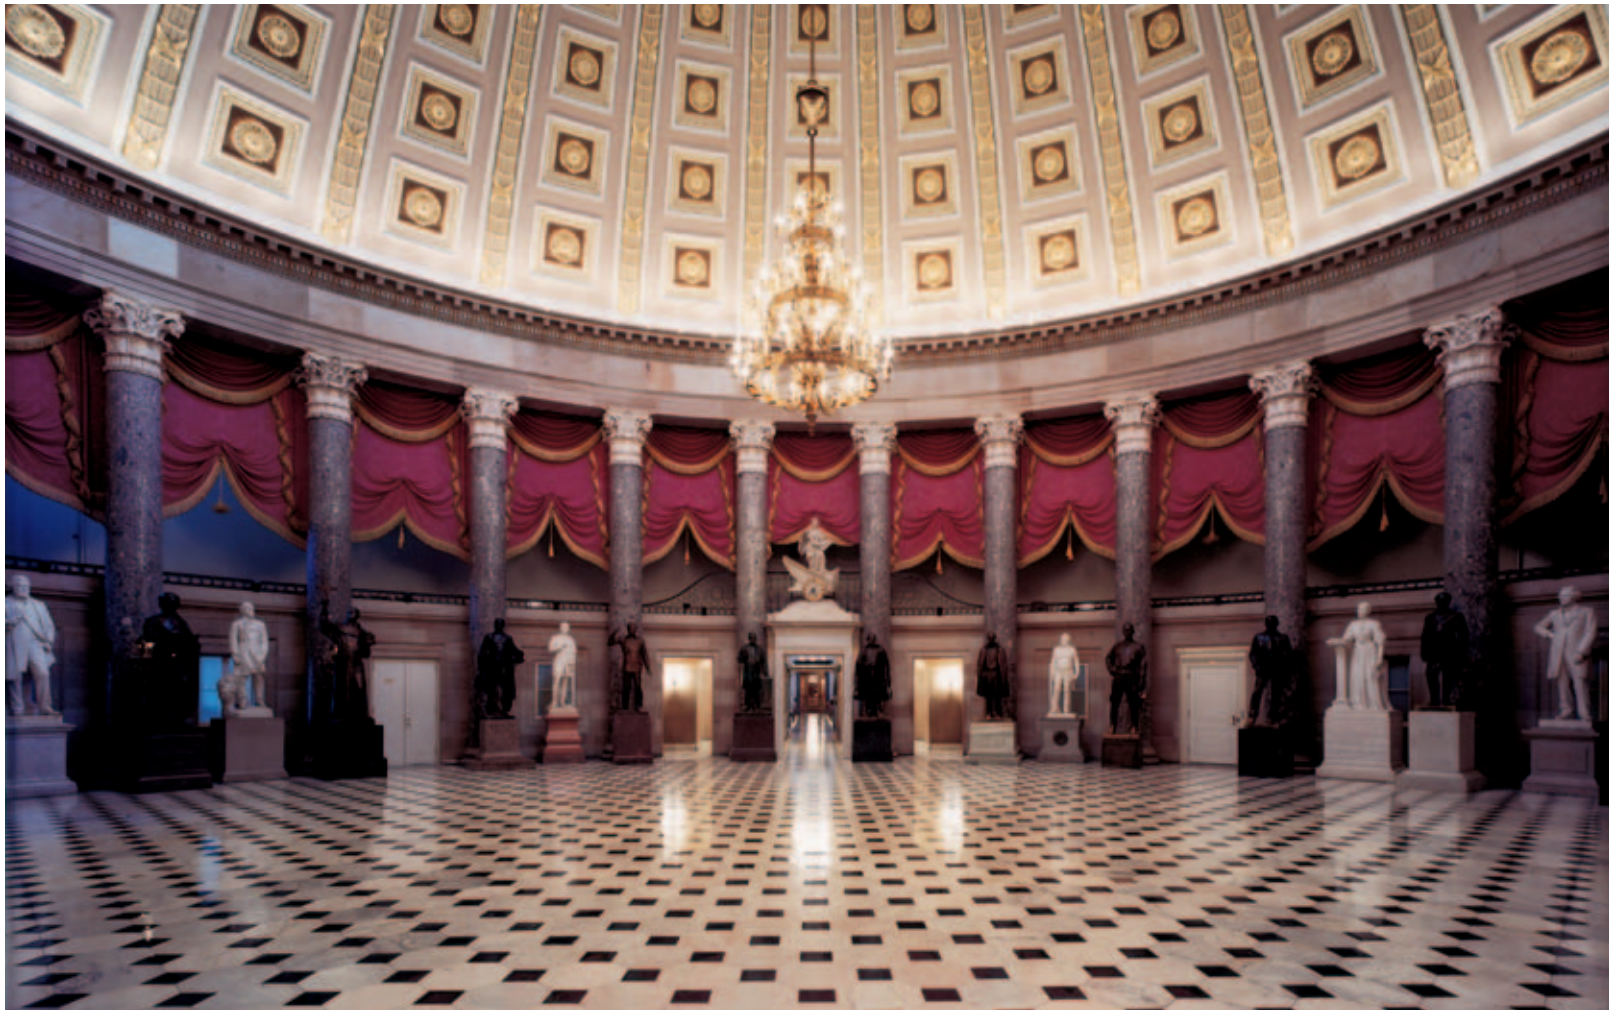
Statuary Hall (Old Hall of the House of Representatives). The fireproof ceiling installed in 1901 was recently restored.

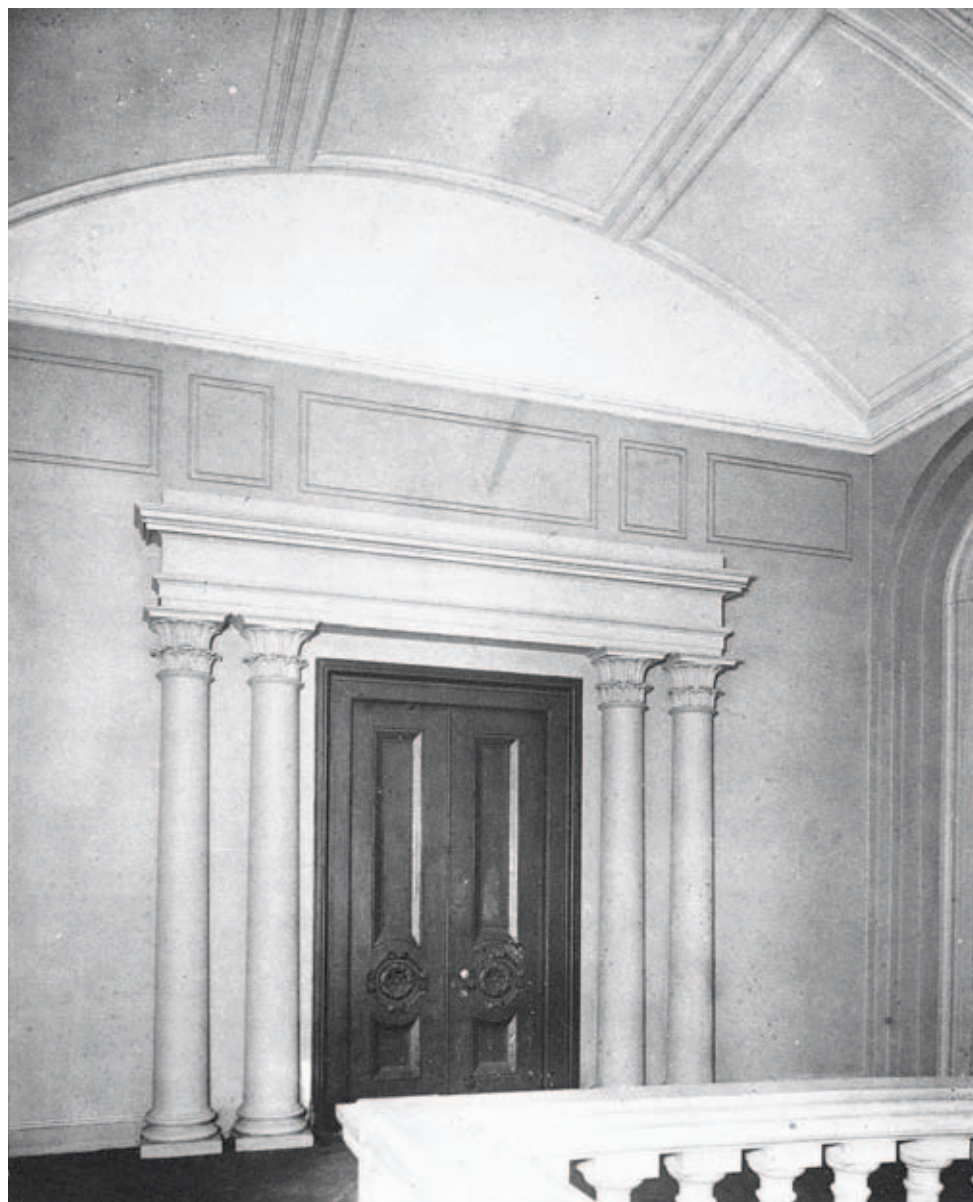
ENTRANCE TO OLD CONGRESSIONAL LIBRARY.

This entrance is no longer extant. The Library of Congress space on the west central side of the Capitol was rebuilt into office space in 1900.

The western door from the Rotunda, passing around both sides of the principal western staircase, leads to the Library [Plate 104], which is situated in the western projection, at the entrance of which are two

marble columns modeled from the Octagon Tower in Athens. There are similar columns at the door opening out on the western colonnade. The original Library occupied only the front portion of the building, and was without the two rooms on the north and south which are familiar to visitors at the present time.

The old portion of the room was 92 feet long, 34 feet wide, and 36 feet high. Extending the whole length of the room was (I say was, for the interior has been changed) a series of alcoves ornamented in front with fluted pilasters which, with their entablature, supported two galleries, divided as below into twelve shelved recesses. Above these sprung the great arch forming the ceiling, decorated with enriched panels, borders, and wreaths of flowers, and pierced with three circular ornamented apertures, which admitted the light and ventilated the room. "A table and chair were in each alcove." The cases were glazed and labeled. This room was heated by furnace from below. The stairway to the north of the Rotunda led to the third story, occupied by committee rooms. The stairway continued to the roof, thence on the exterior of and over the roof to the top of the Dome. The House of Representatives, Senate, and Library in height occupied the space of two stories or extended from the principal floor to the roof. The other portions of the attic story were used by the Houses of Congress [Plate 105].¹⁴
