# MELVILLE CONDITION SURVEY

Rhode Island Port Authority and  
Economic Development Corporation

July 1, 1982

RE: Melville Condition Survey  
CEM No. 4001

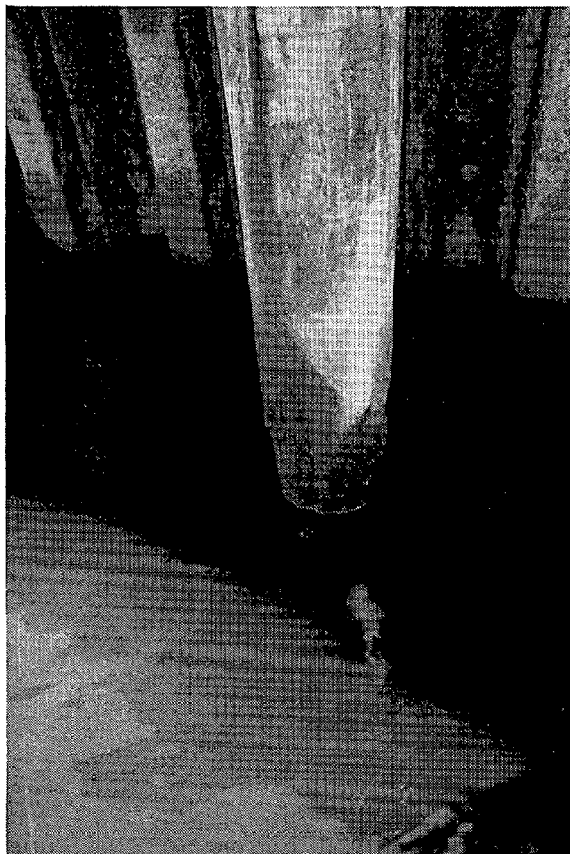
PHOTO 2 - MARINE BORER  
ATTACK OF TIMBER FENDER  
PILE

indicative of a recent repair. Untreated fender piles showed marine borer activity at low water; the treated piles did not. (See photo 2)

Several fender piles revealed signs of marine borer attack at the waterline and mudline. Piles showed as much as a 2 inch reduction in cross sectional diameter. Note that borer attack was noted in fender piles only and not in foundation piles. A probable explanation is that the foundation piles were treated with either a different type of preservative or higher concentration of the preservative.

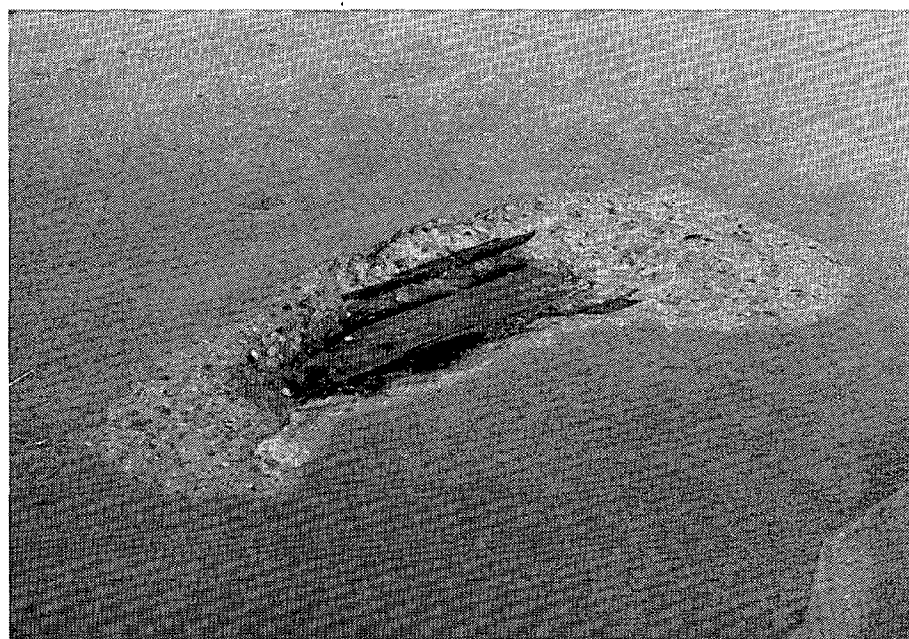
PHOTO 4 - SPALLED CONCRETE DECK AT THE FBM PIER  
NOTE SPLIT PIPE AT LOWER EDGE OF SPALL

FBM Pier & Access Trestle: The FBM pier appeared in excellent condition except for isolated damage as noted in the field notes. There are three small areas on the deck which require minor concrete repairs one of which was most probably caused by the freezing and expansion of an encased steel conduit. See photo 4.
