# Investigation of L'Ambiance Plaza Building Collapse in Bridgeport, Connecticut

Center for Building Technology  
National Engineering Laboratory  
National Bureau of Standards  
Gaithersburg, MD 20899

Issued September 1987

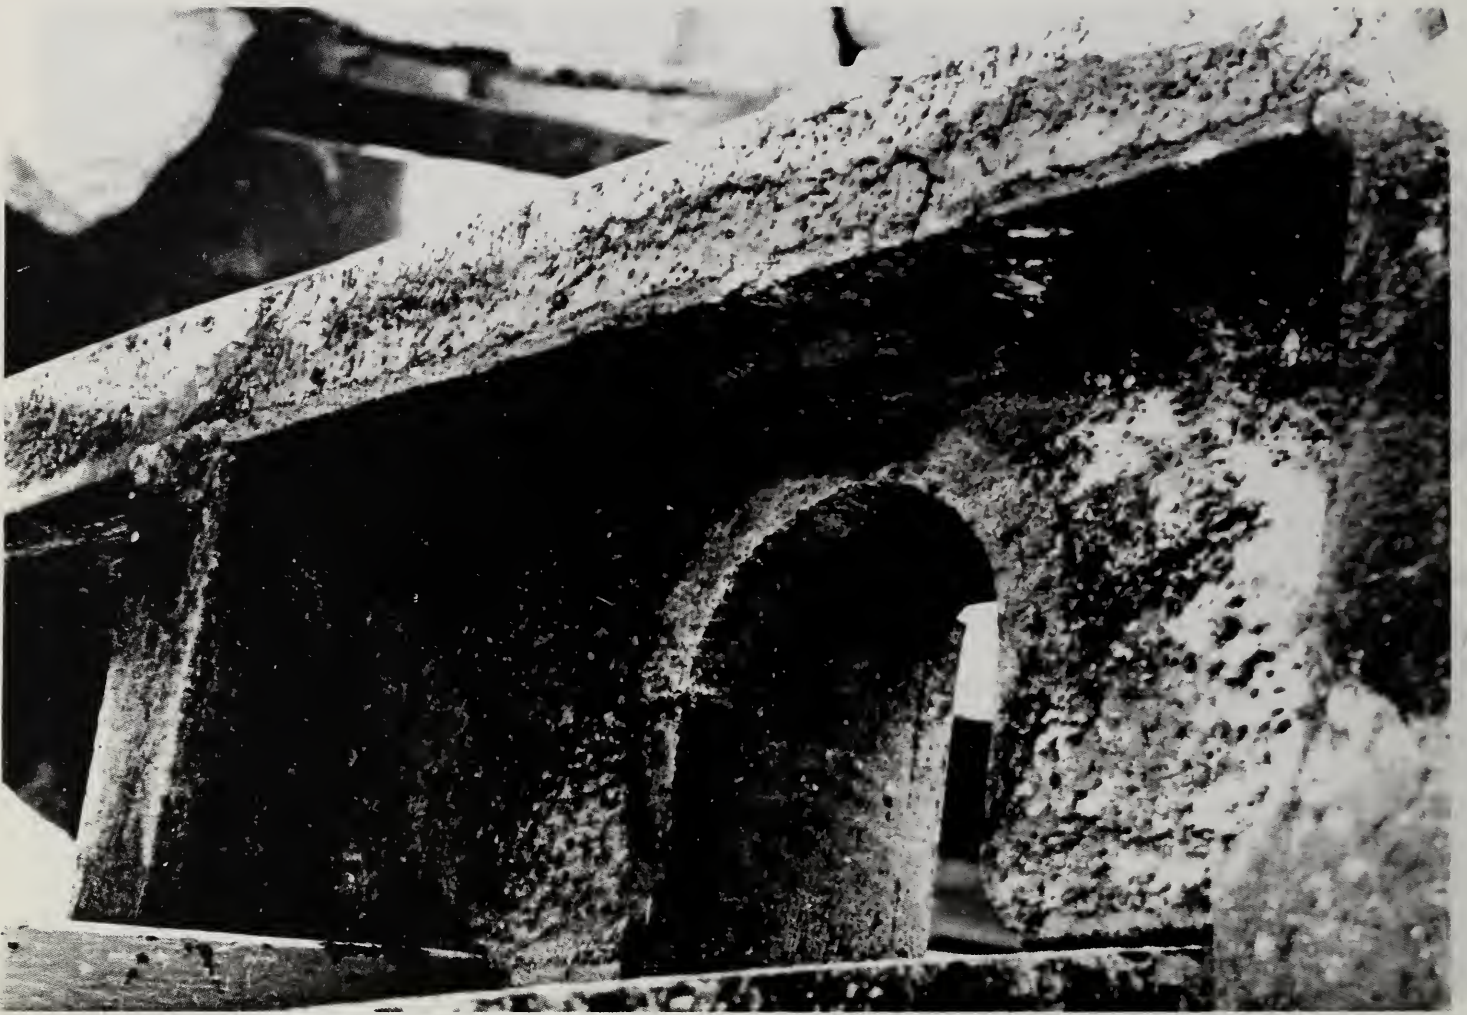
Figure 4.4.33 Typical indentation in underside of lifting angle

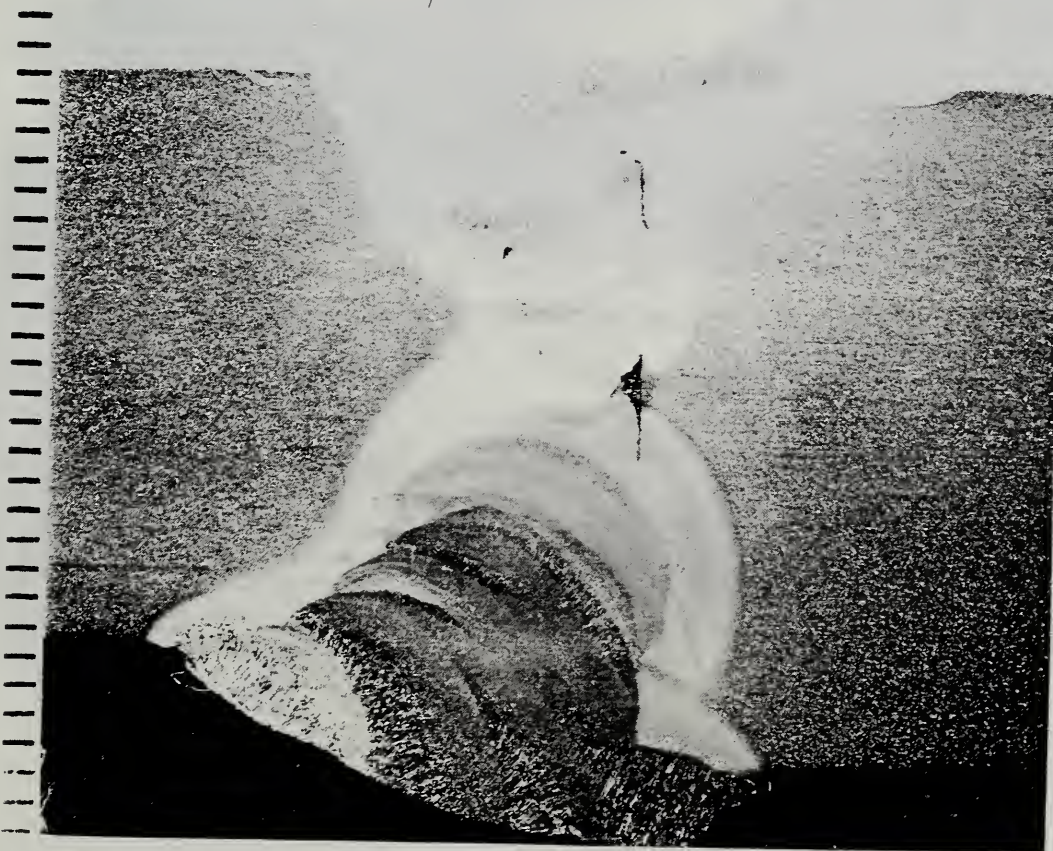
Figure 5.4.10 Cross section showing the weld in specimen NBS 4-F1 (x 4)

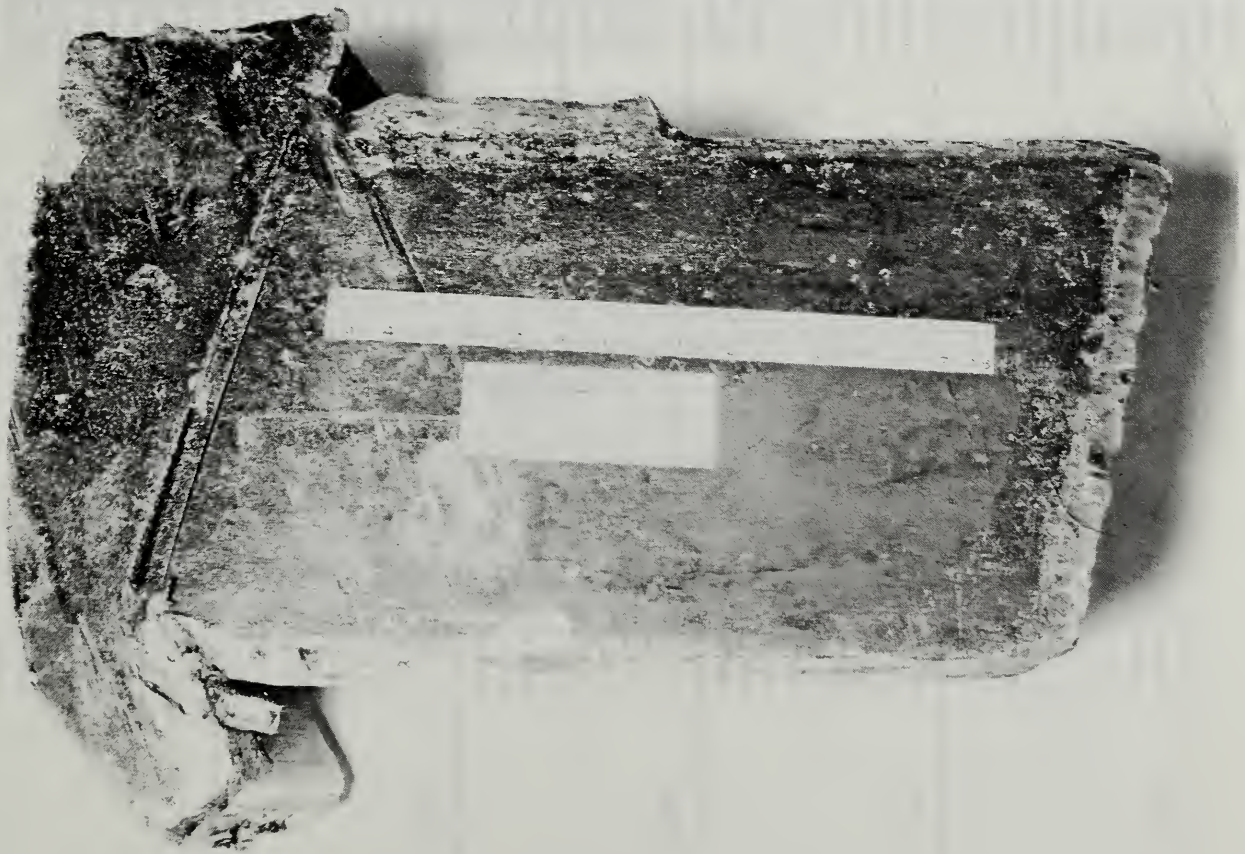
Figure 5.4.13 NBS specimen 33A, weld block/wedge sample from debris

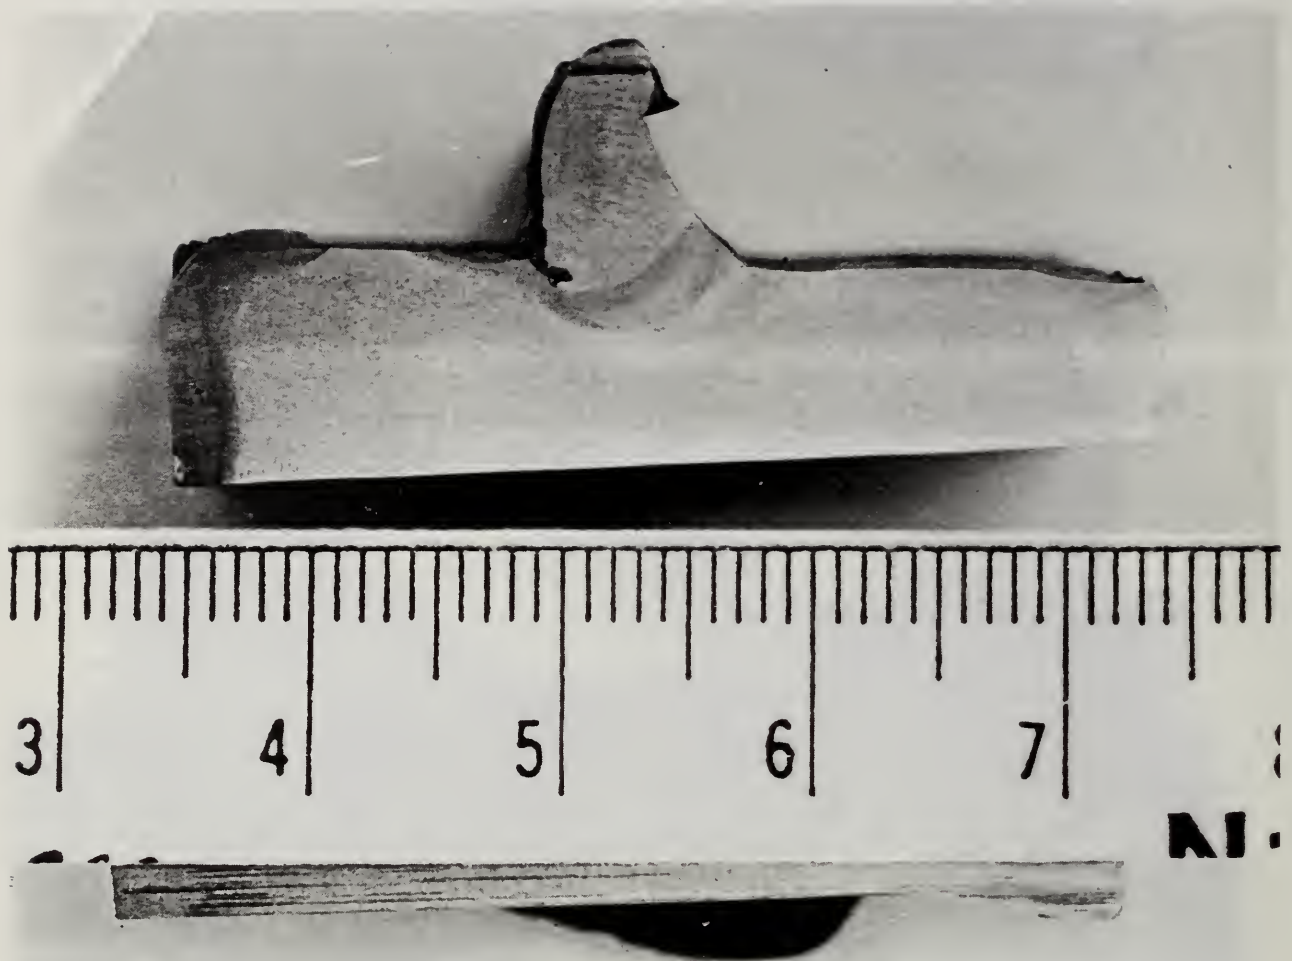
Figure 5.4.14 Metallographic cross section #1 -  
specimen NBS 33B

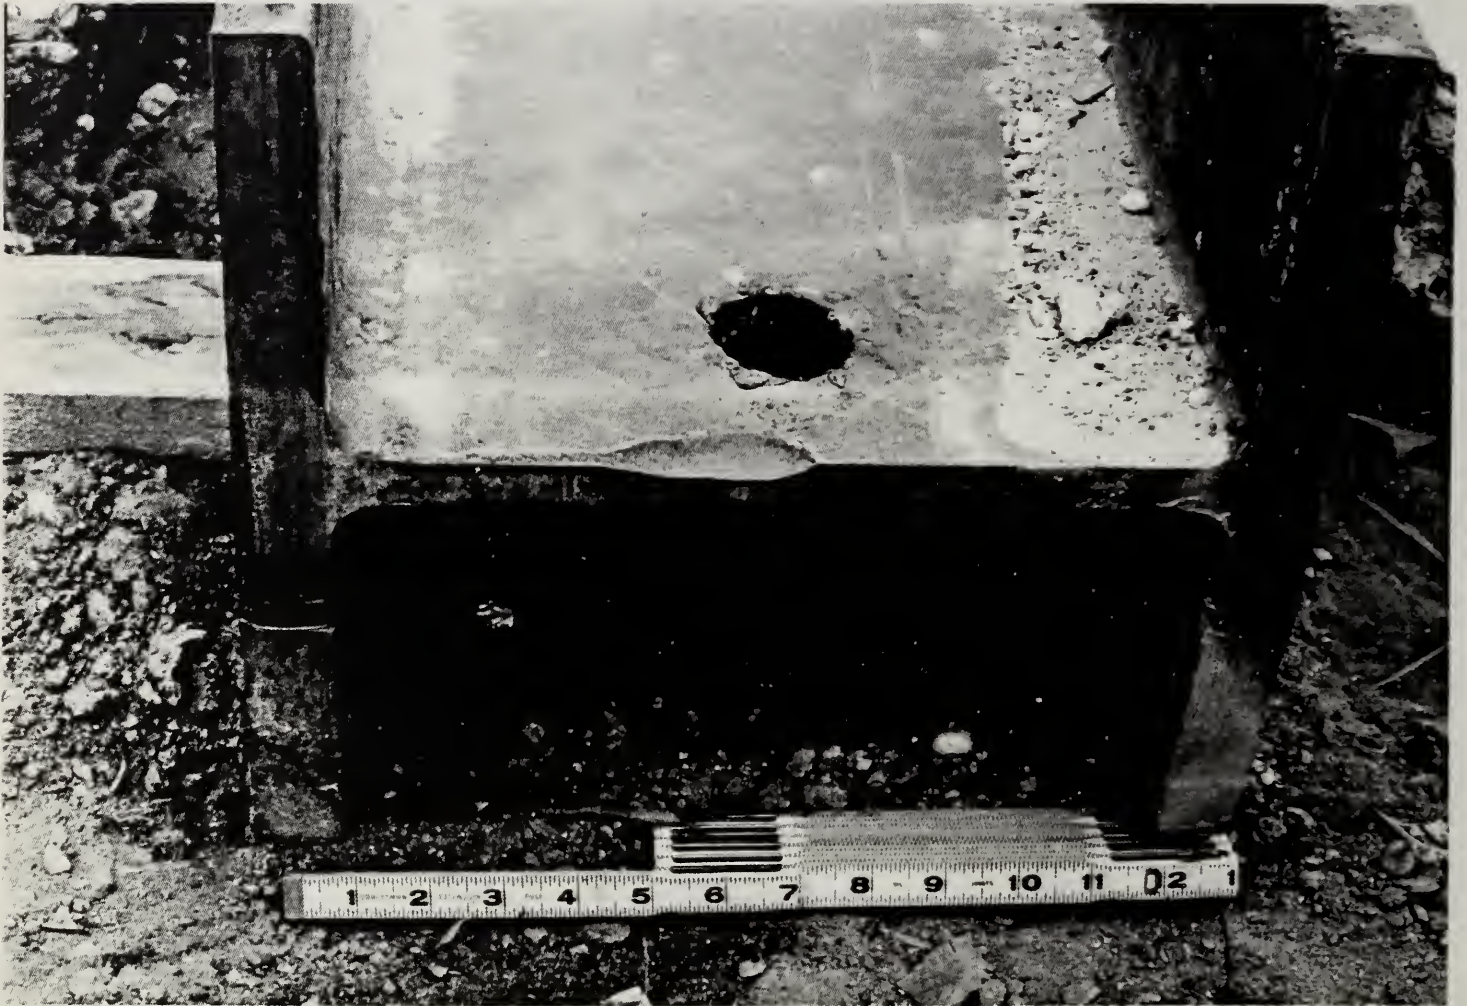
Figure 9.3.1 Indentation in top of column E4.8

The top of column E4.8 is shown in figure 9.3.1. The form of the indentations suggests that one of the jack rods lost its load, allowing the jack to roll off the column top and chamfering the edge of the web. An examination of the column showed the existence of lifting nut impact marks on each side of the web at approximately 52 in (1.32 m) below the top of the column. These impact marks are an indication that each of the lifting nuts "kicked out" from under the lifting angles on the shearhead at slab 9. The bottom surfaces of the lifting angles are shown in figure 9.3.2. The bearing surface on the left clearly shows the lifting nut contact area. The contact area on the right is
