NBSIR 84-2858 (R)

Report No. 11

Observations of the April 8, 1979 Railroad Accident at Crestview, Florida

April 1984

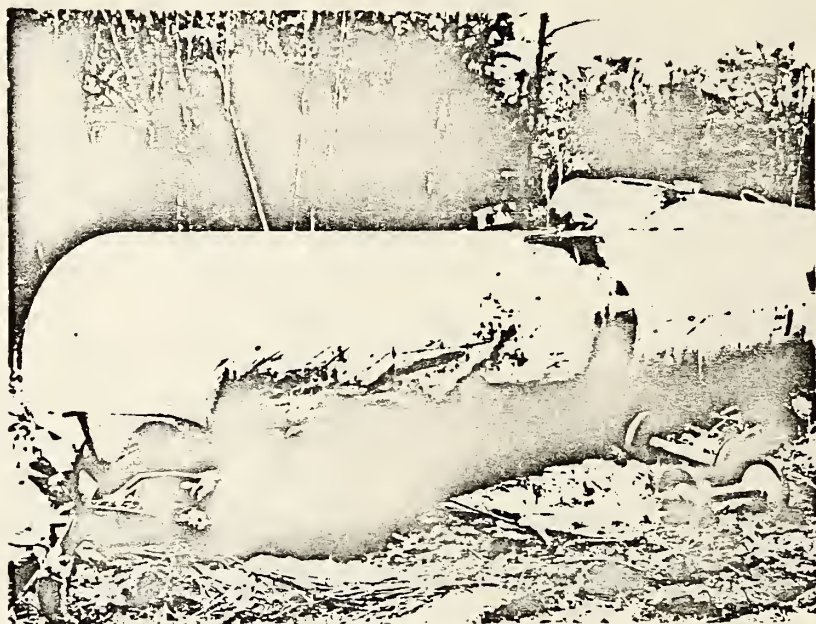
Photo 1-4: B-end of tank-car GATX 55836.

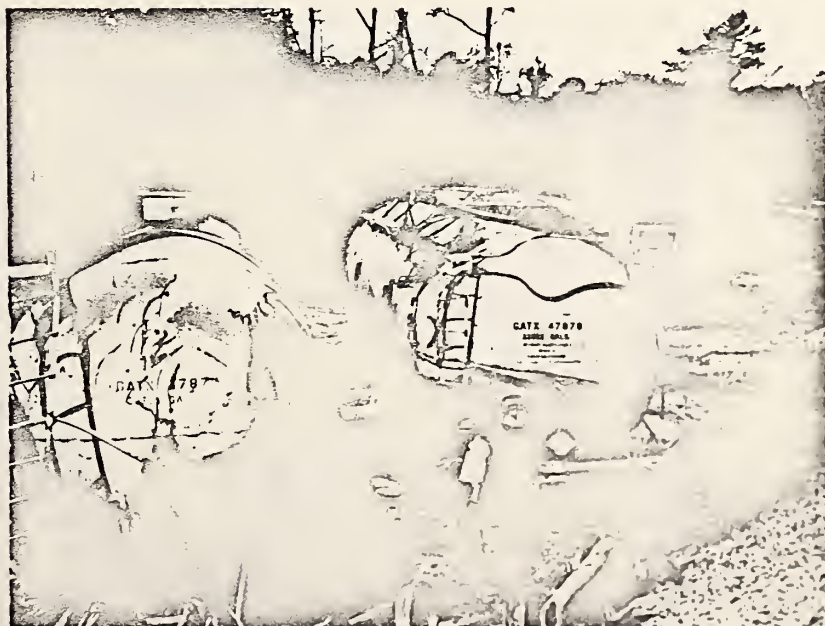
Photo 1-8: Tank-cars GATX 47872 (left) and GATX 47878 (right).

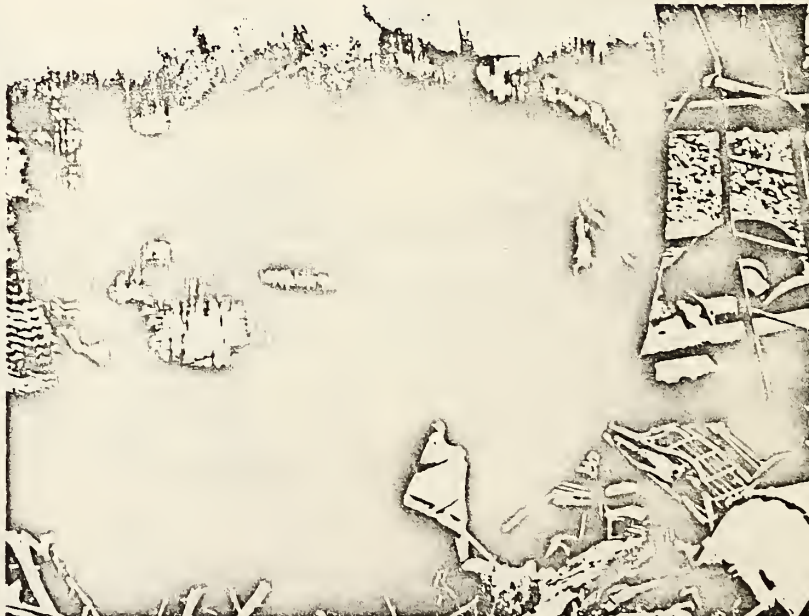
Photo C1-11: B-end of tank-car GATX 47872.

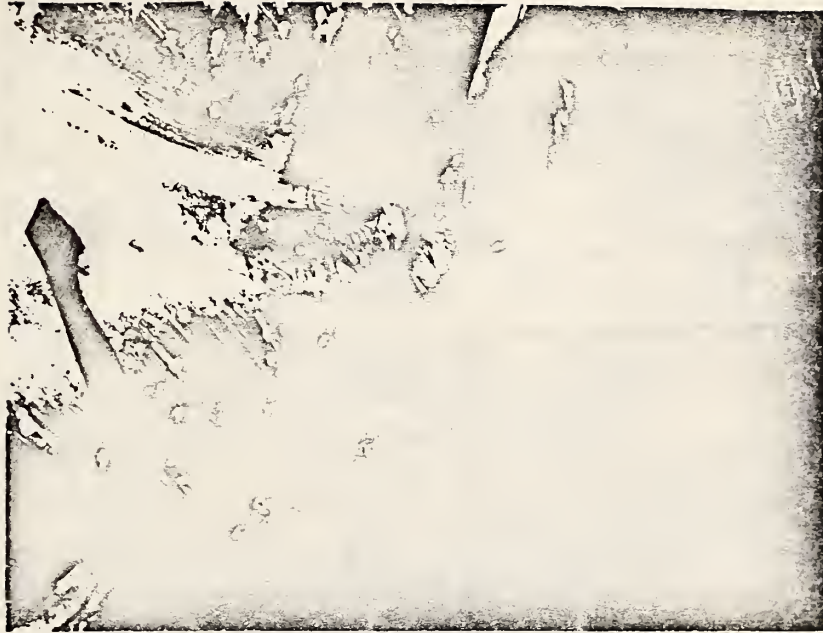
Photo C1-14: Tank-car 47872.

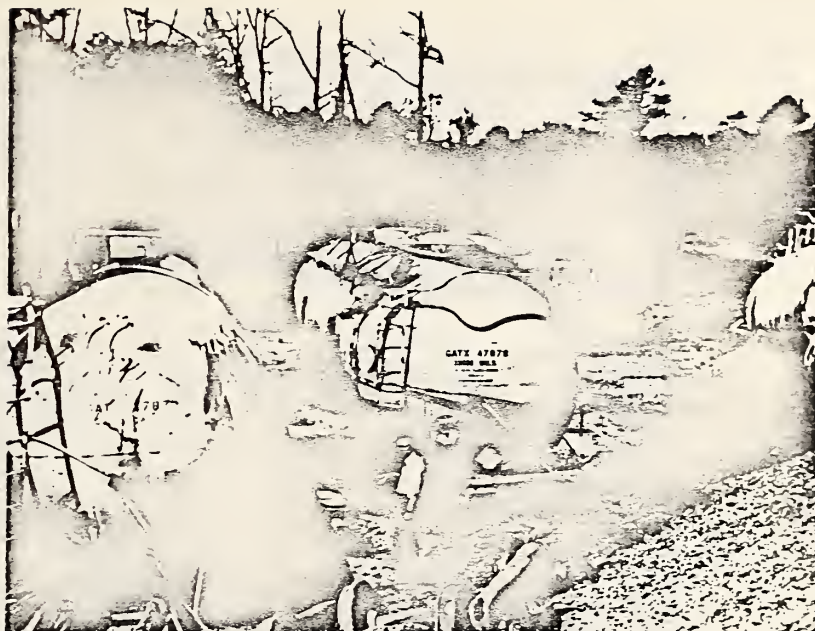
Jacket: No Jacket _____ or Describe: Dented and scratched, and ruptured (see 1-8 and 1-8B) in head (small) and shell area (larger).

Photo 1-8: Tank-cars GATX 47878 (right) and GATX 47872 (left).

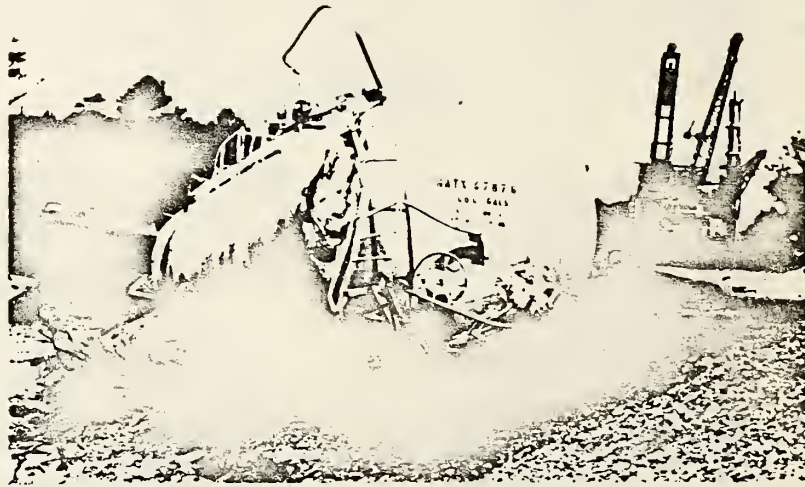
Jacket: No Jacket _____ or Describe: Damaged at one end. Both A
and B-heads jackets have dents at edge.

Photo 1-9: B head of tank-car GATX 47876.

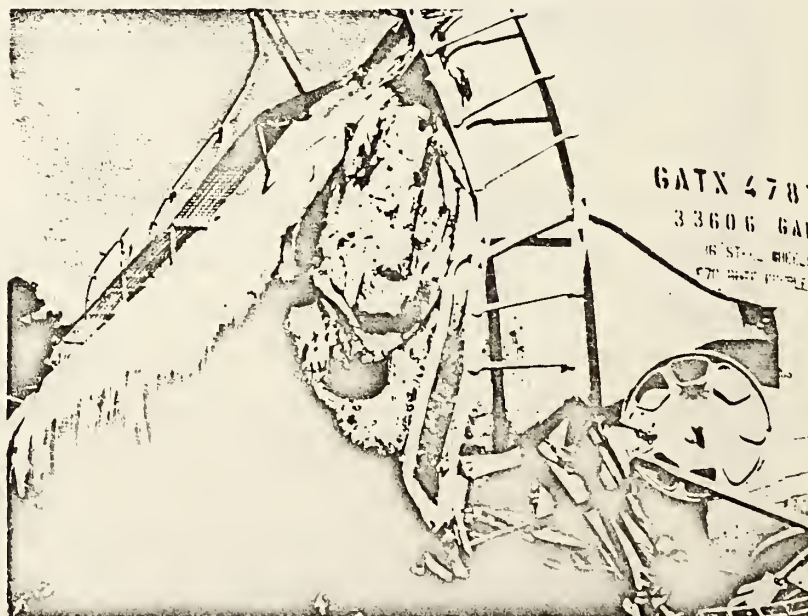
Photo C1-13. Closer view of the B head of tank-car GATX 47876.

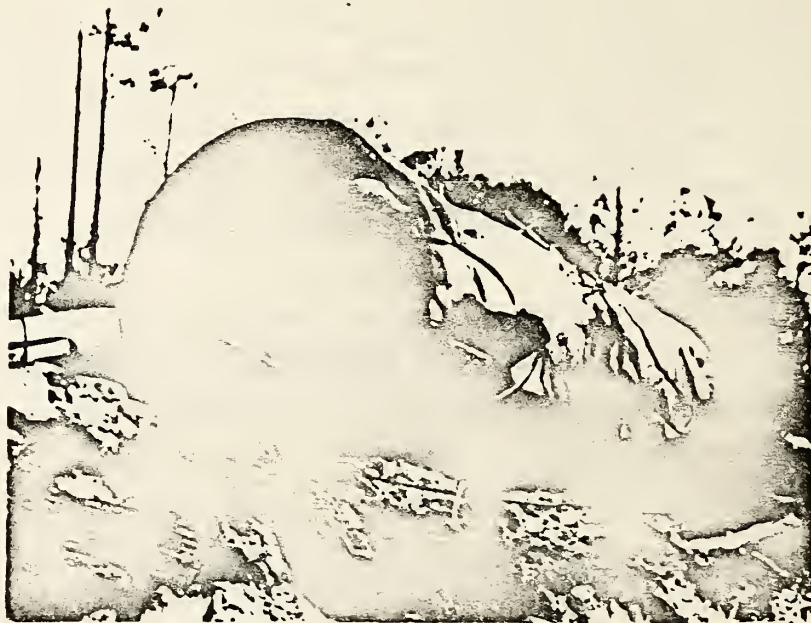
Jacket: No Jacket _____ or Describe: Badly damaged. Severe dents in both A and B-heads.

Photo 1-10: A-head of tank-car GATX 92097.

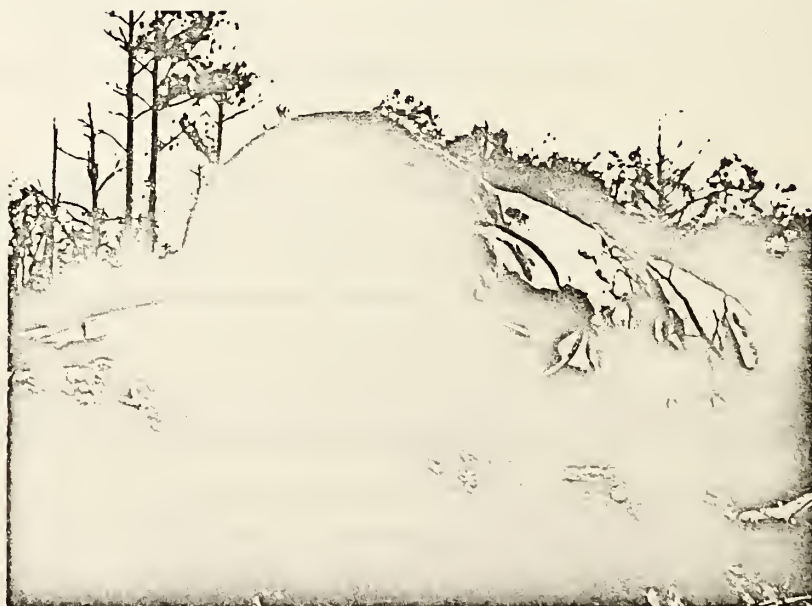
Photo 1-11: A-head of tank-car GATX 92097.

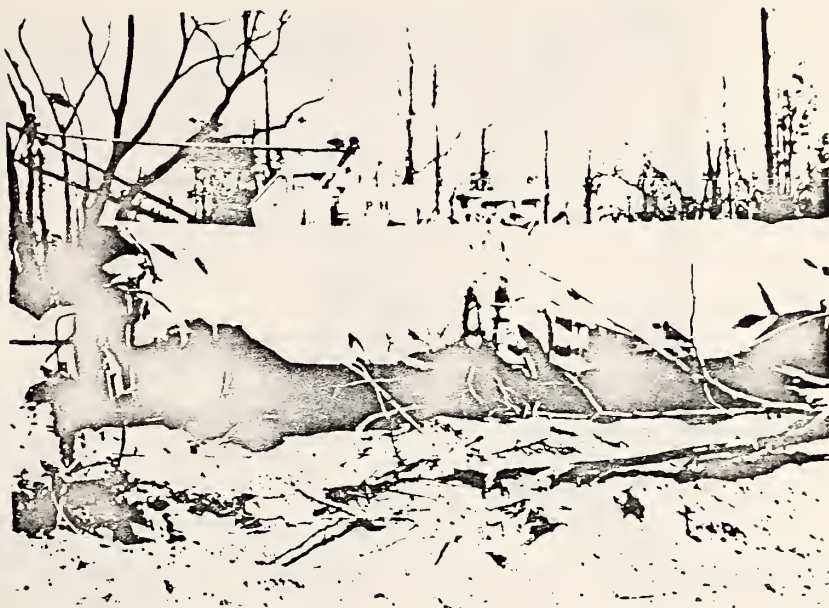
Photo C1-17: A-end of tank-car GATX 92097.

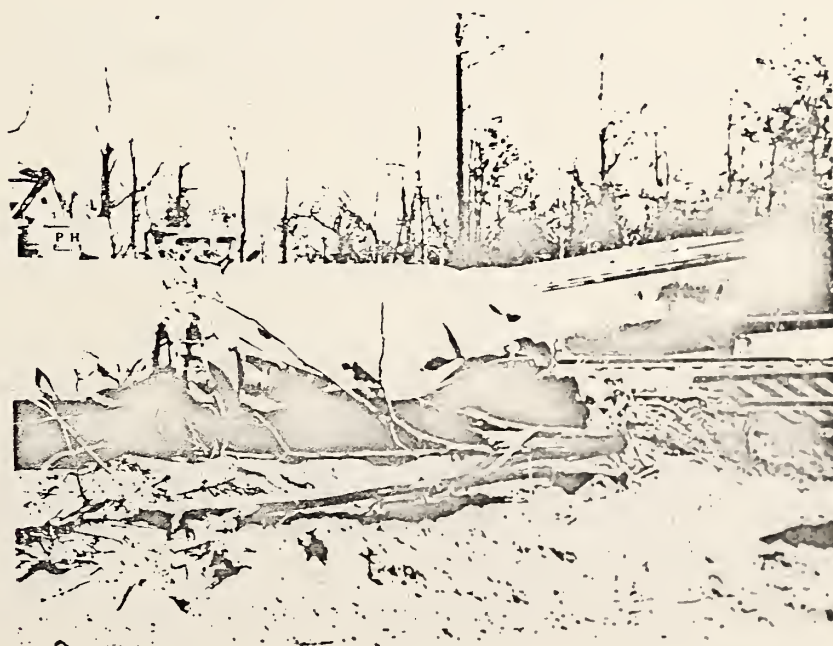
Photo C1-18: B-end of tank-car GATX 92097.

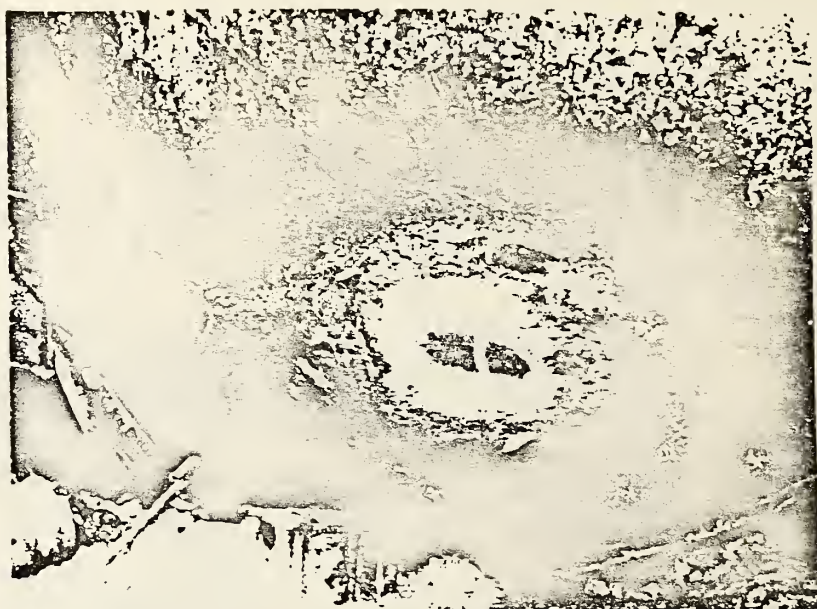
Photo C2-1: B head of tank-car GATX 92097.

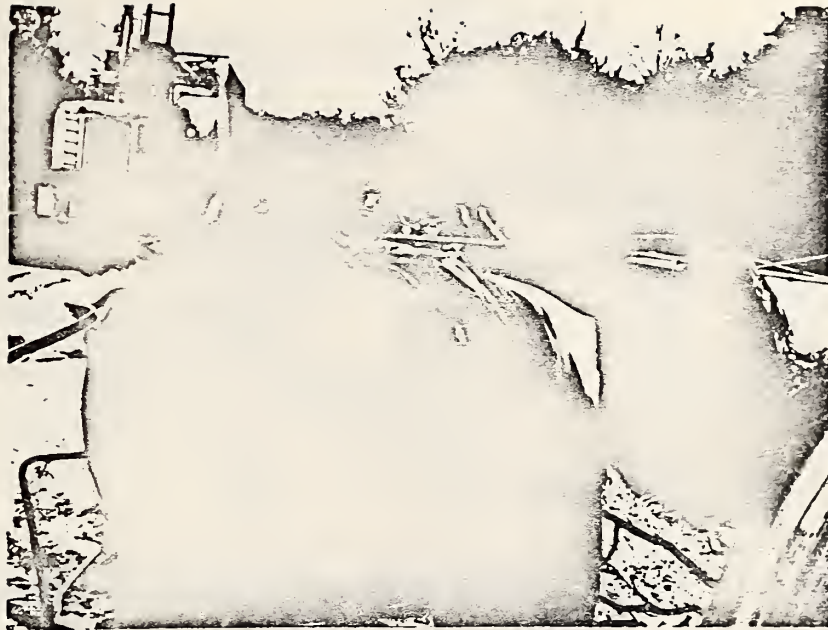
Photo 1-22: A-head of tank-car GATX 44019.

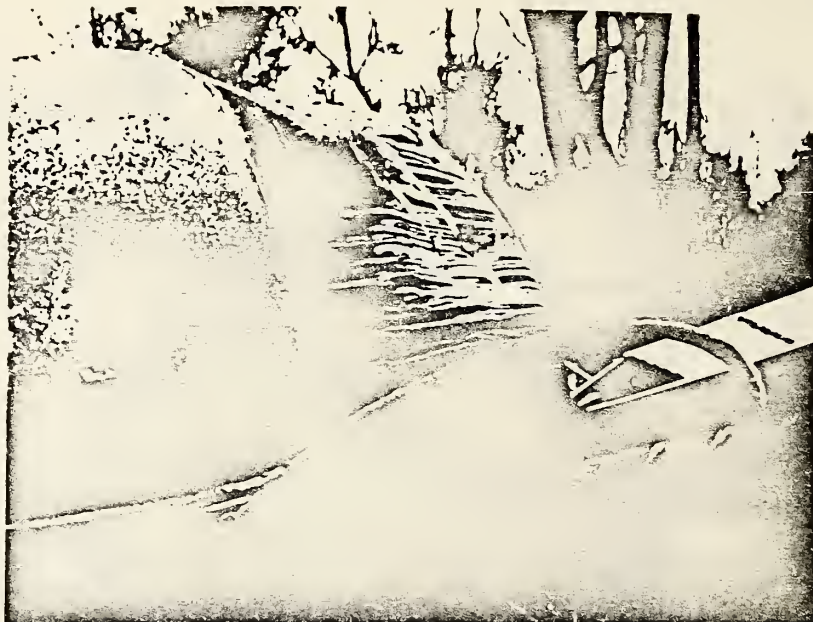
Photo C2-6: Close-up view of the A-head of tank-car GATX 44019.

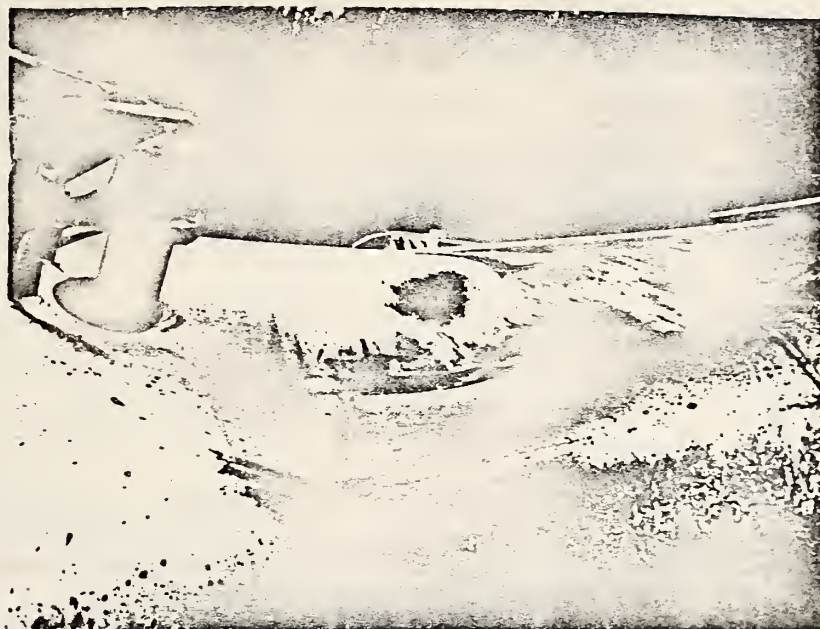
Photo 1-20: Large dent in the top of tank-car
GATX 44019.

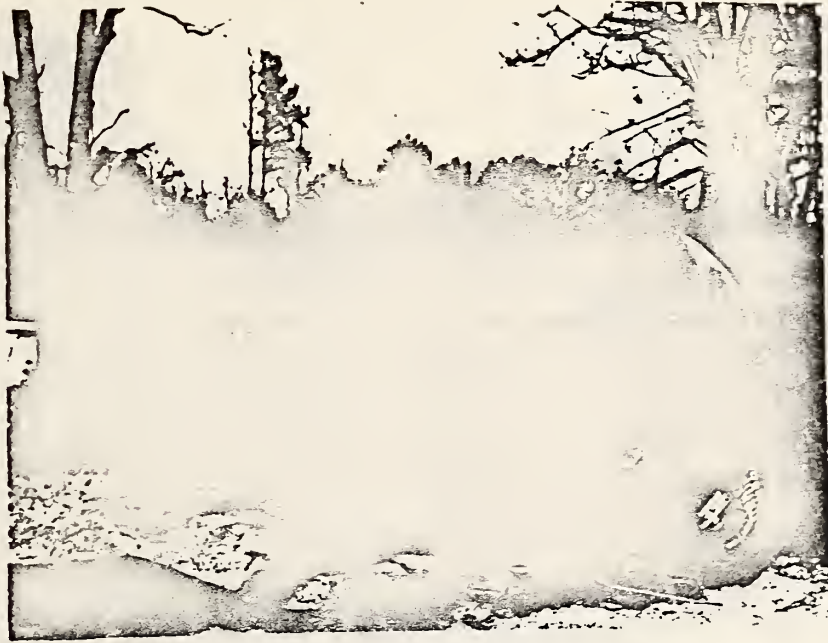
Photo 2-21: B-end of tank-car NATX 23367.

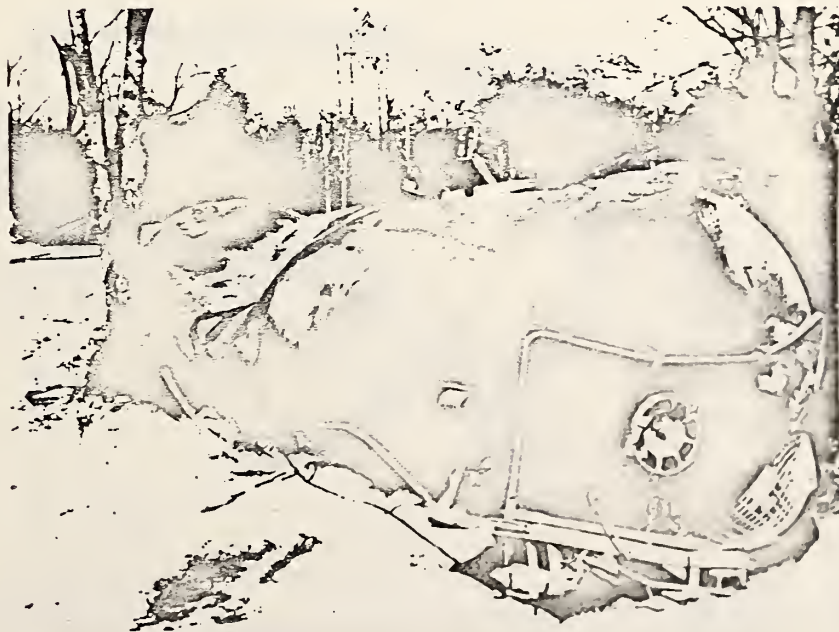
Photo C3-11: B-end of tank-car NATX 23367.

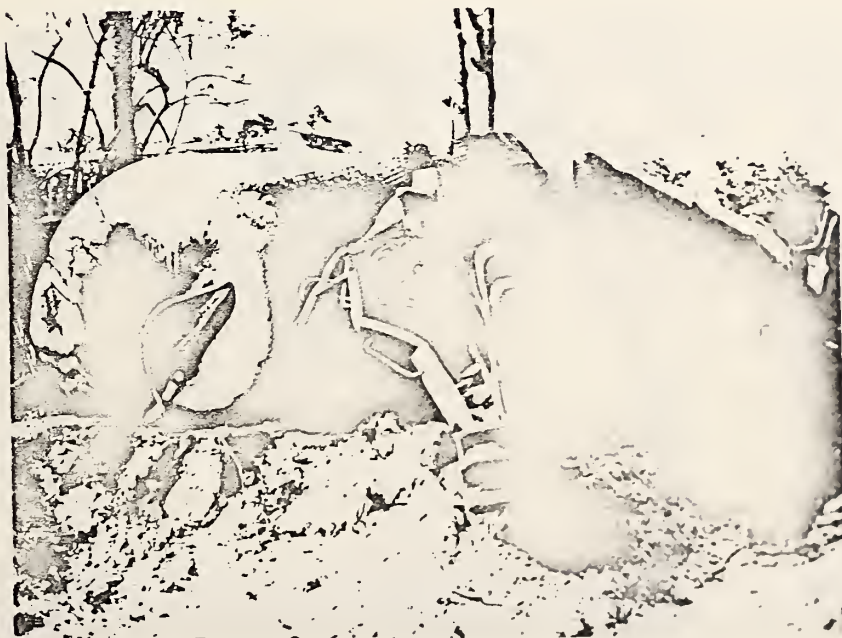
Photo C3-14: Tank-car ACFX 81395.

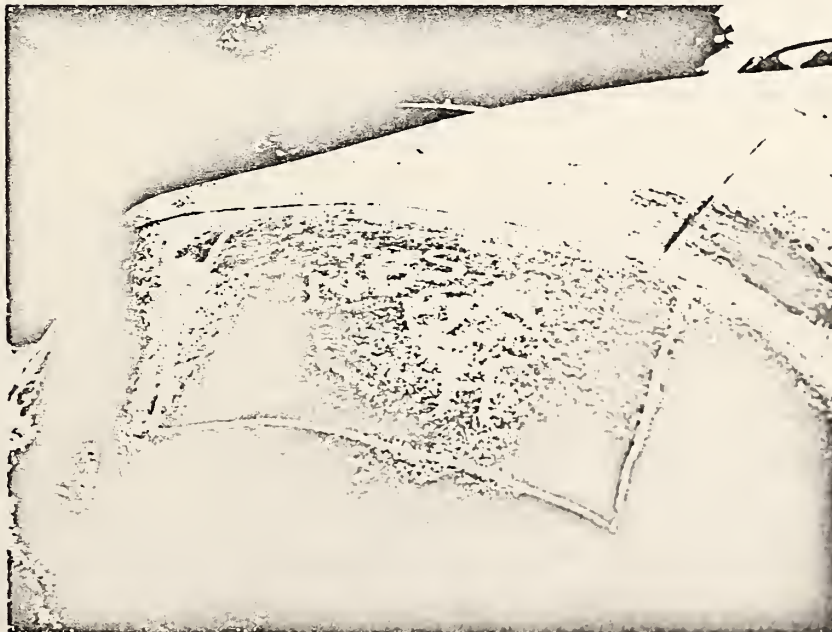
NBS 13 is located in two shell courses (one contains 63" rupture); NBS 13A is located in the severely dented head plate, but it is in a relatively undeformed part of this head plate.

Photo C5-9: Close-up of sample NBS 13A marked on the B-head-plate of tank-car ACFX 81395.

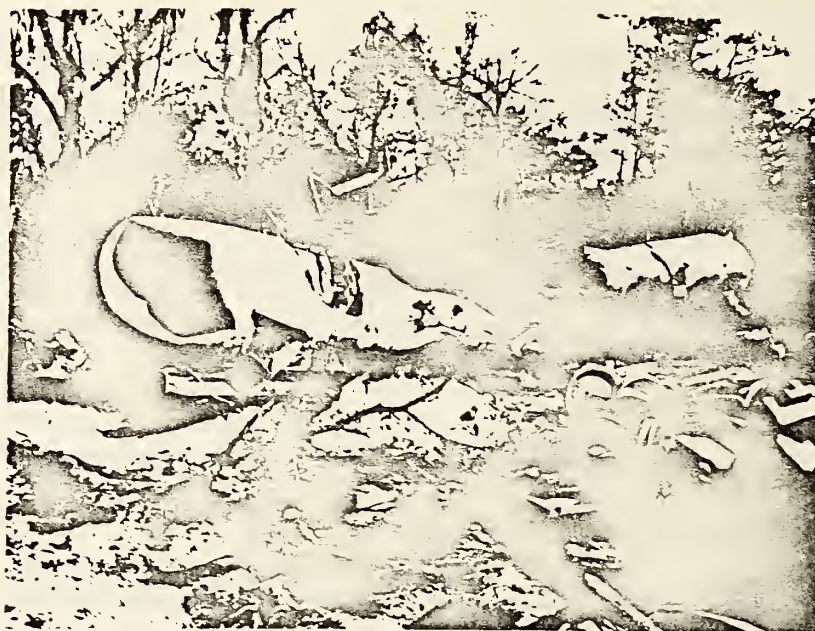
Photo C3-12: A-end of tank-car ACFX 82959 (left) and tank-car IMCX 2827 (right).

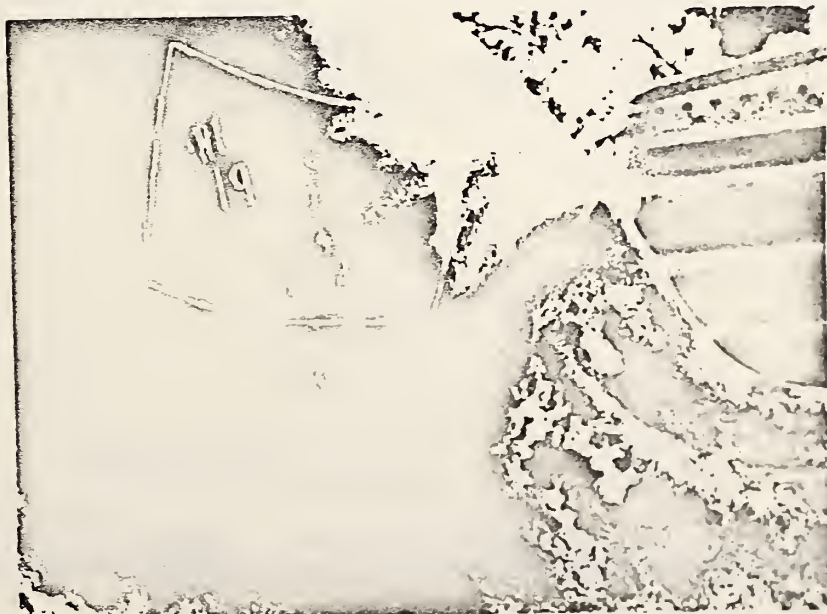
Photo C4-22: B-end of tank-car ACFX 82959 showing sample NBS 19.

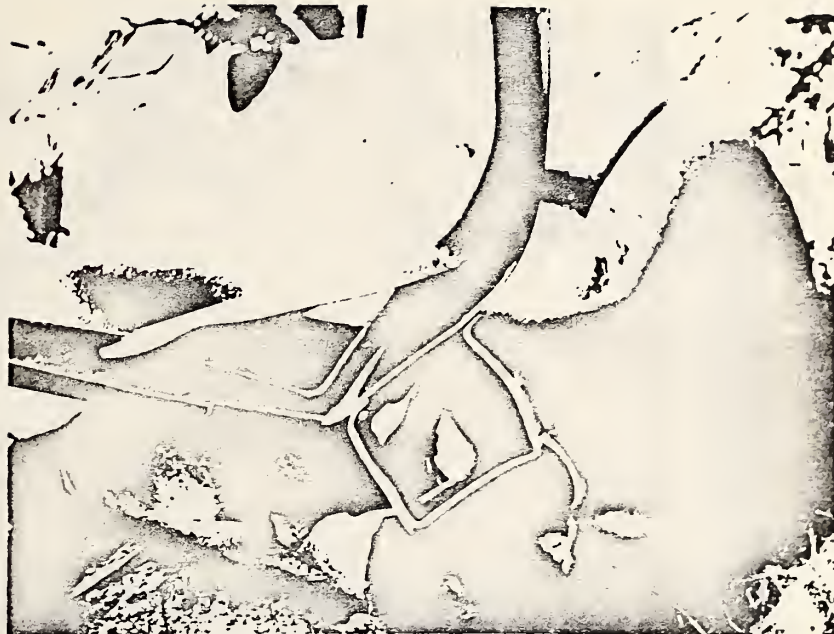
Photo C3-19: B-end of tank-car ACFX 82959 showing a large hole at the end of the car.

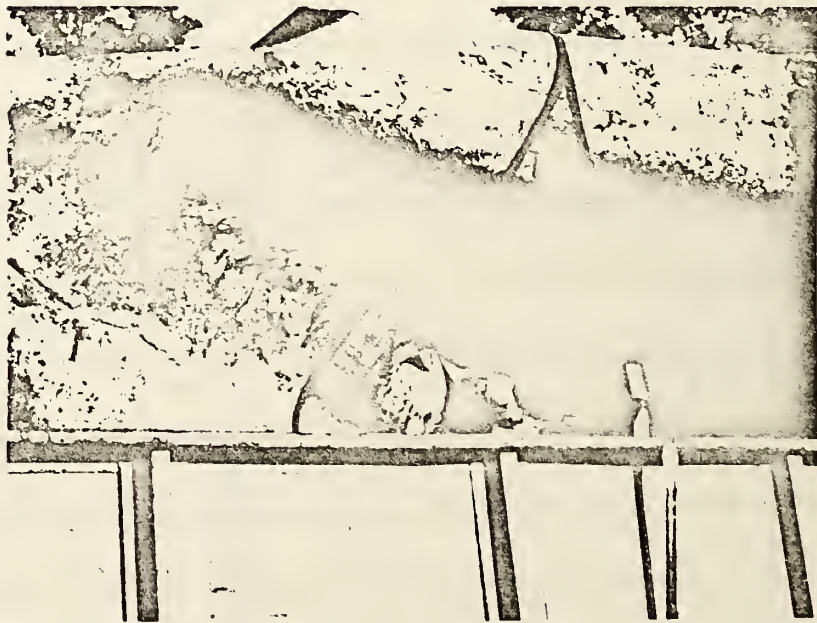
Photo C4-15: A-end tub of tank-car ACFX 89990 being carried in a gondola car showing a large hole.

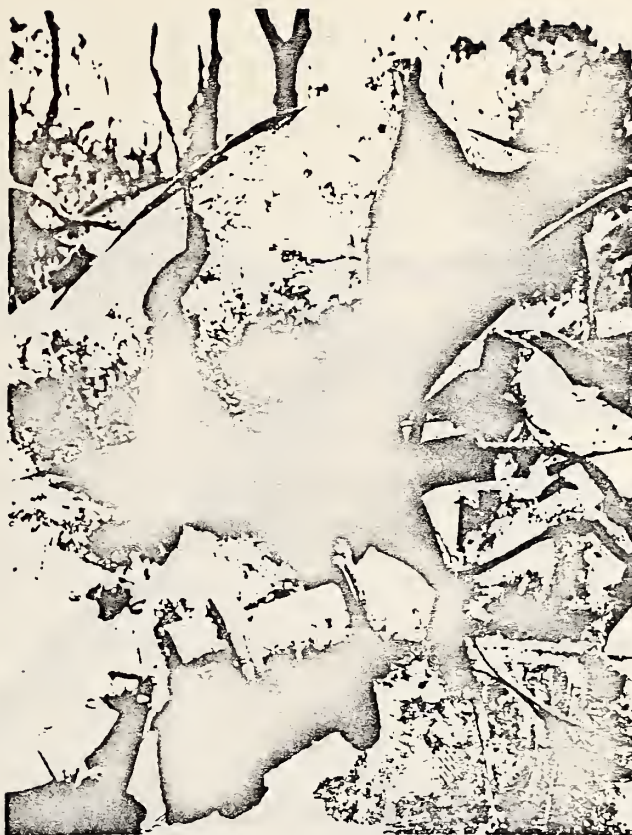
Photo C2-16: A-end tub of tank-car ACFX 89990 at the valve area.

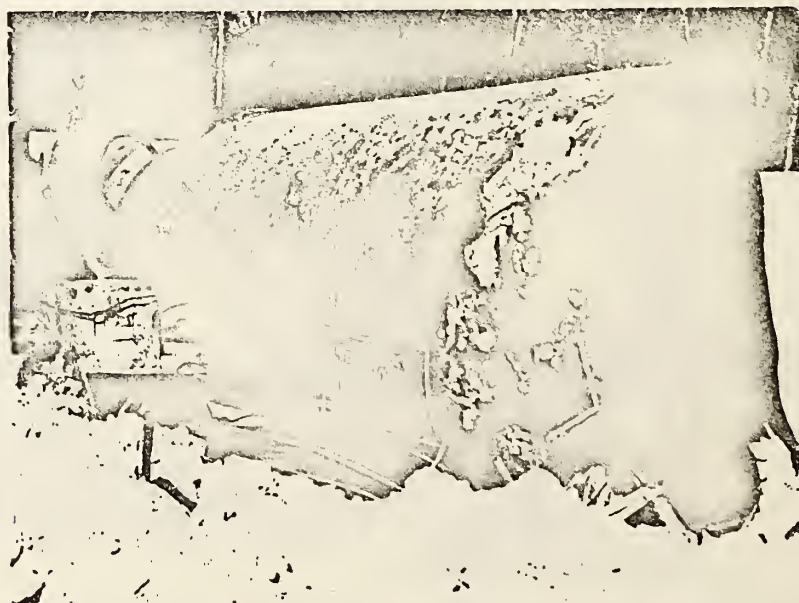
Photo 2-9: B-end of tank-car ACFX 89990 showing samples NBS 9 and NBS 10.

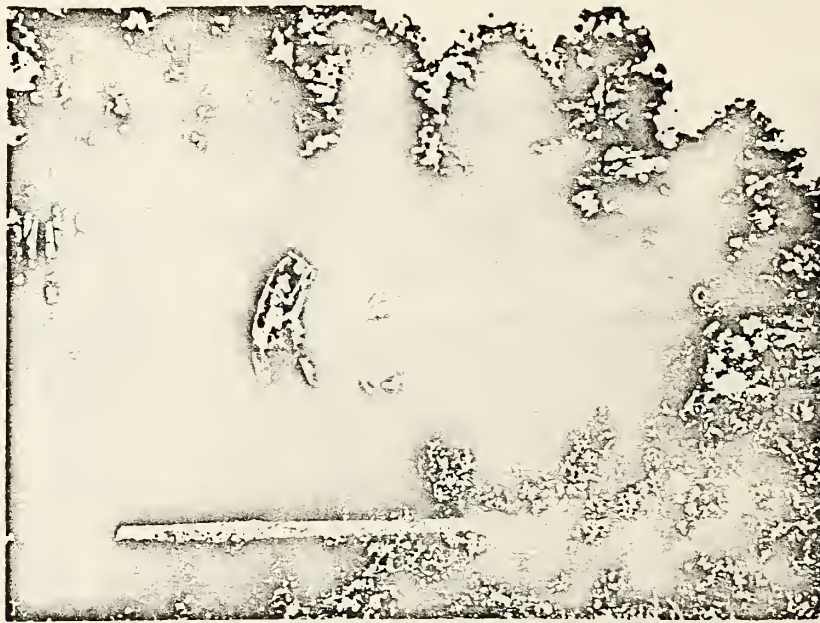
The tub containing the B-head was generally intact, although deformed so that it no longer is a cross-section of a cylinder. The B-head itself exhibited a massive dent at one edge, but no sign of rupture. The tub containing the A-head was severely flattened with numerous ruptures, along girth welds (between the head and shell plate and between shell plates).

Photo C4-16: B-end tub of tank-car ACFX 89990 showing a large dent in the B head-plate.

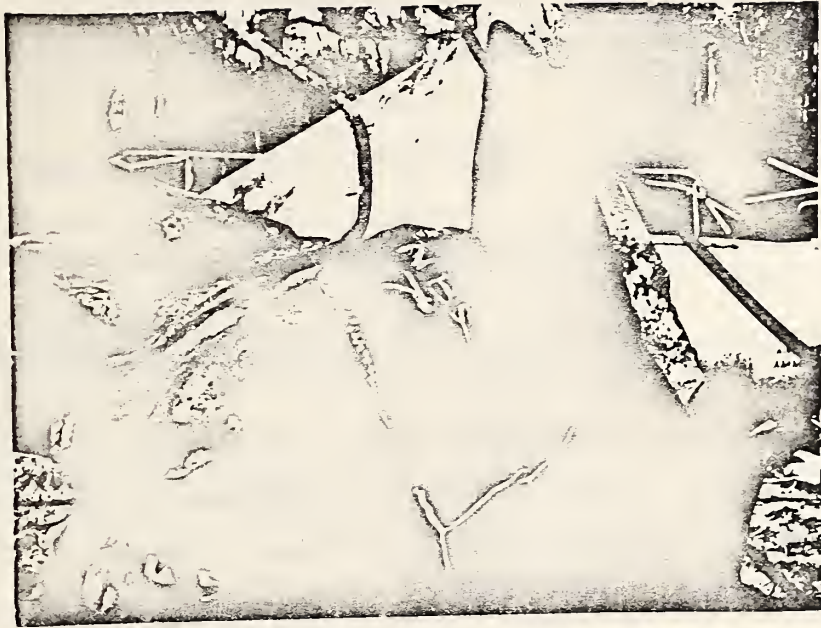
Shell and Head Plates: Badly damaged head plate that fractured (C3-5 photo) but did not run. Shell course (C2-13 photo) fractured but did not run. No significant damage observed on the (cont. on Attachment A)
Sill, Coupler, Wheel, other parts (in that order) _____

B-head. The A-head contained numerous dents, one of which contained a short rupture.

Photo C3-5: Tear in A-head of tank-car GATX 5013.

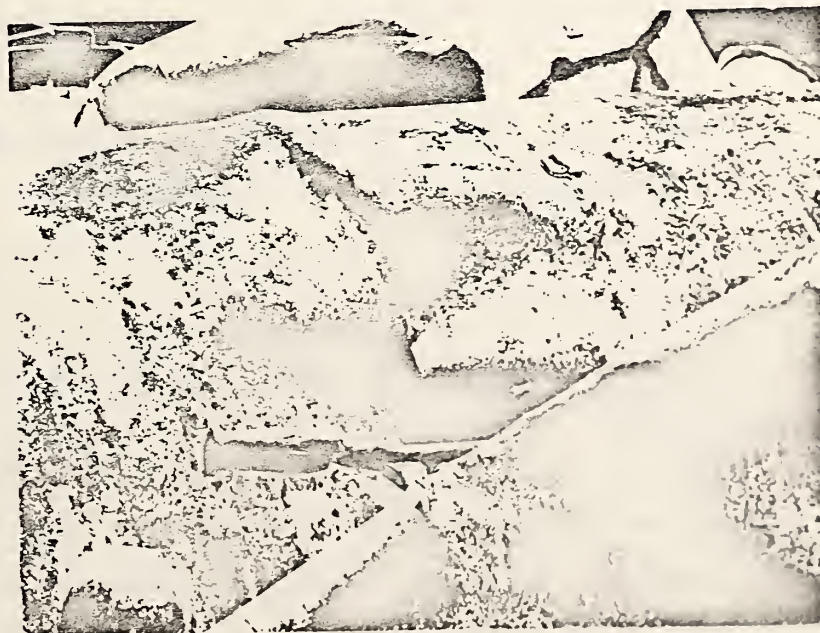
Substantial deformation of the shell courses was observed with one fracture along a girth weld between two shell courses.

Photo C2-13: Close-up of tear at a shell seam in tank-car GATX 5013.

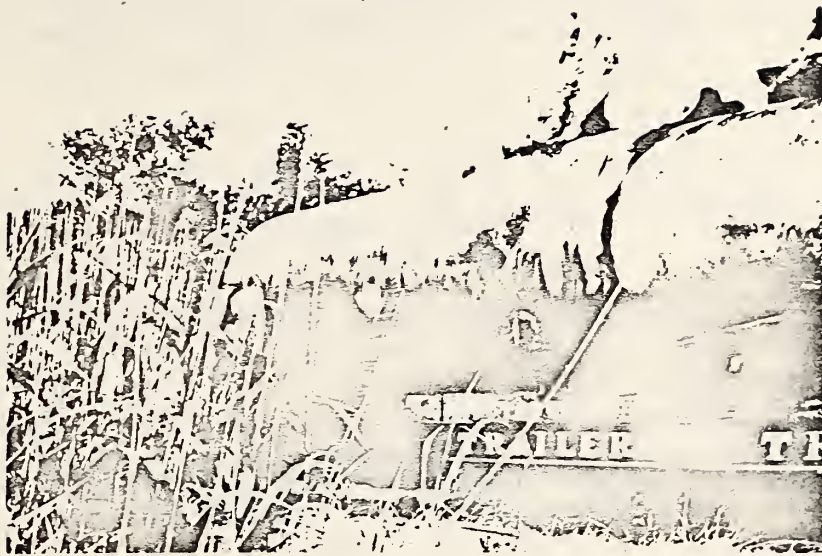
Shell and Head Plates: The leaking shell course had a hole punched in it just below the middle of the shell course.

Photo C4-19: Tank-car UTLX 28727 showing a hole in the center shell course.

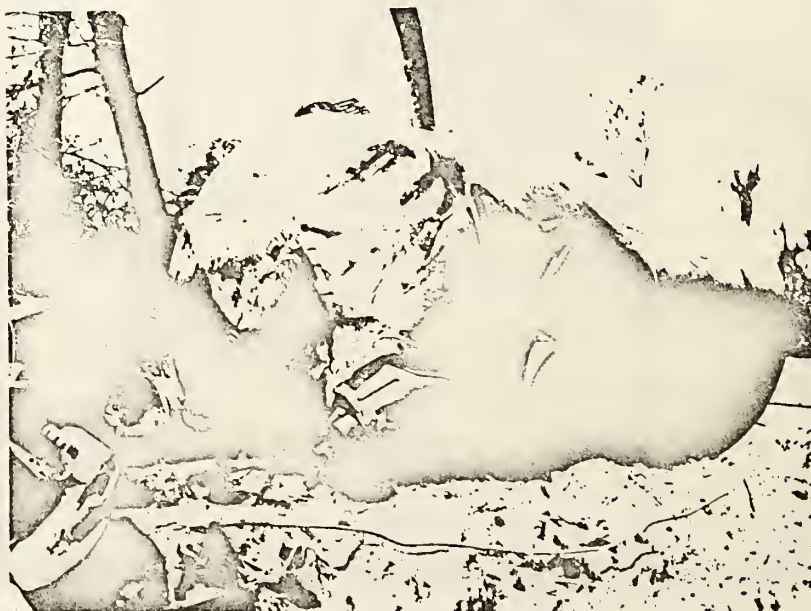
Rocketed tub, with 2-1/2 shell courses, was found on the south side of tracks. It had a badly dented head plate with no fractures. NBS 1 was taken on this head plate. The fracture line on this tub is contained in NBS 2.

Photo 1-14: Head plate of the south side tub (A-end)
of tank-car IMCX 2513 showing sample
NBS 1.

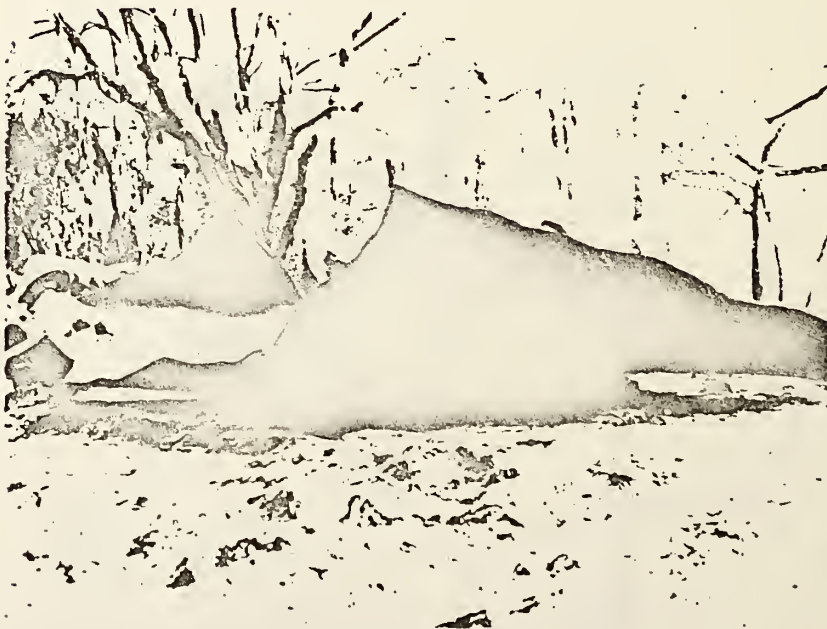
Photo C3-9: Center section of tank-car IMCX 2513 on the south side of the tracks.

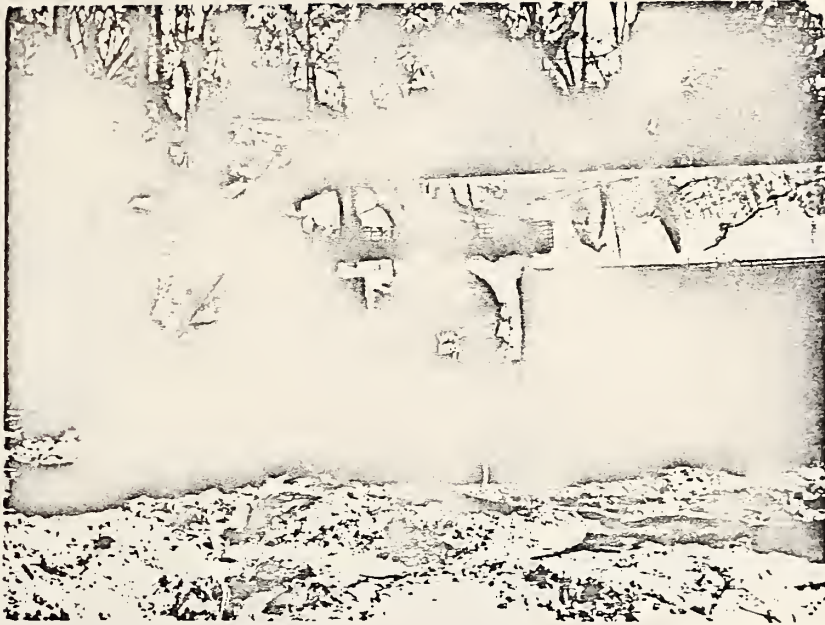
Photo 2-7: North side tub (B-end) of tank-car
IMCX 2827 showing sample NBS 11 (valve).
