NIST Special Publication 901

The January 17, 1995 Hyogoken-Nanbu (Kobe) Earthquake

*Performance of Structures, Lifelines, and Fire
Protection Systems*

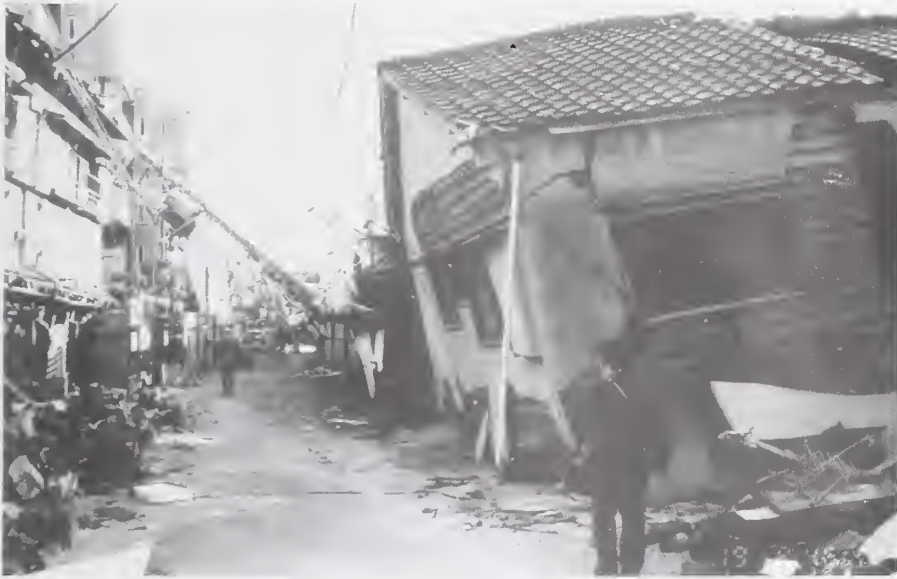
The number of collapsed houses constituted about 10 percent of the houses in the Kobe area. It was reported [3] that nearly 55000 houses collapsed and over 35000 houses were partially destroyed. These included both Shinkabe and Ohkabe houses. Typical damaged houses are shown in Figures 3.3.1 and 3.3.2.

Figure 3.3.1 A collapsed Ohkabe construction-type house.

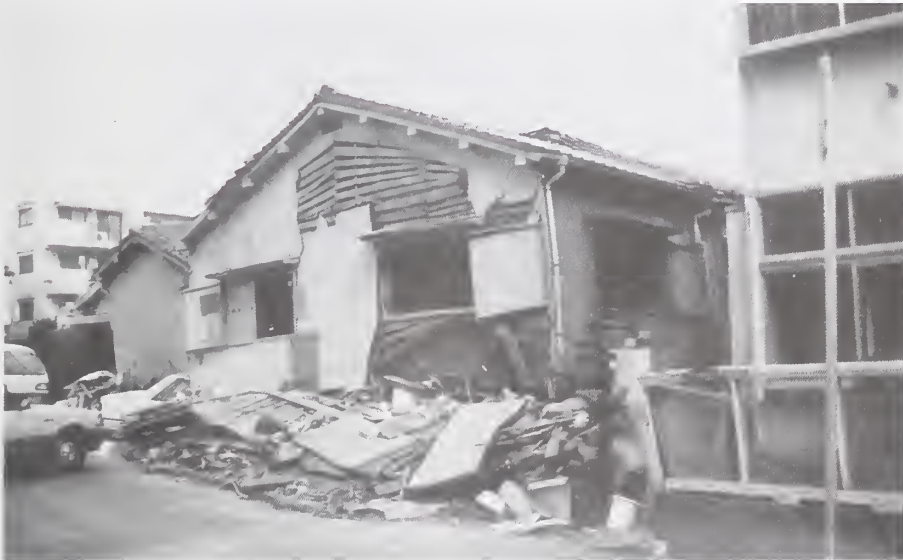
Figure 3.3.2 Same as Figure 3.3.1.

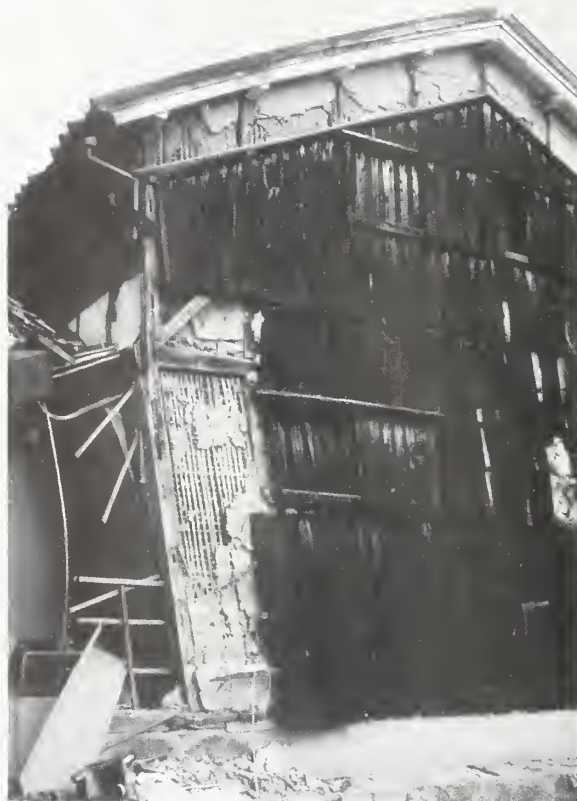
In general, more Shinkabe houses sustained complete collapse. The Shinkabe construction employed walls of bamboo thatch tied with rope and packed with mud. The outside facade consisted of stucco or some light coverings with no structural resistance. Figure 3.3.3 shows a damaged two-story Shinkabe construction and Figure 3.3.4 shows a completely collapsed Shinkabe house. In Ohkabe construction, the columns were joined by thin wooden slats (80 mm x 20 mm) placed horizontally (see Figure 3.3.5). Some parts of the Ohkabe houses were also reinforced by light wooden cross braces, and they performed better than the unbraced parts (see Figure 3.3.6). There were no indications of plywood or particle-board shearwalls being used in these constructions, as is a common practice in the United States. Only a few wood houses had some type of diagonal bracings, and a majority of the wood houses had essentially no significant lateral load carrying capacity to withstand earthquake loads.

Figure 3.3.3 A damaged two-story Sake factory with Shinkabe construction.

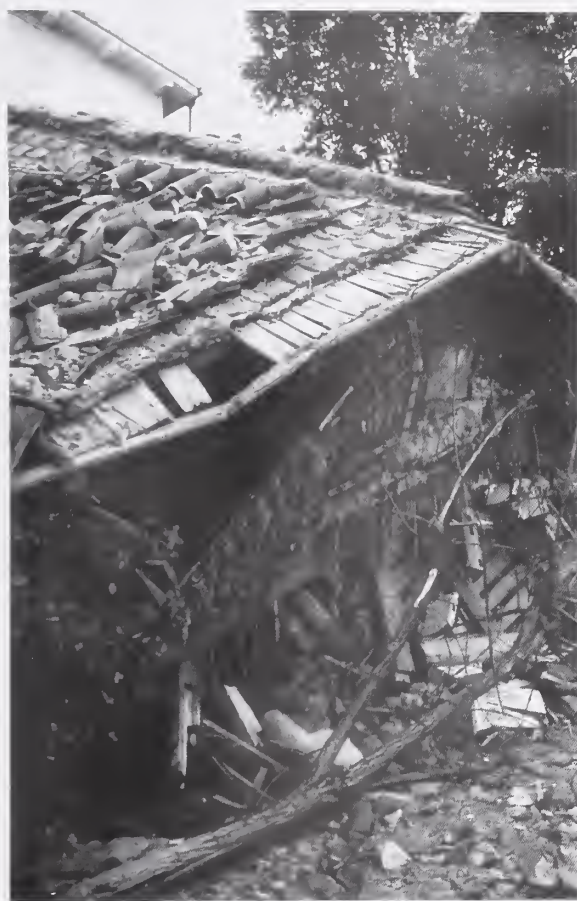
Figure 3.3.4 A completed collapsed Shinkabe construction-type house.

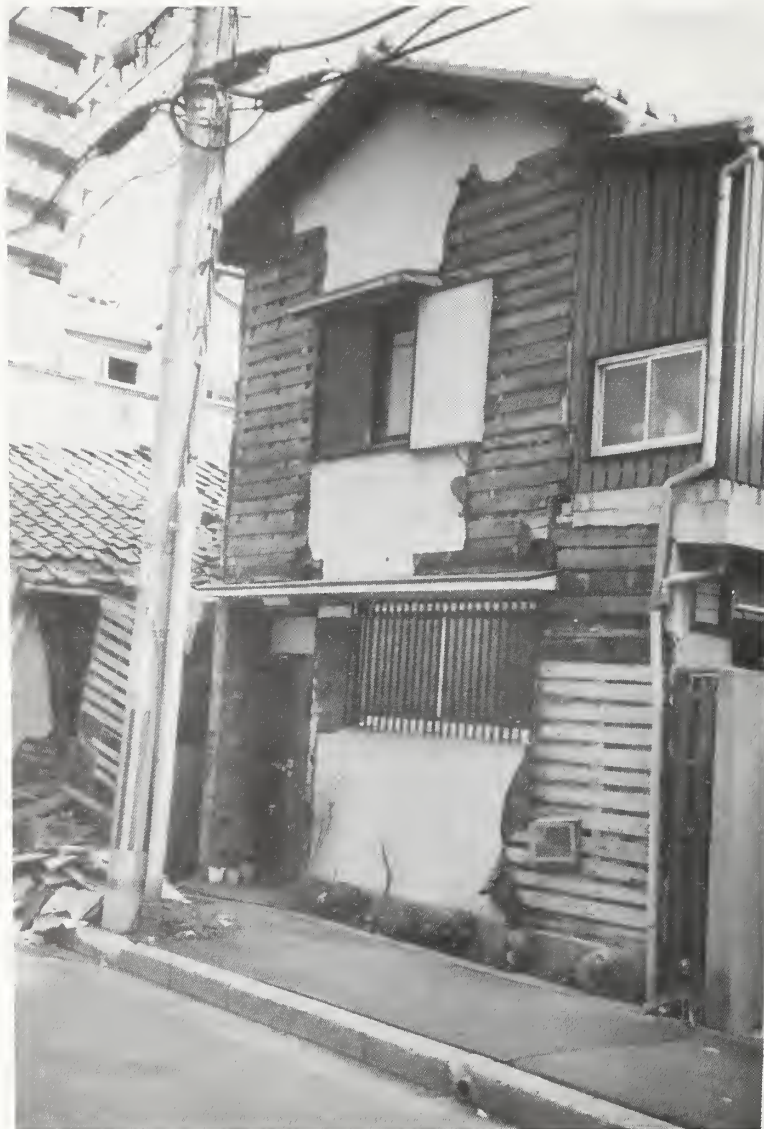
Figure 3.3.5 An Ohkabe house with only architectural design. Note a shadow of diagonal bracing on the left side of second story.

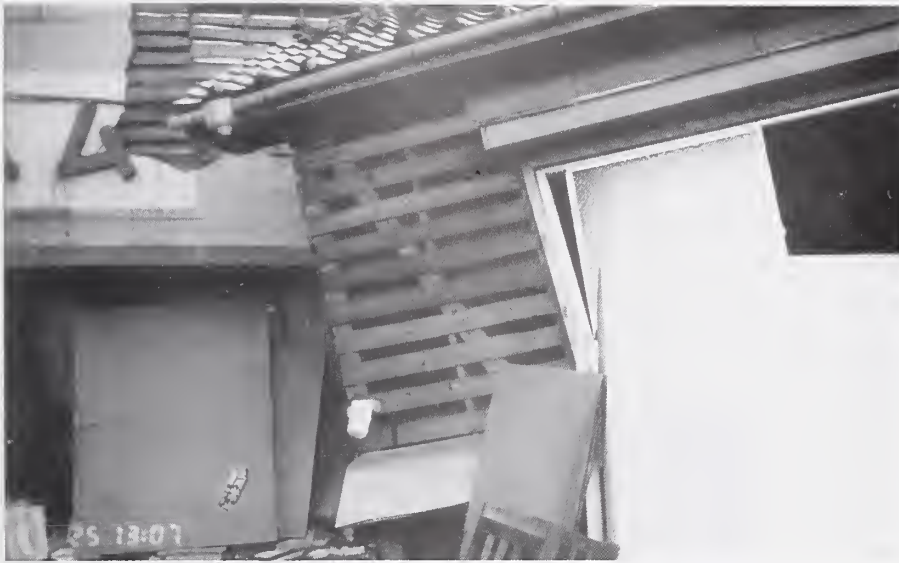
Figure 3.3.6 Intact upper story (braced) of a collapsed unit - Ohkabe construction.

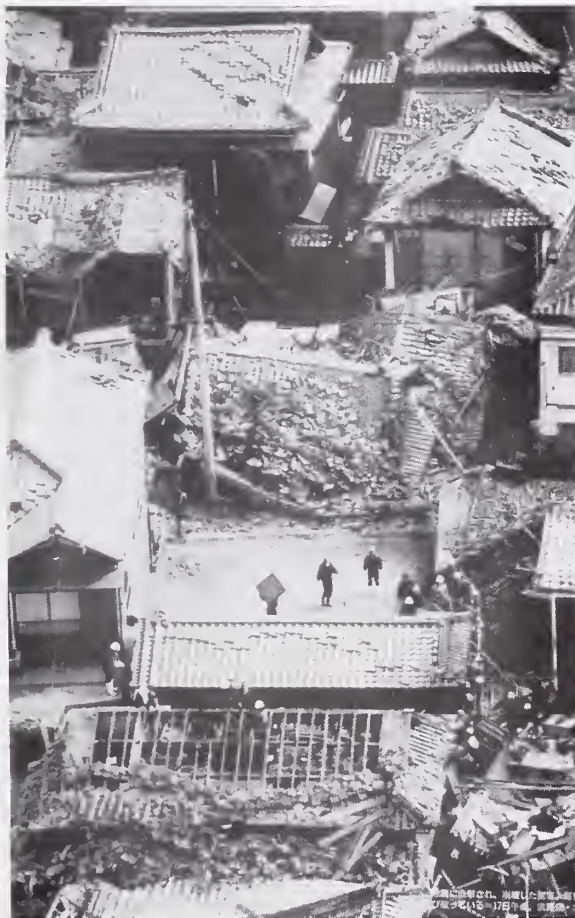
Many severely damaged houses had heavy ceramic roof tiles set on soil as bedding (see Figure 3.3.7). It is believed that heavy tiled roofs were preferred not only for the aesthetic and architectural reasons, but also because they could not be easily dislodged by gusty winds in a typhoon. The heavy roofs of these houses have contributed a great deal to their collapse. On the other hand, some of the older houses which used less elaborate and less expensive synthetic roofing made of light material performed well in this earthquake.

Figure 3.3.7 Collapse of some heavy tiled roof houses - Shinkabe construction.

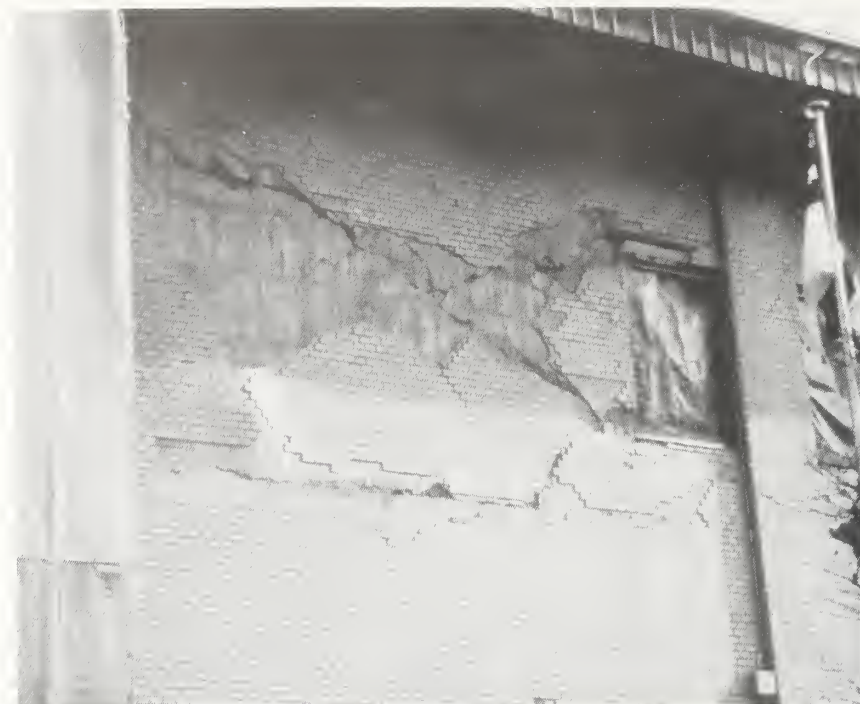
Figure 3.4.2 Damage to shear walls - Kobe Central Post Office.

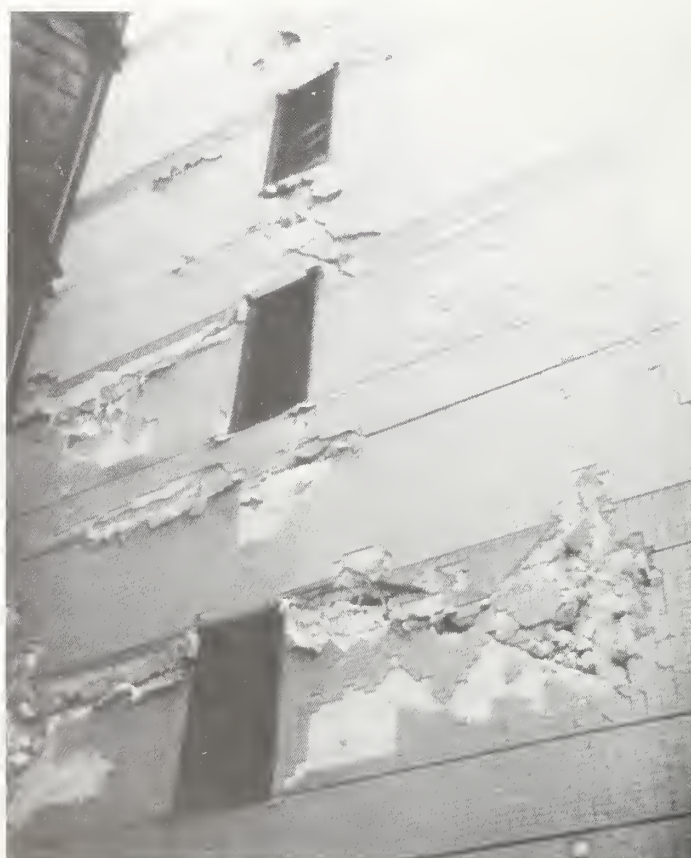
Figure 3.4.3 Damage to shear walls - office building in downtown Kobe.

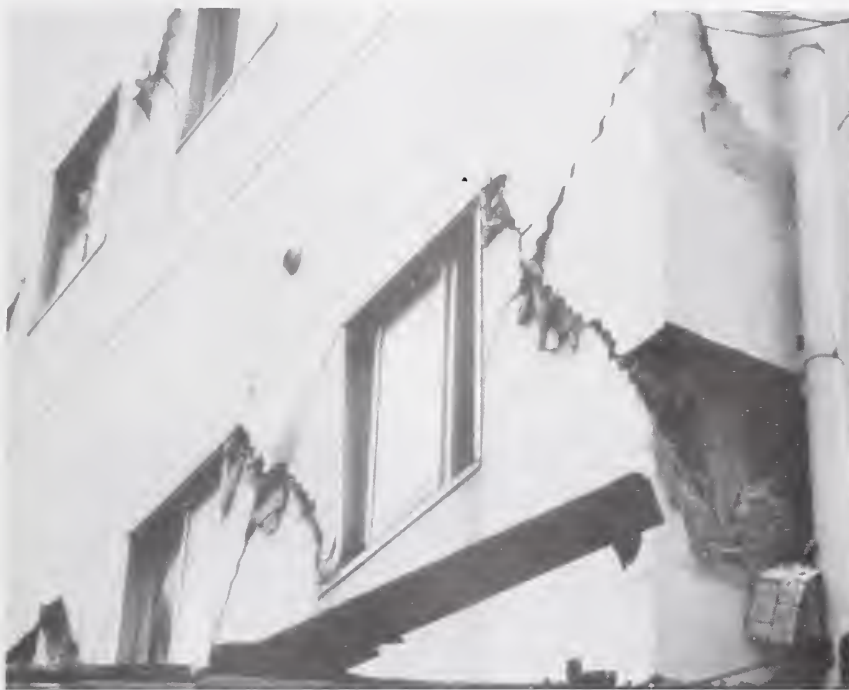
Figure 3.4.4 Diagonal tension cracks - apartment building in Nishinomiya area.

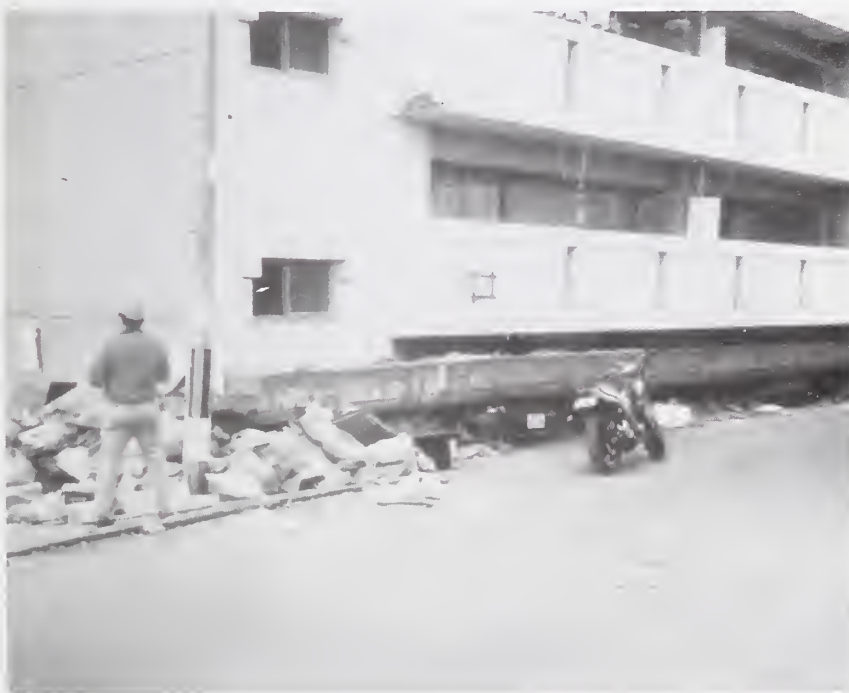
Figure 3.4.5 Failed ground floor shear wall - apartment building.

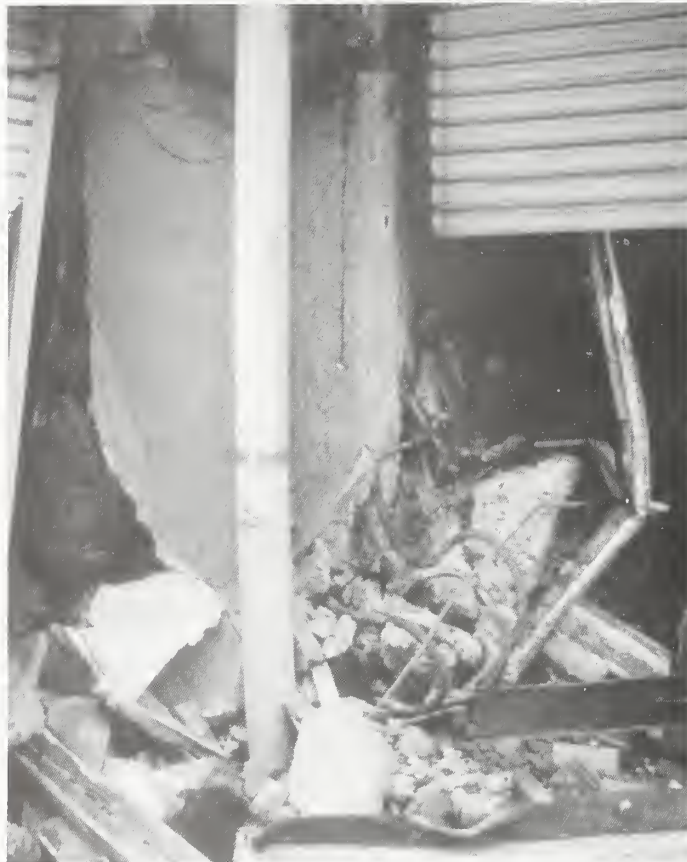
Figure 3.4.6 Failure of older column - local bar buckling.

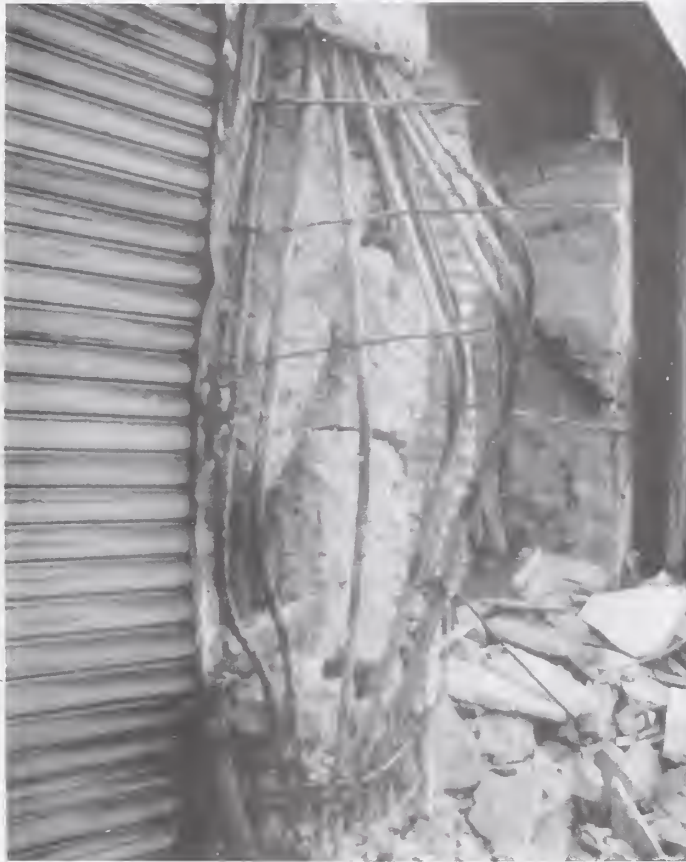
Figure 3.4.7 Failure of older column - general bar buckling.

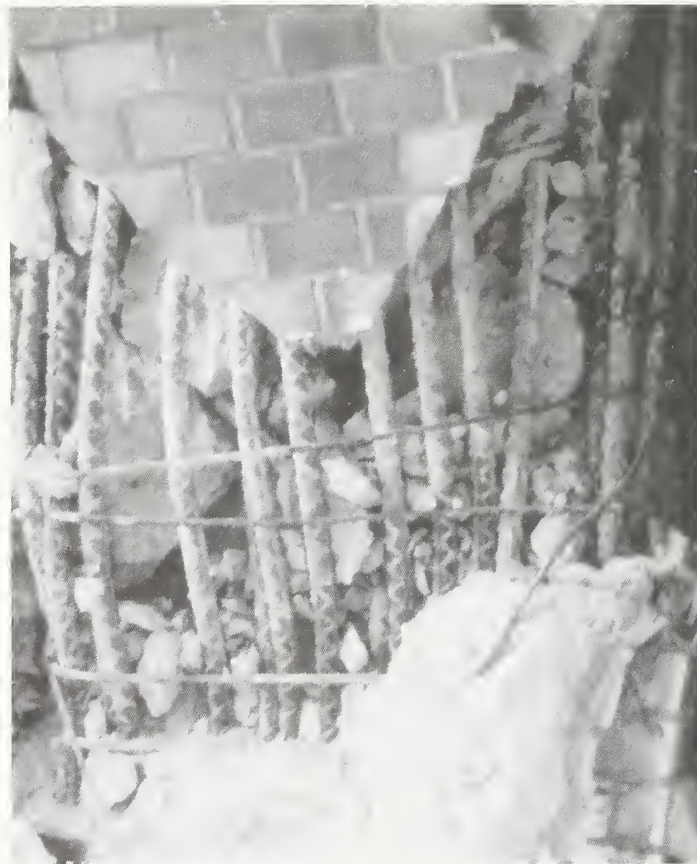
Figure 3.4.8 Failed column in commercial structure.

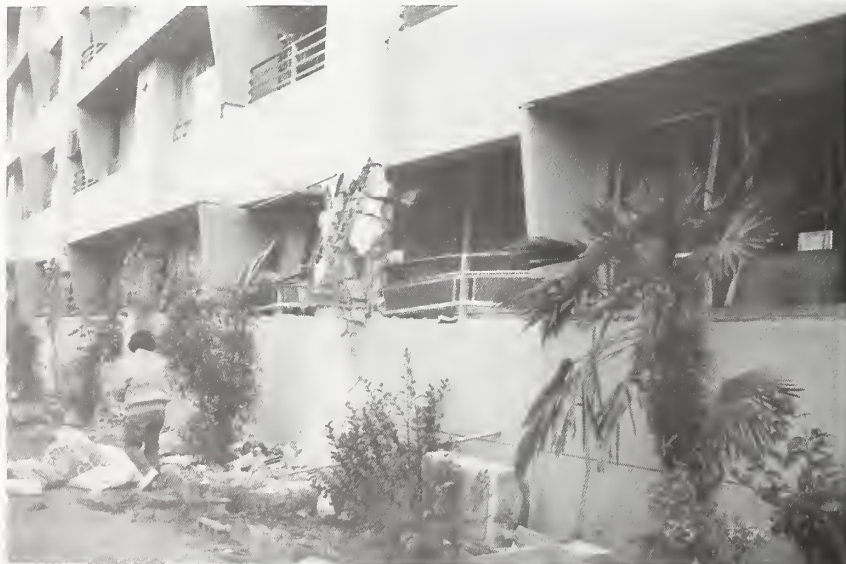
Figure 3.4.11 Short column effects - Fukae Mitsuku Housing Project.

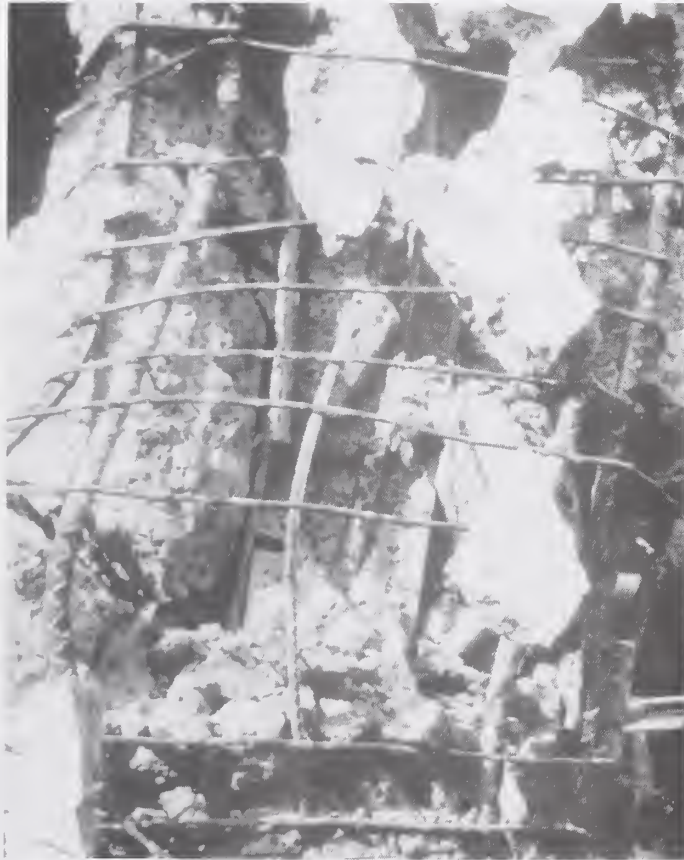
Figure 3.4.12 SRC column - Fukae Mitsuku Housing Project.

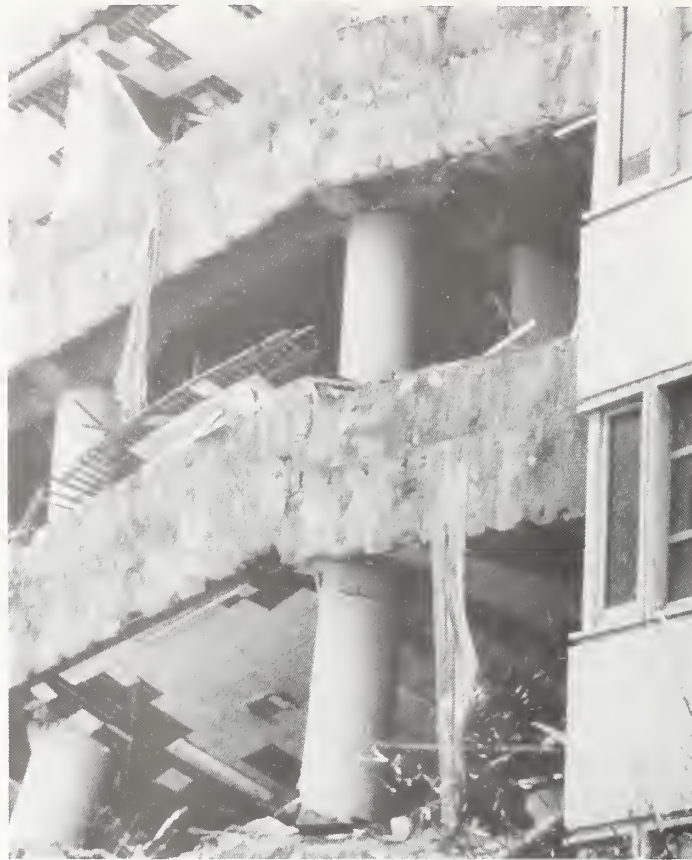
Figure 3.4.13 Strong beam-weak column failure.

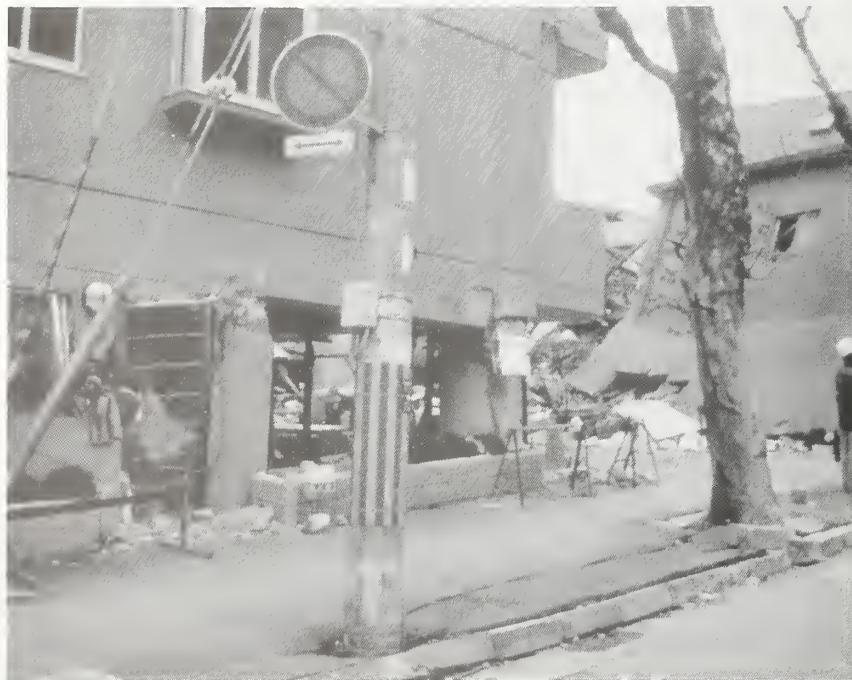
Figure 3.4.14 Collapsed first story near JR Line.

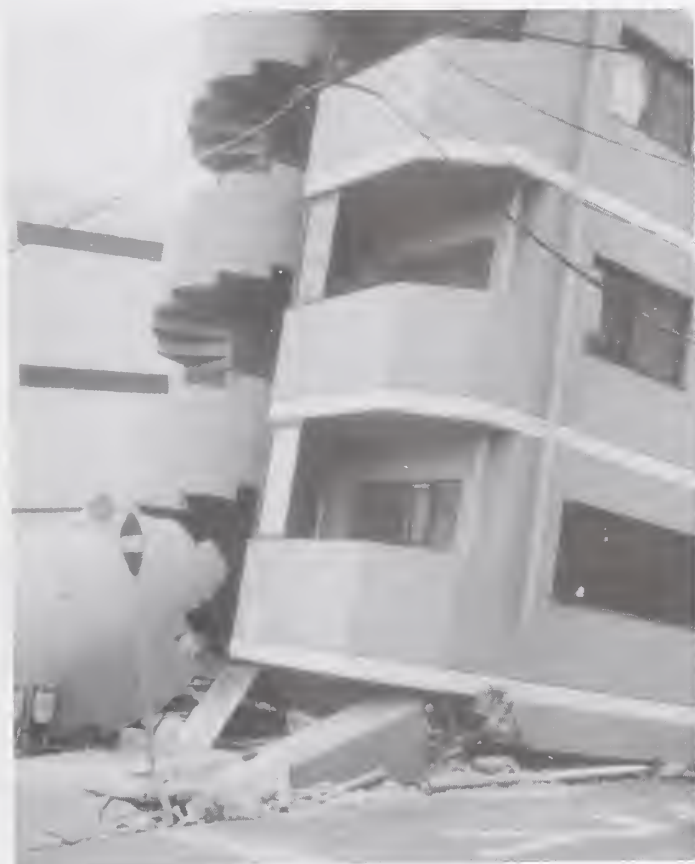
Figure 3.4.15 Collapsed first story.

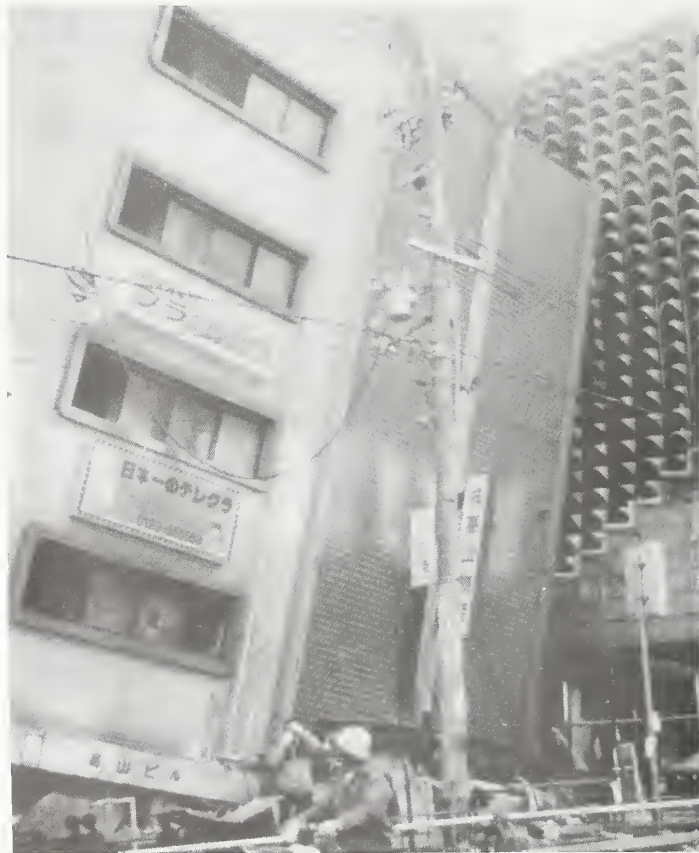
Figure 3.4.16 Collapsed first story - downtown Kobe.

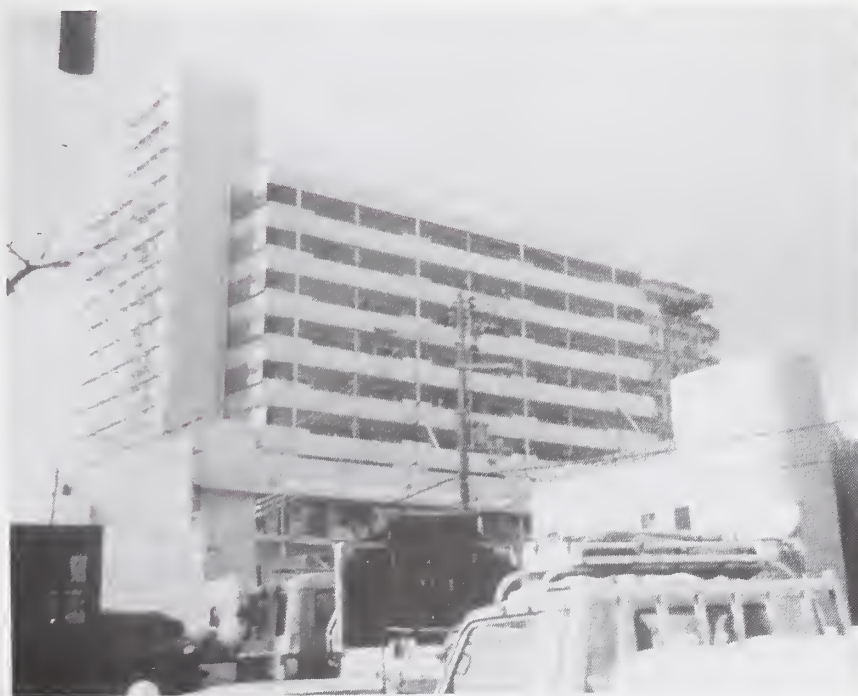
Figure 3.4.18 Fourth story collapse in apartment building.

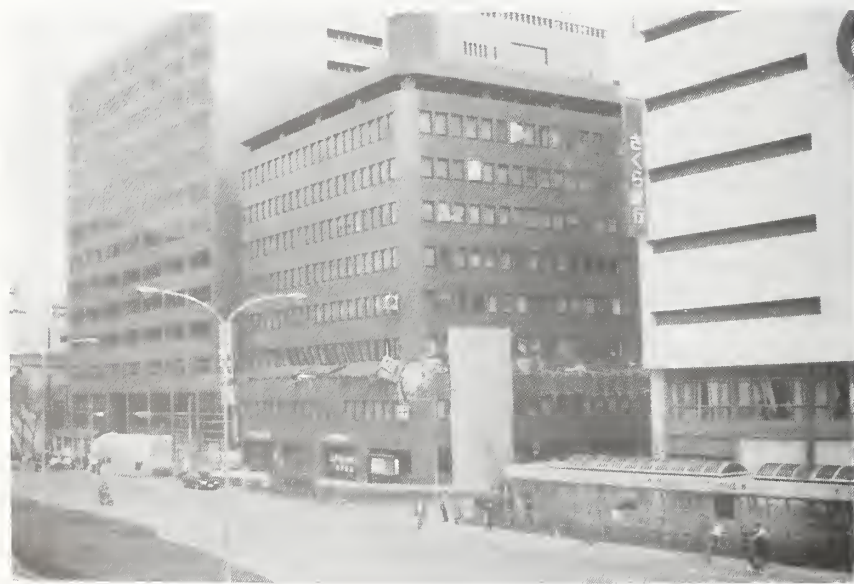
Figure 3.4.20 Third story collapse - Downtown Kobe.

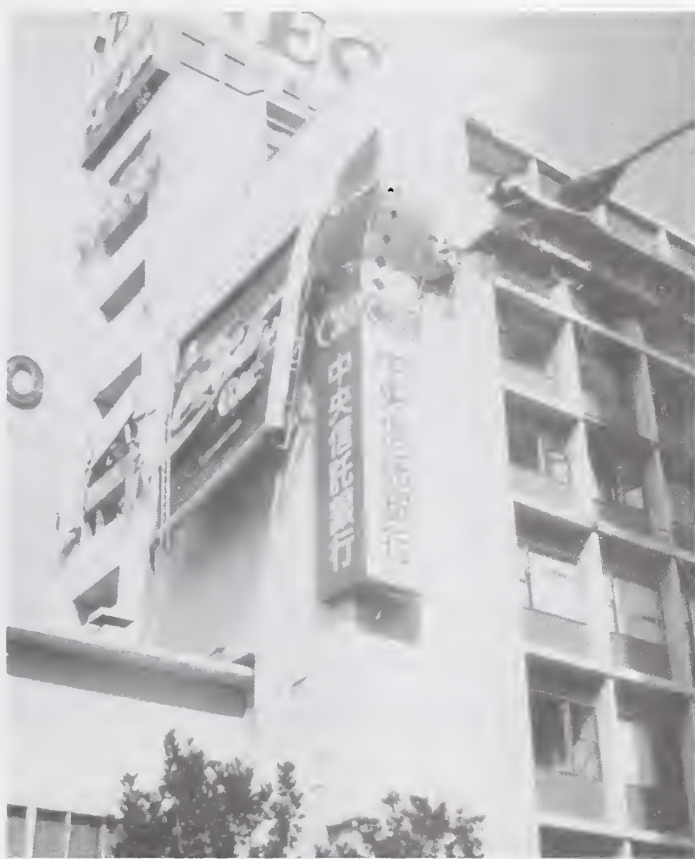
Figure 3.4.21 Upper story collapse - Downtown Kobe.

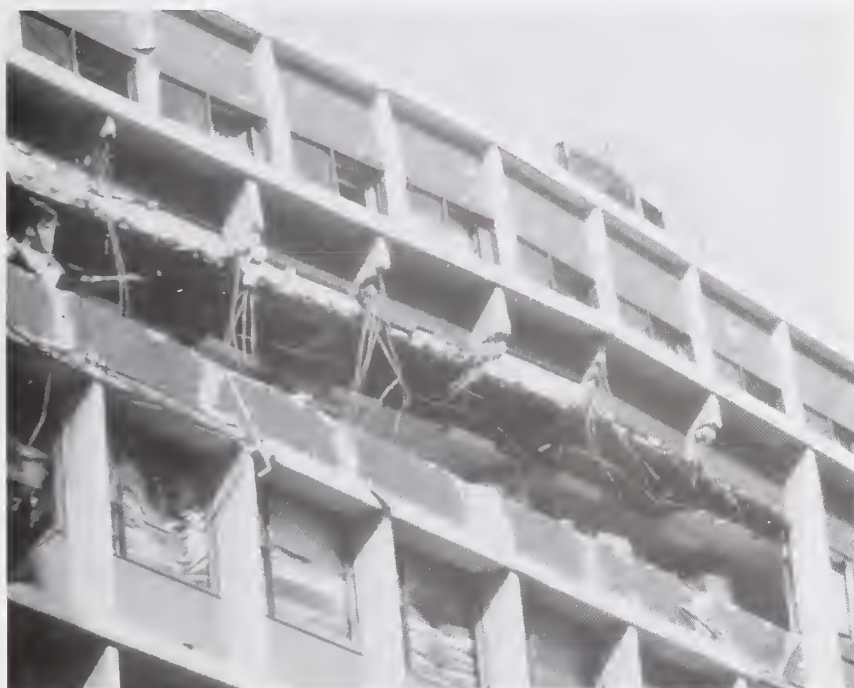
Figure 3.4.22 Upper story collapse - Downtown Kobe.

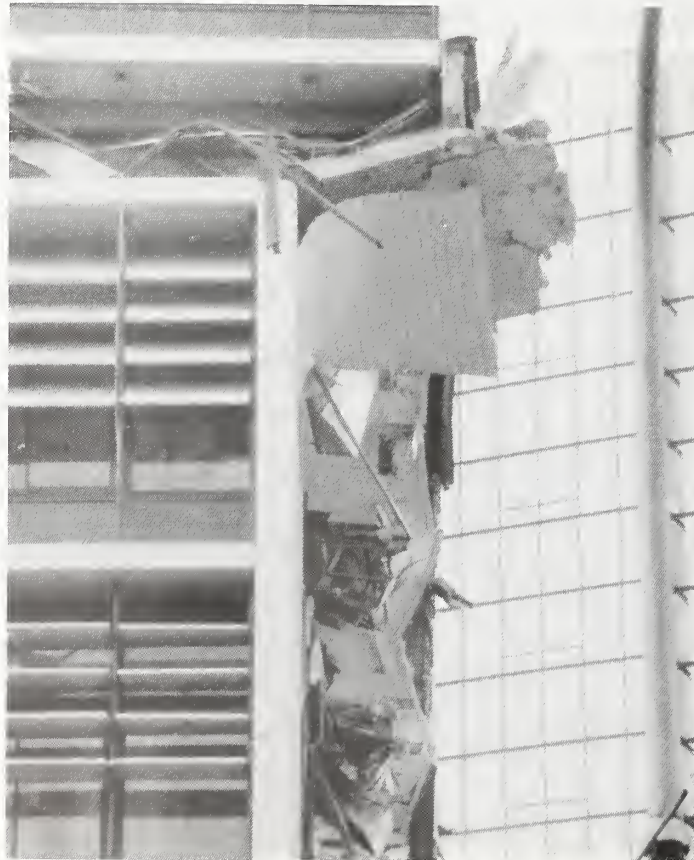
Figure 3.4.24 Collapsed upper story, north end - Kobe City Hall Annex.

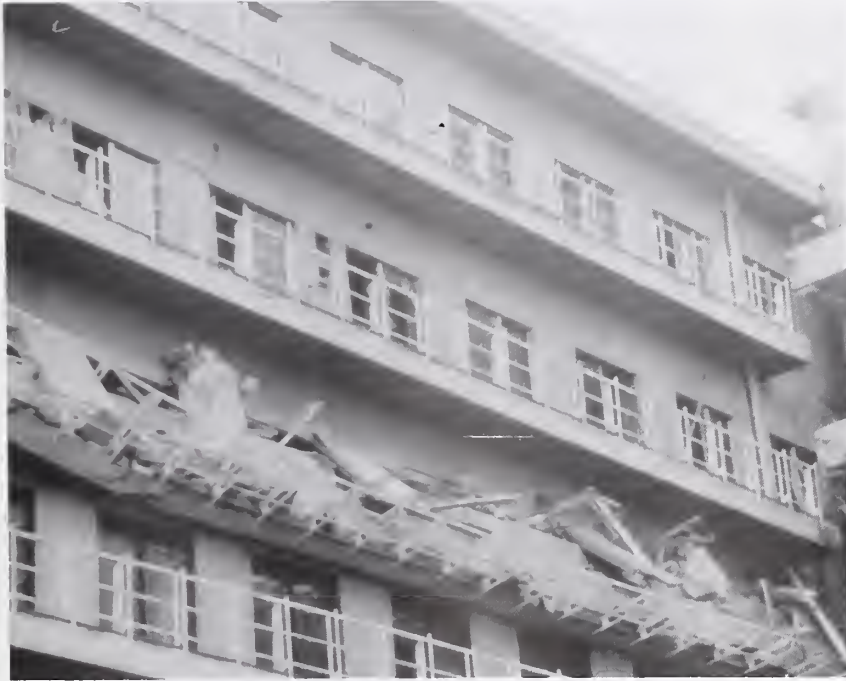
Figure 3.4.25 Collapsed upper story, northeast corner - West Kobe Citizens' Hospital.

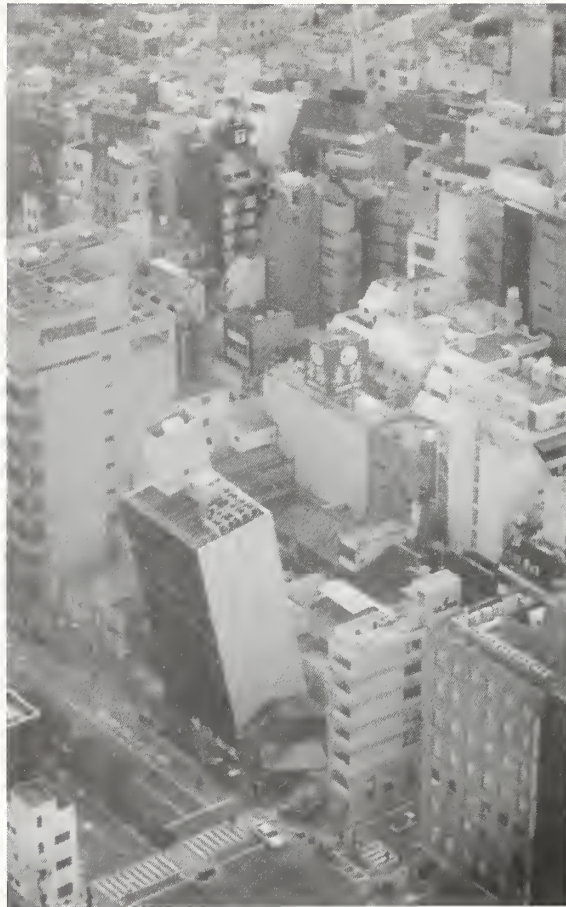
Figure 3.4.27 A leaning 9-story SRC building on Flower Road prior to total collapse.

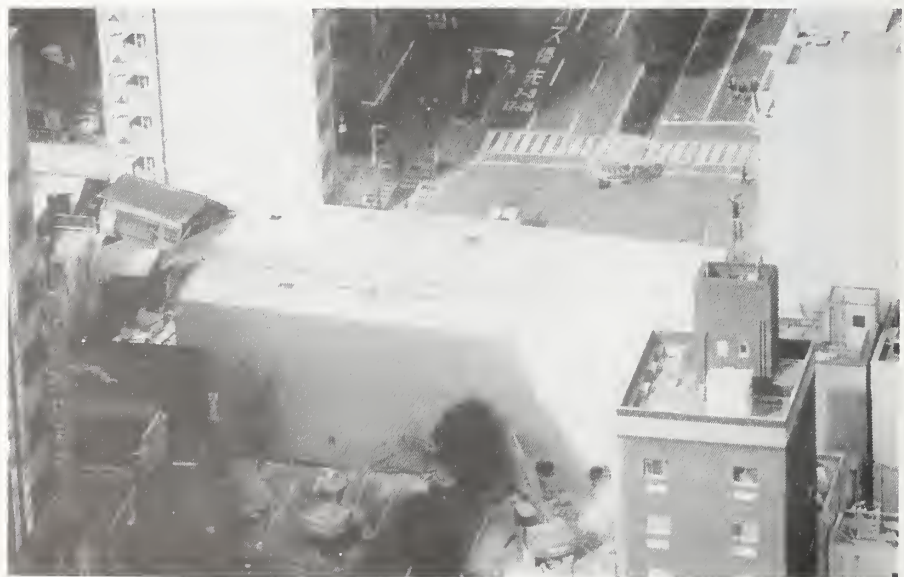
Figure 3.4.28 Totally collapsed building shown in Figure 3.4.27.

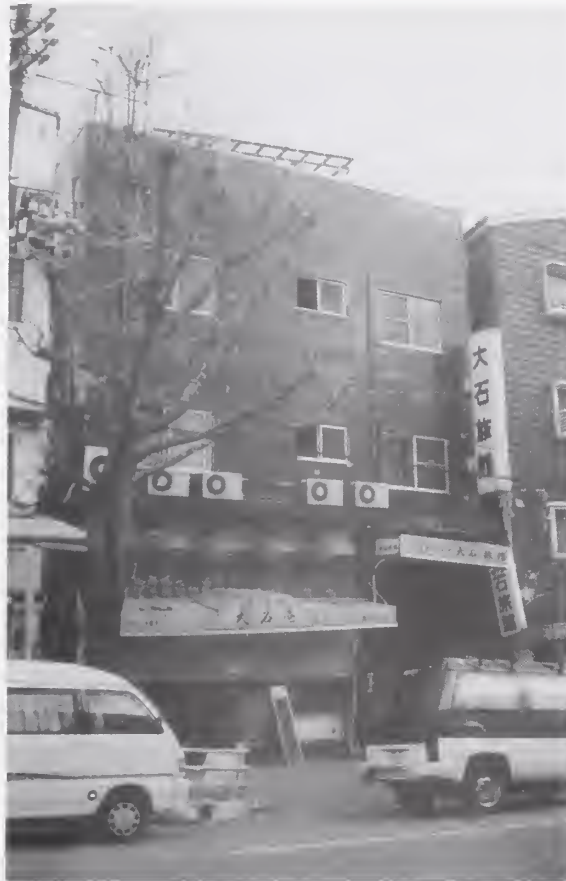
Figure 3.5.6 Three-story brick-faced light gage steel apartment. Has roll up door. Closeups (Fig 3.5.7) show that there is a great deal of rust at the connections at the second floor which connect 8 inch light gage wide flange columns. Rust clearly was at fault in the failure, not the steel frame itself... this is a common type of failure that seems peculiar to this form of light gage steel frame construction... perhaps it is the salt atmosphere of a port city that leads to such extensive corrosion.

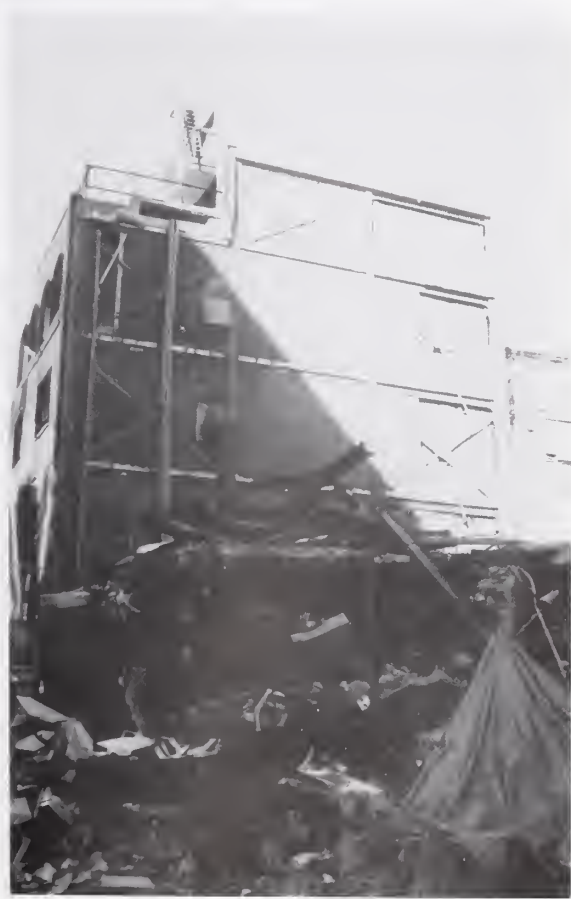
Figure 3.5.8 Braced steel frame, 5-story, in downtown Chuoku (Kobe). Masonry infill walls appear to have saved this structure while a neighboring structure did not fare as well.

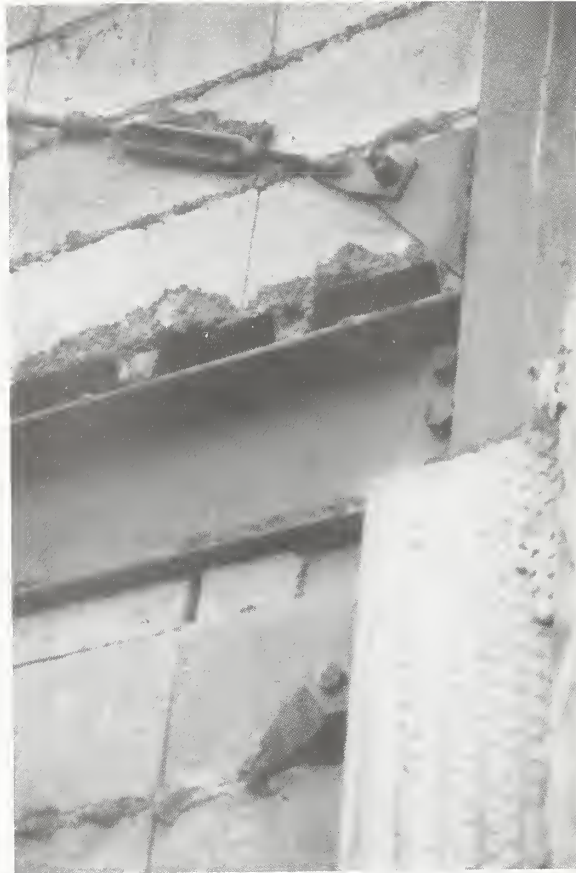
Figure 3.5.9 Many braced frame structures had failures of the diagonal braces at the welded connections. This photo shows a weld fracture between the turnbuckle rod and the gusset plate.

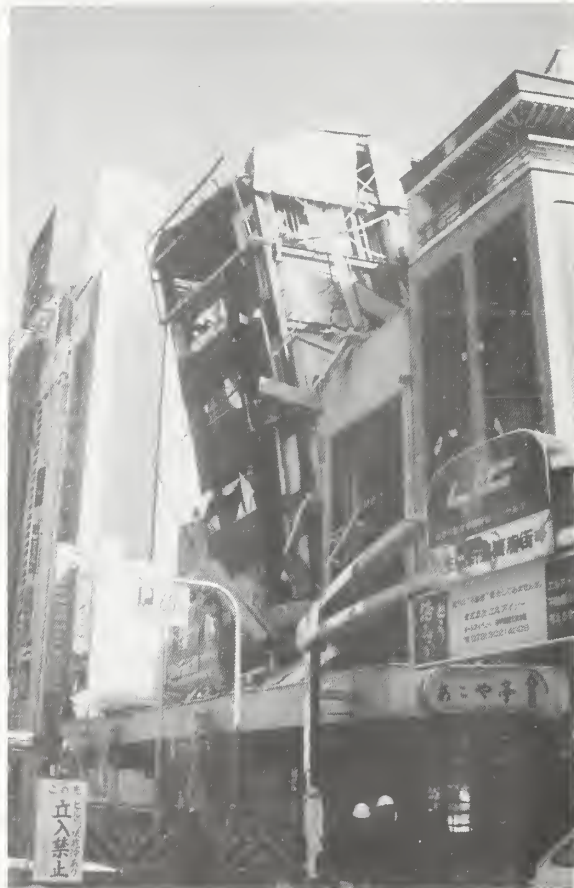
Figure 3.5.11 West side of the building shown in Figure 3.5.10.

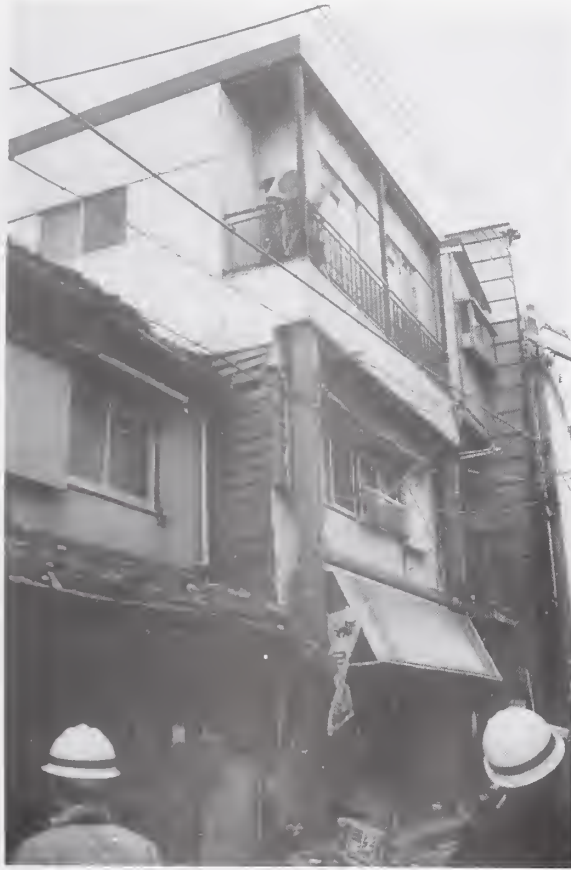
Figures 3.5.12 and 3.5.13 are of a rather unique braced frame failure in Higashi Nada ward. This was originally a two story Ohkabe type traditional dwelling, as evidenced by the exposed slat timber wall construction beneath the stucco in Figure 3.5.12. At some time a third story was added. To do this, an exterior steel braced frame was used. During the earthquake the cross braces (18 mm round bars) failed. These were attached to the steel frames apparently by means of field welded clip angles (Figure 3.5.14). The clip angle welds failed and the third floor shifted westward by approximately 300 mm.

Figure 3.5.12 Two-story traditional Ohkabe construction house with a third story add-on supported by a steel braced frame near the Mikage metro station, Nada ku.

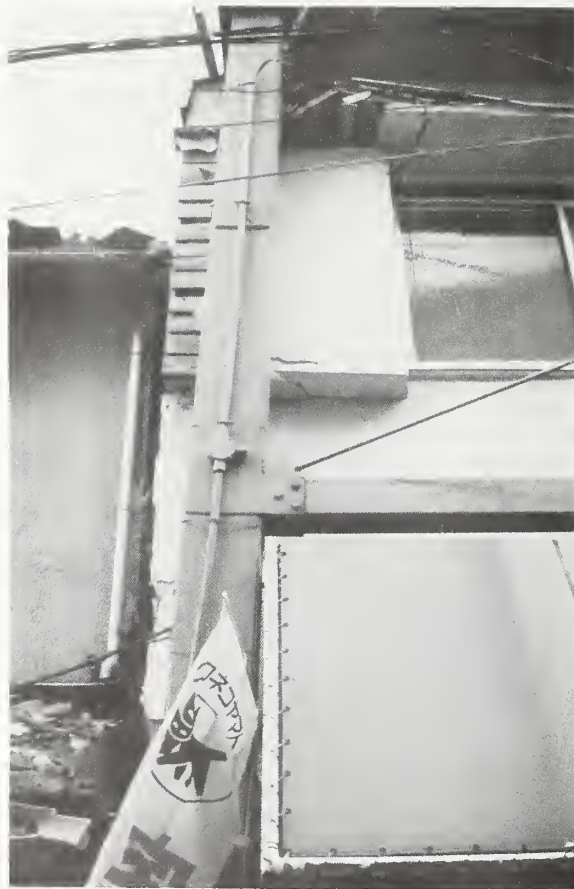
Figure 3.5.13 Detail showing drift in the building shown in Fig. 3.4.16 when diagonal braces failed.

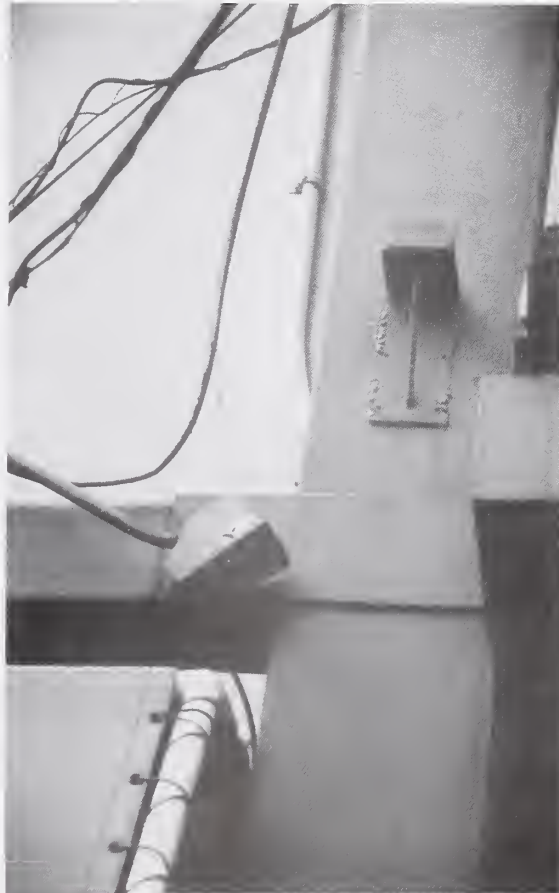
Figure 3.5.14 Detail of brace failure: angle plate weld to the steel frame failed (not the tension diagonal rod).

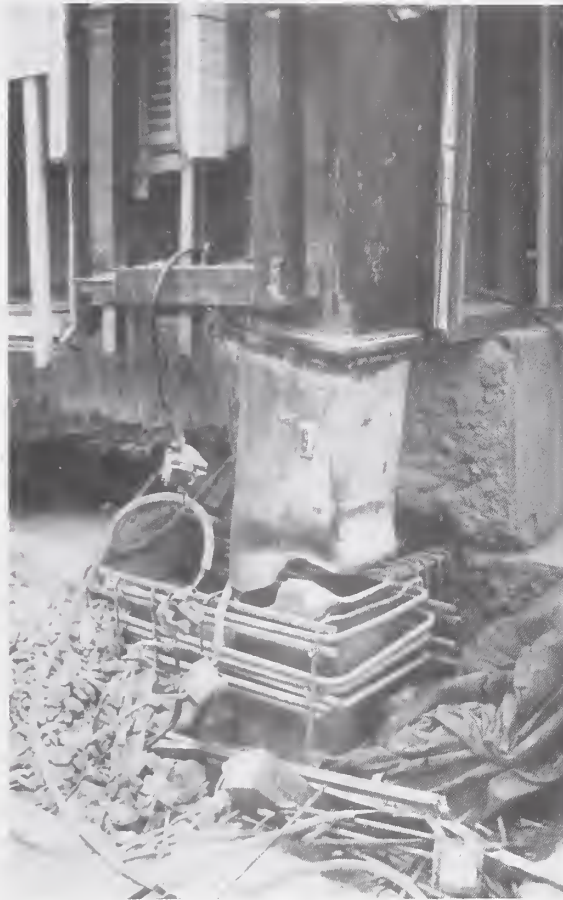
Figure 3.5.16 Closeup of the buckled tubular column in Figure 3.5.15.

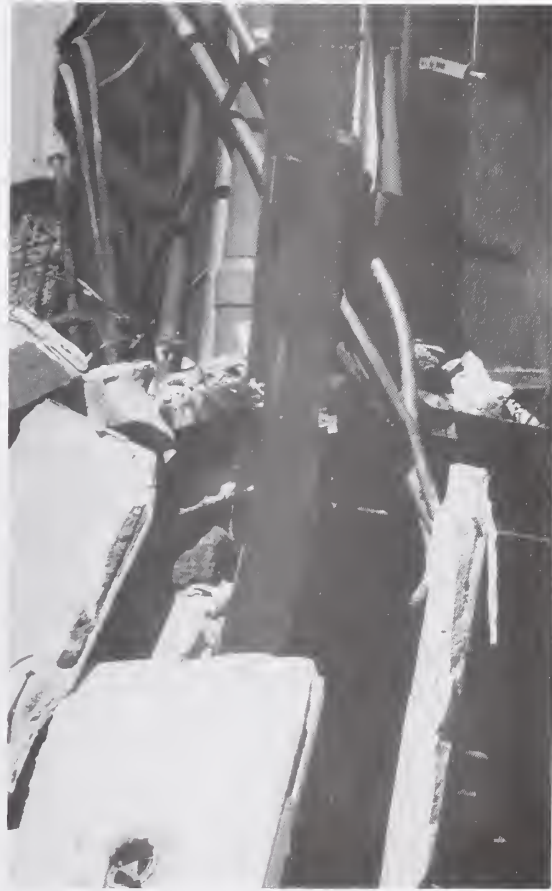
One example of moment frame structures which did suffer severe damage was a seven-story Nari Hiro Building in downtown Kobe (Figure 3.5.17). Figure 3.5.18 shows a closeup view of the southwest column, second story junction showing lateral buckling of the first story column. This, however, was a result of more dramatic weld failures on the east face of the building.

Figure 3.5.18 Closeup photo of the southwest column, second story junction in the Nairo Hiro building showing lateral buckling of the column.

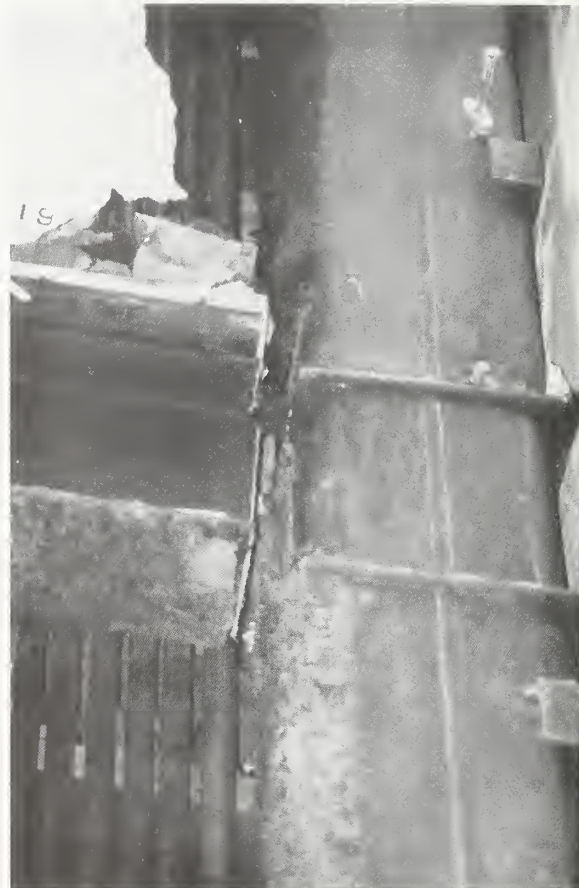
Figures 3.5.19 show details of a beam stub-to-column connection failure on the east face of the same building. Figures 3.5.20 and 3.5.21 show first floor column to second story column joint fillet weld failure.

Figure 3.5.19 Beam Stub-to-Column weld failure on the east face of the Nairo Hiro building.
