NIST Special Publication 901

The January 17, 1995 Hyogoken-Nanbu (Kobe) Earthquake

*Performance of Structures, Lifelines, and Fire
Protection Systems*

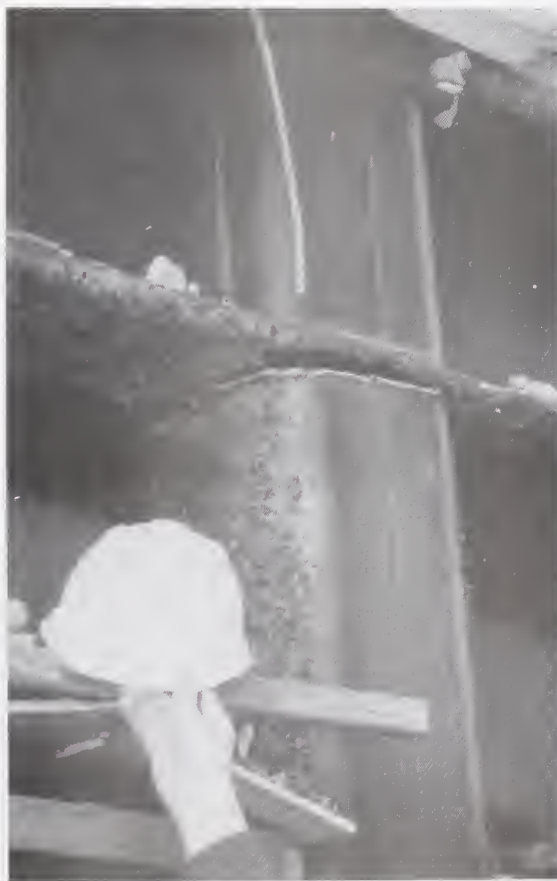
Figure 3.5.21 Closeup photo of column fillet weld failure in the Nairo Hiro building .

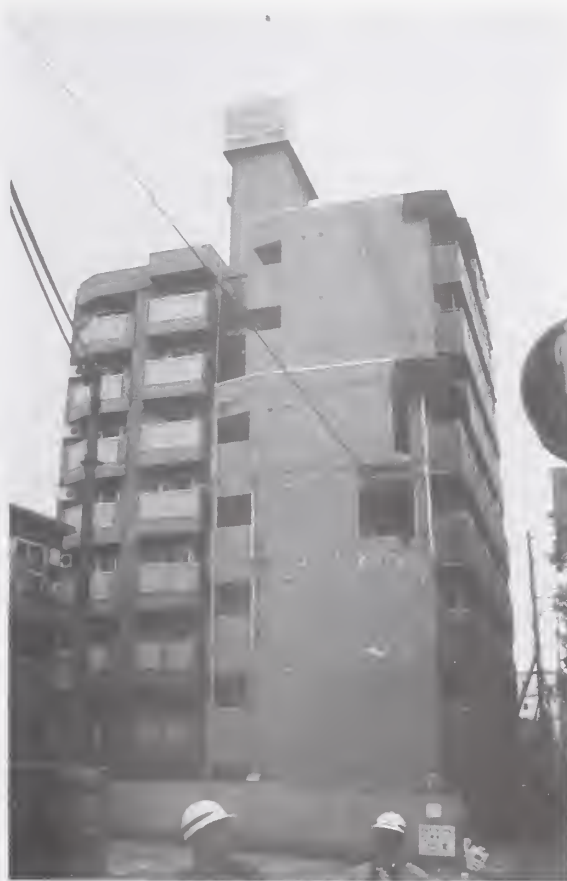
Figure 3.5.24 West face of the Liberty apartment complex in Higashi Nada-ku. This eight-story steel moment frame was typical of the performance of mid-rise steel structures designed according to post-1981 procedures.

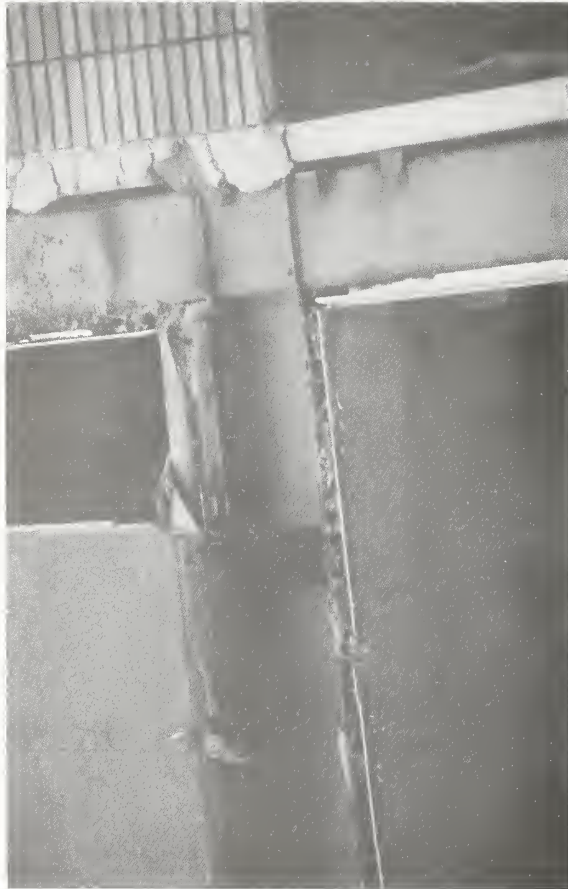
Figure 3.5.25 is a closeup view of west face steel moment frame of the Liberty apartments. The shop welded frame shows no damage but autoclaved lightweight concrete cladding suffered brittle failures along panel edges. Figures 3.5.26 and 3.5.27 show details of the east face of this same building. In this case one beam-column joint showed flaked paint indicative of local yielding.

Figure 3.5.25 Closeup photo of west face steel moment frame of the Liberty apartments. Shop welded frame shows no damage but autoclaved lightweight concrete cladding suffered brittle failures along panel edges.

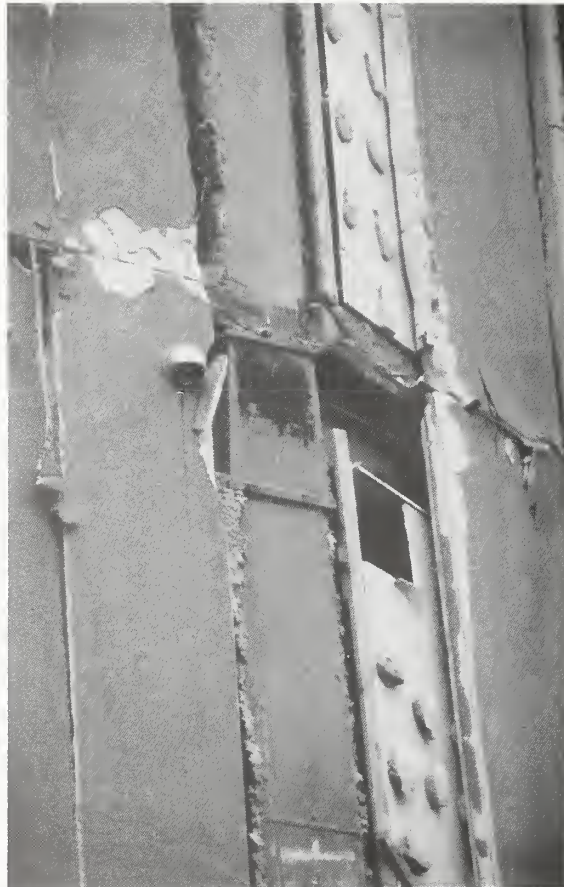
Figure 3.5.27 Closeup photo showing locally yielded third floor column joint in the Liberty apartment complex.

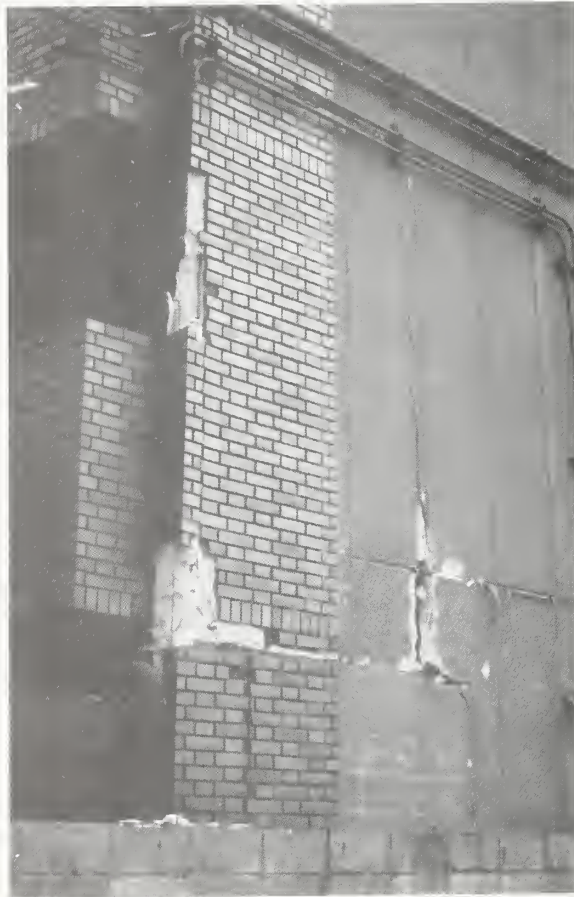
Figure 3.5.29 Closeup of cladding cracking at the Silver Heights Hotel.

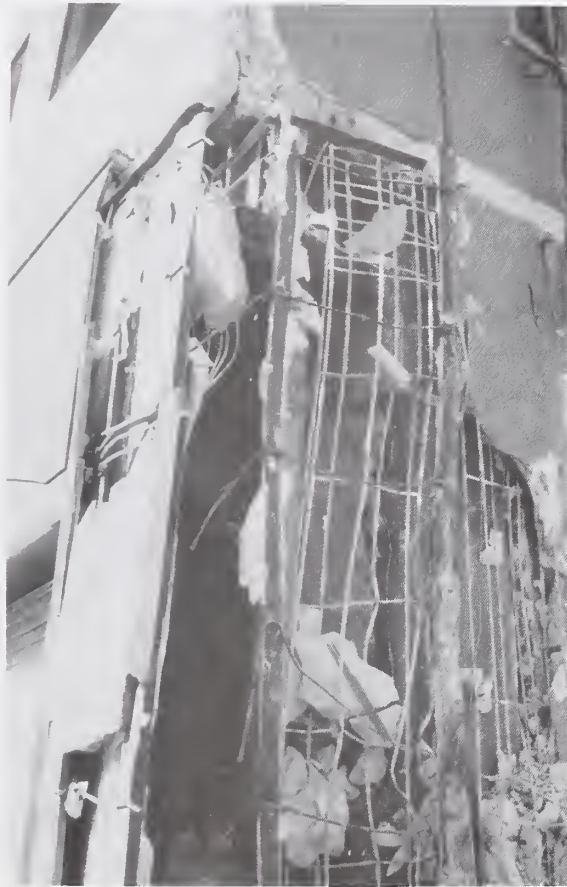
Figure 3.5.32 Closeup photo revealing steel moment frame beneath failed cladding of the Pacific Power Corporation building.

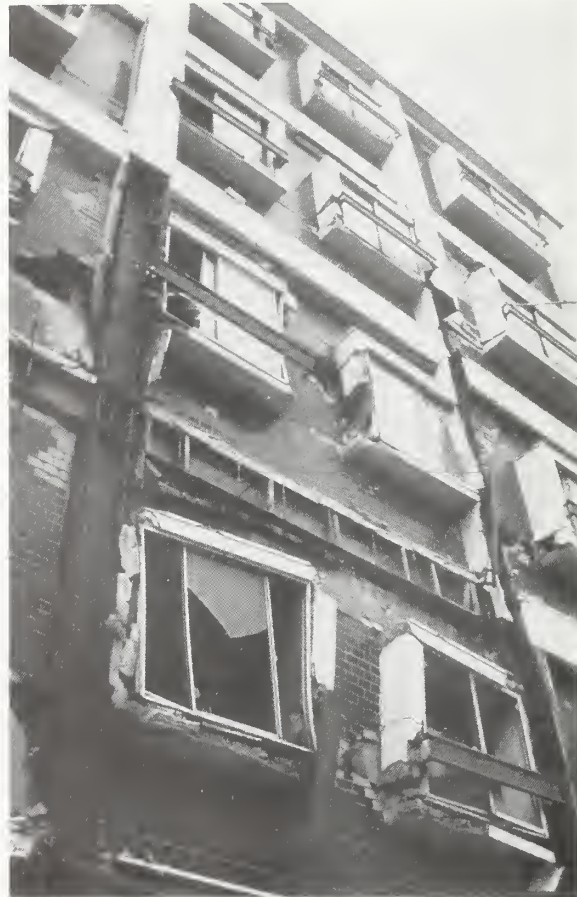
Figure 3.5.33 Older 5-story steel moment frame building showing extensive cladding damage to brittle cladding in Nada-ku near the Mikage metro station.

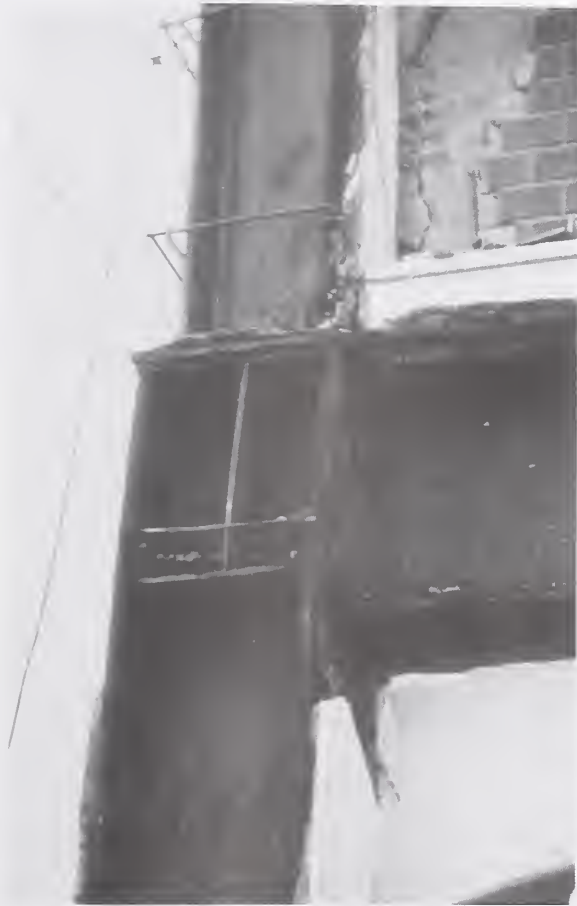
Figure 3.5.34 Closeup of rusted, older steel moment frame.

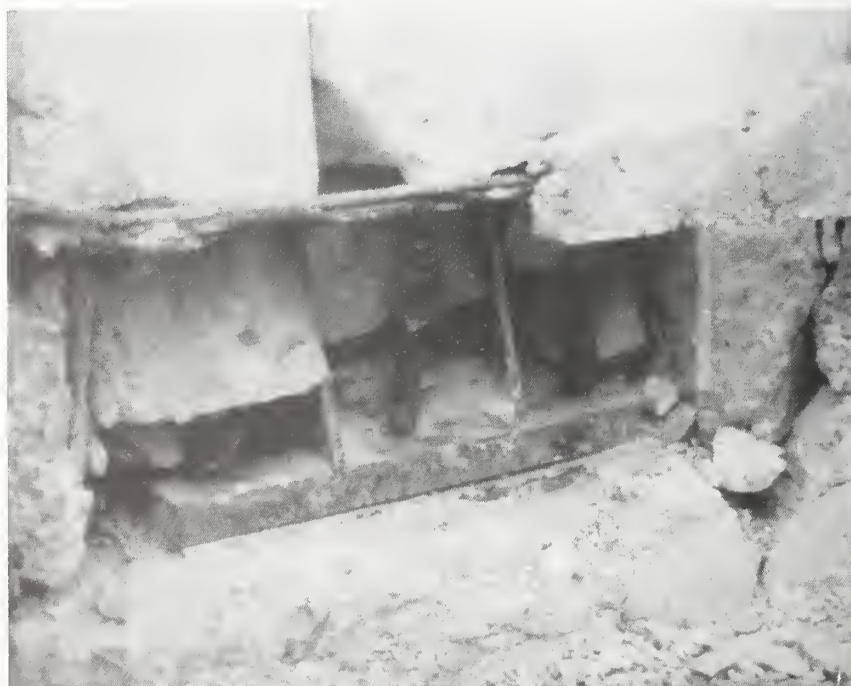
Figure 3.5.36 SAGA Building, anchor bolt was pulled out about 10 cm.

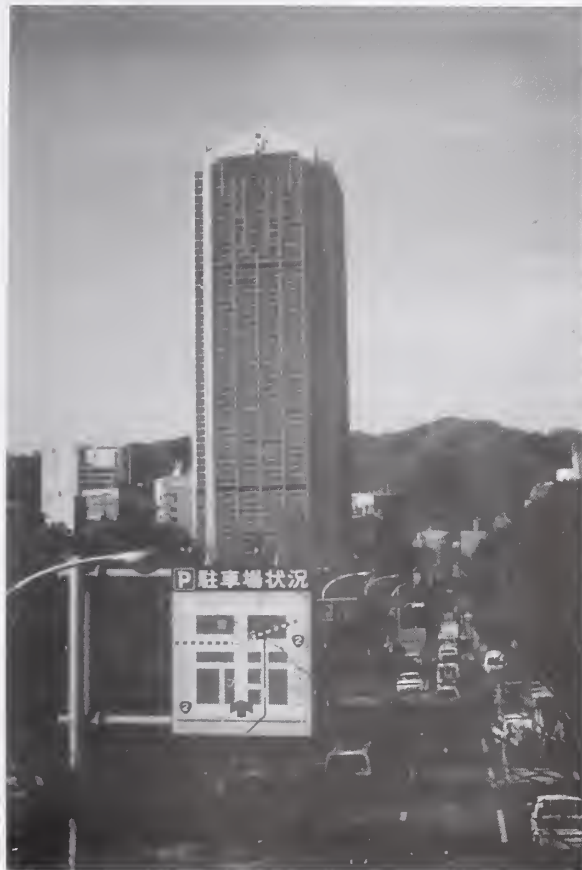
Figure 3.5.37 New Kobe City Office building. A 30-story steel frame structure without reported damage. The adjacent old Kobe City Office building sustained severe damage.

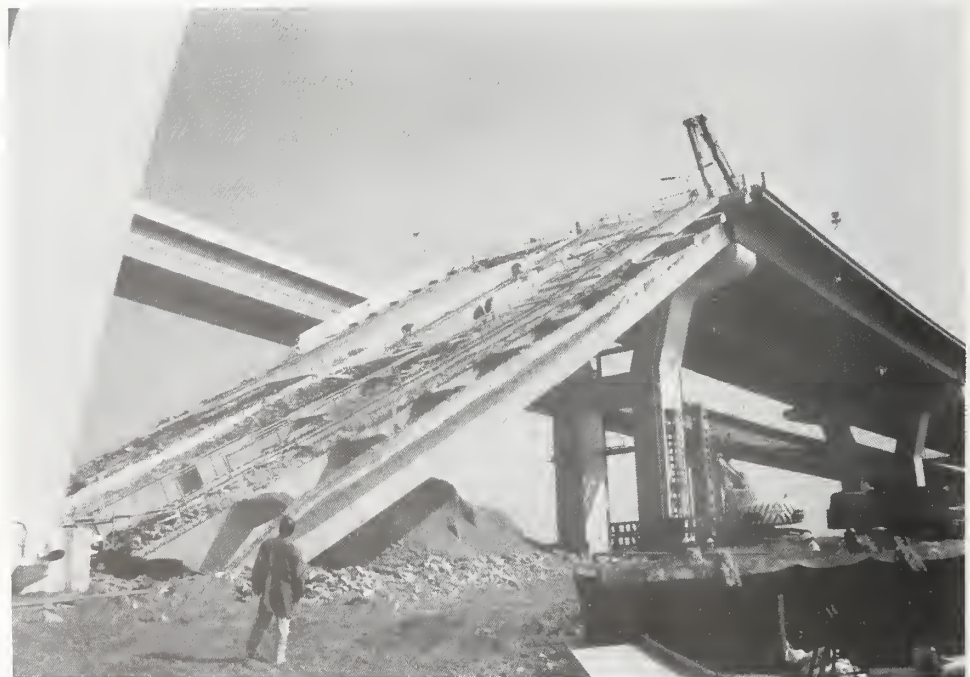
Figure 4.2.2b Collapsed approach span between Piers 111 and 112, Nishinomiya-ko Bridge.

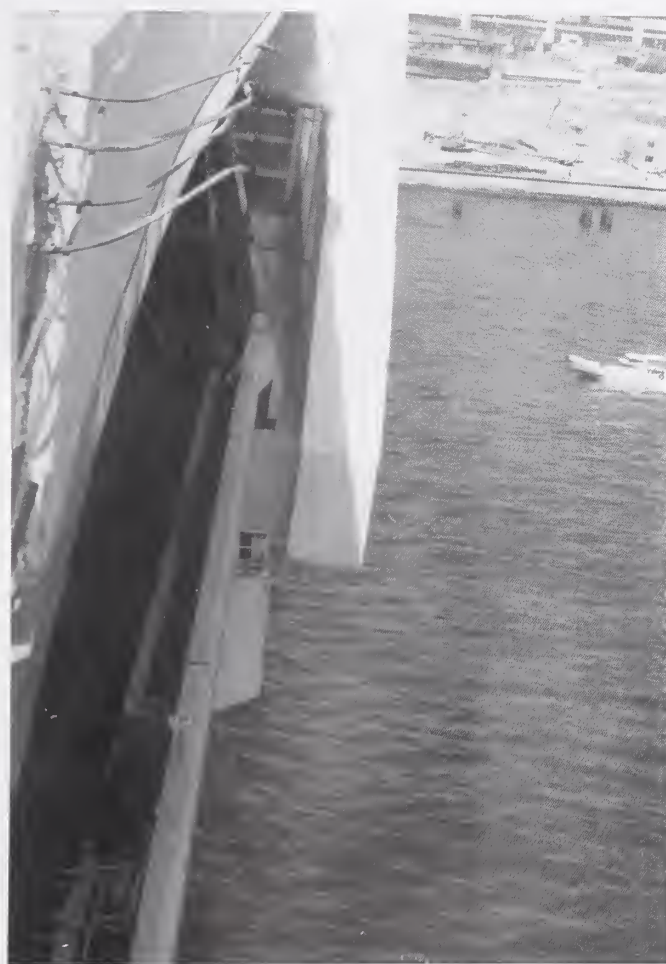
Figure 4.2.7 Lateral offset at east face of South Pier, Rokko Island Bridge.

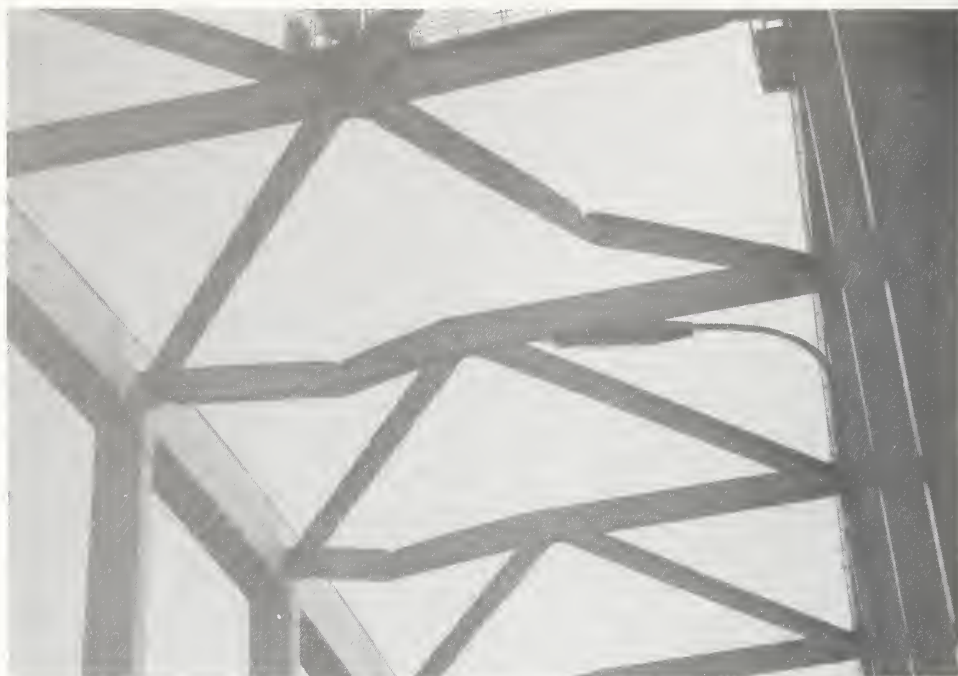
Figure 4.2.8 Buckled cross-members in Upper Chord, Rokko Island Bridge.

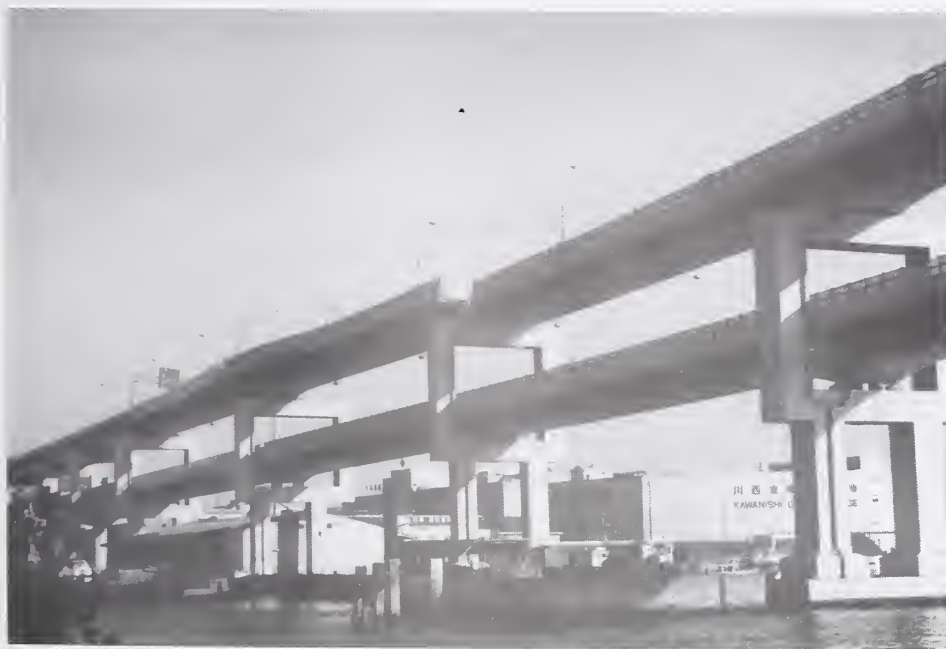
Figure 4.2.13 Lateral offset at Pier 36 in upper level of Hamate By-Pass due to bearing failures at Piers 34 through 38.

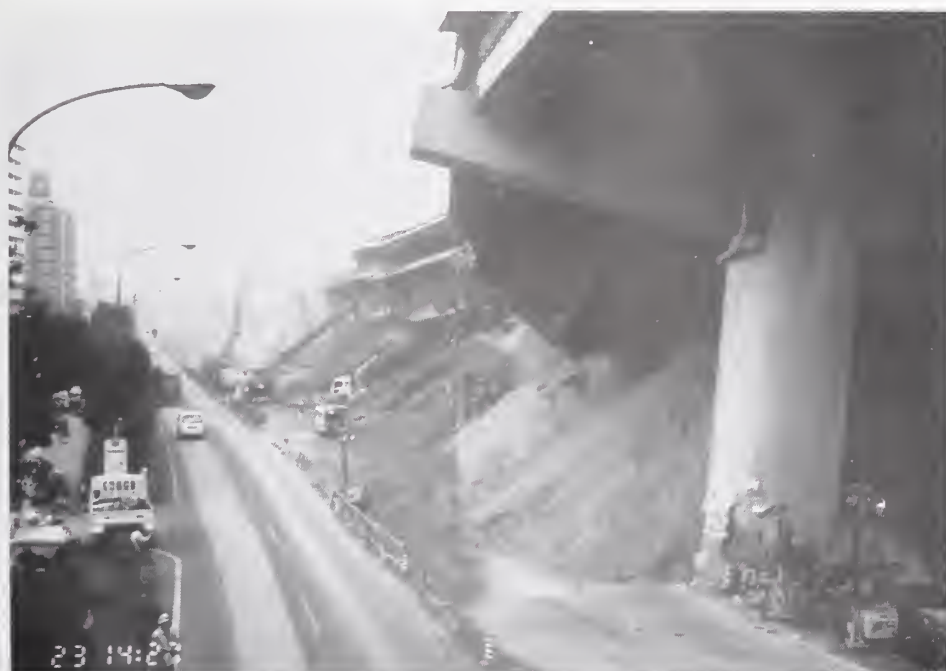
Figure 4.2.14 View of the collapsed Higashi-Nada Viaduct looking west from Pier 125.

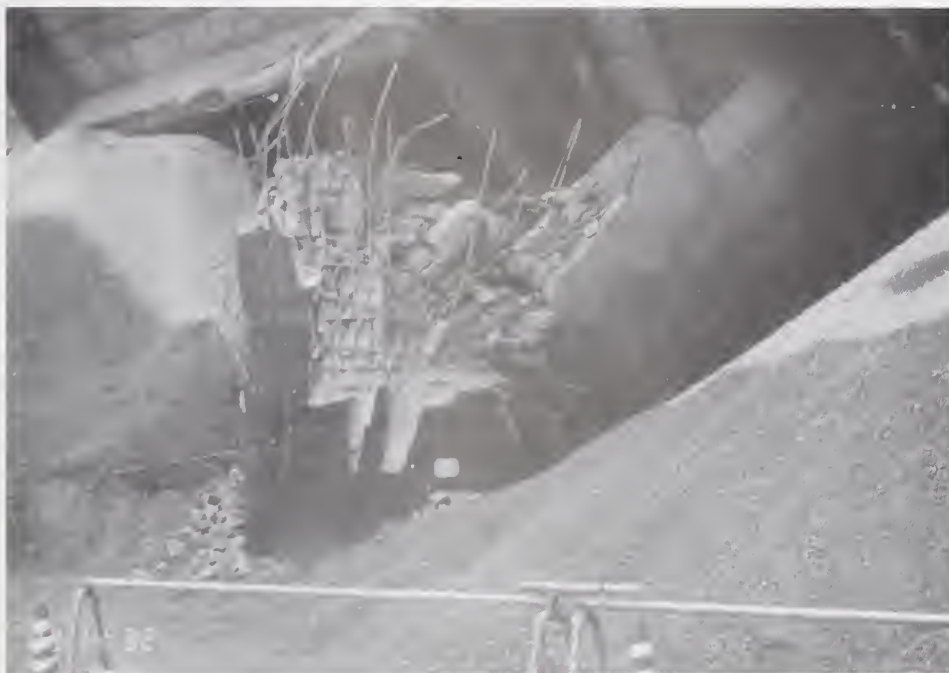
Figure 4.2.17 General view of Hashin Expressway (Route 5) near Uozaki showing collapse of section over Pier 240 in middle distance.

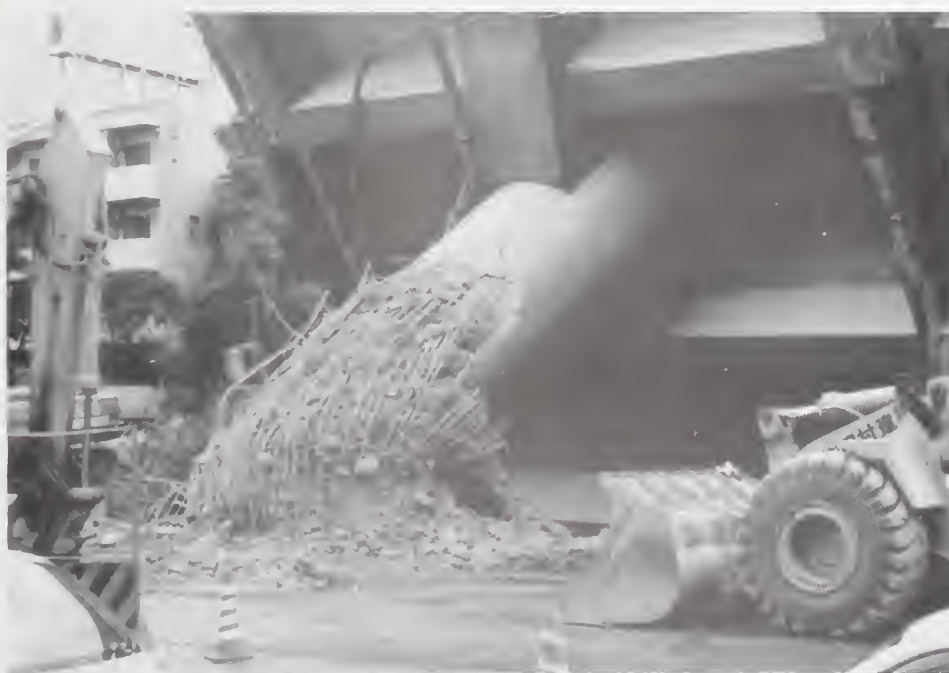
Figure 4.2.18 Pier 240 of Hanshin Expressway showing temporary repair to this single column bent.

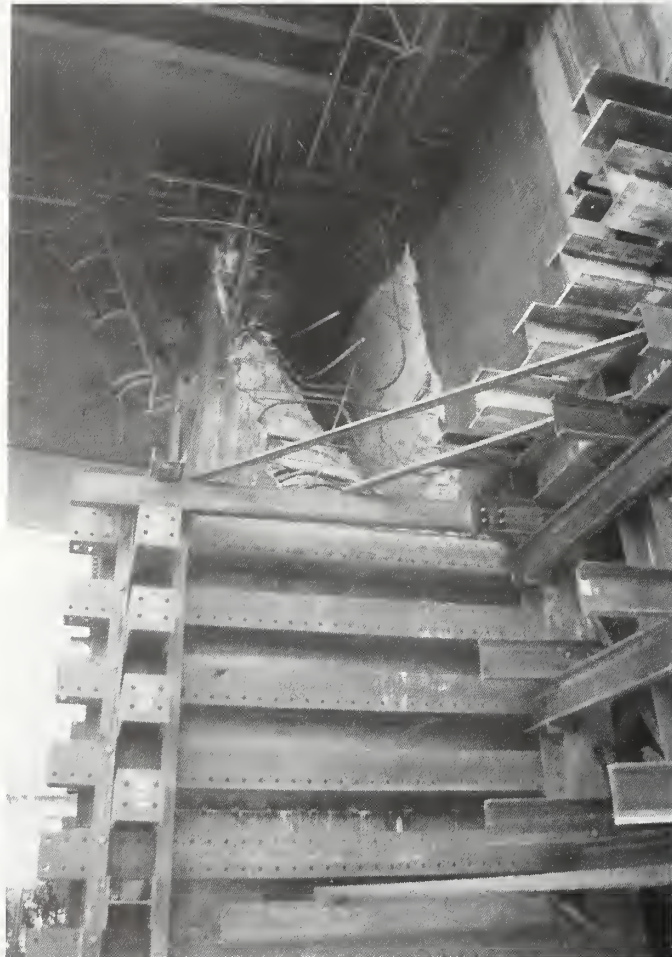
Figure 4.2.19

Shear failure in Pier 240 of Hanshin Expressway showing temporary repair to column to prevent total collapse.

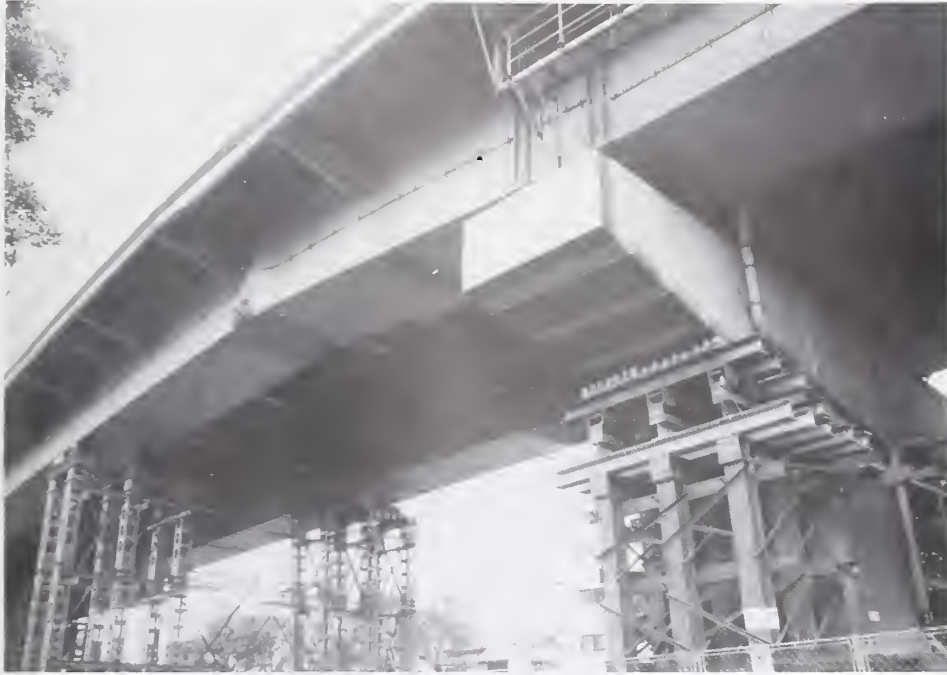
Figure 4.2.20 Compressive failure in lower flange of steel box girder between Piers 238 and 239 of Hanshin Expressway.

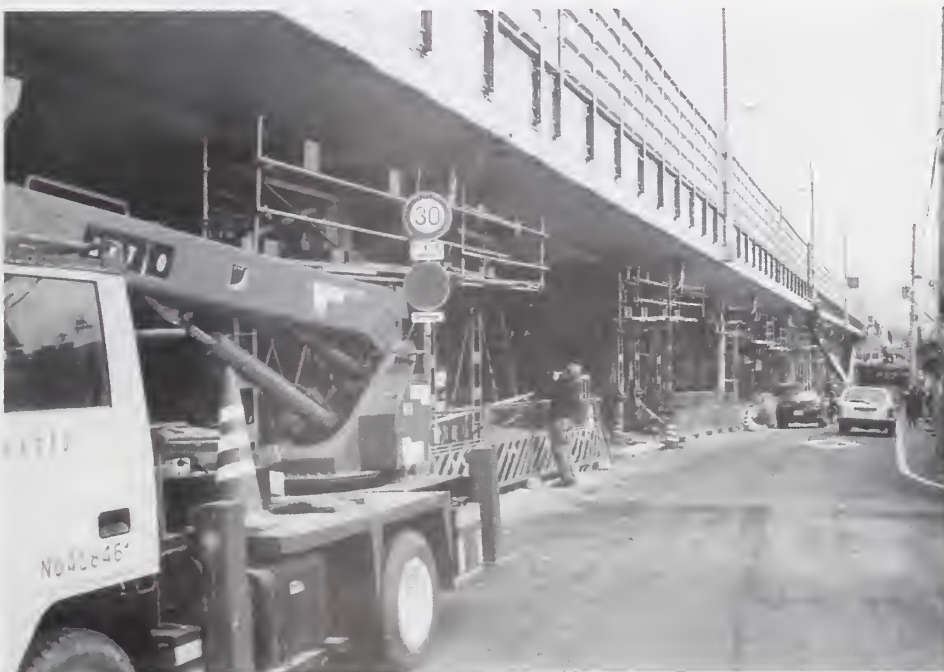
Figure 4.2.21 General view of Takarazuka Viaduct, Chugoku Expressway.

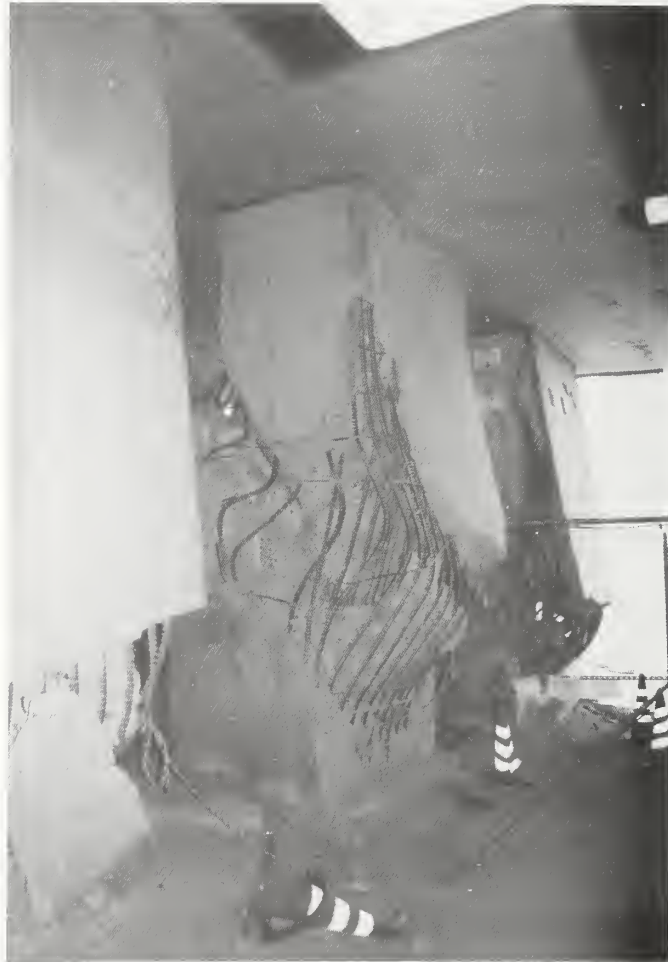
Figure 4.2.22 Shear failures in 3-column bent at Pier 3, Takarazuka Viaduct.

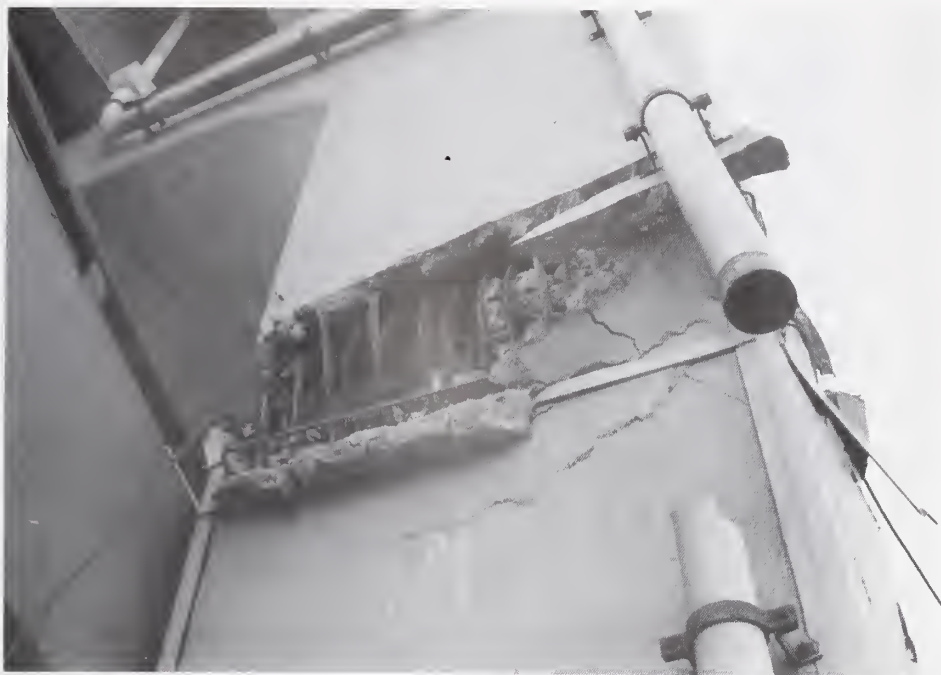
Figure 4.2.26 Hinge formation in east column of Pier 23, Kobe-Ohashi.

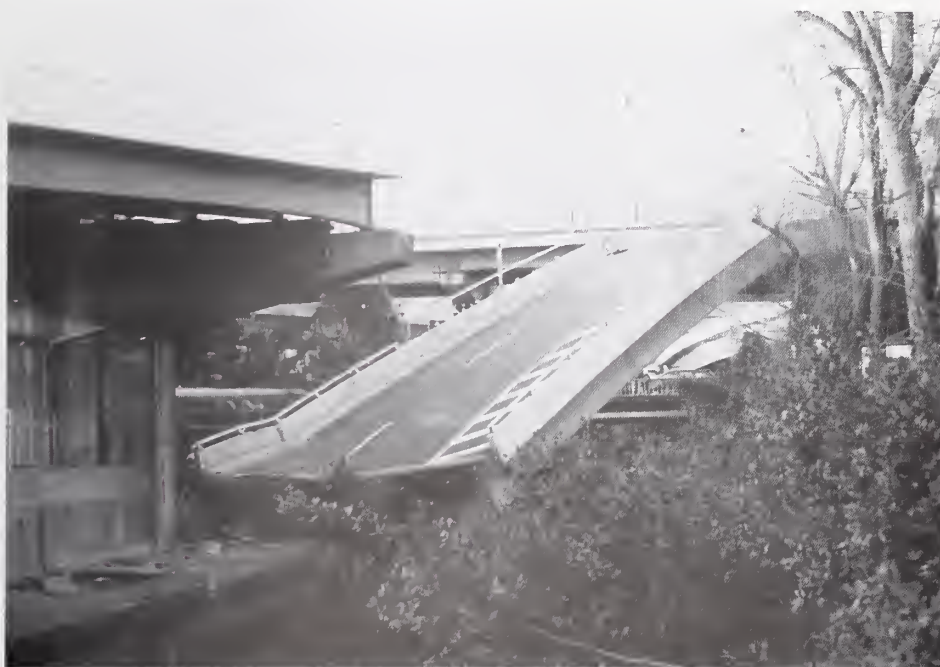
Figure 4.2.27 Collapse of Southeast Ramp at the Minatogawa Interchange.

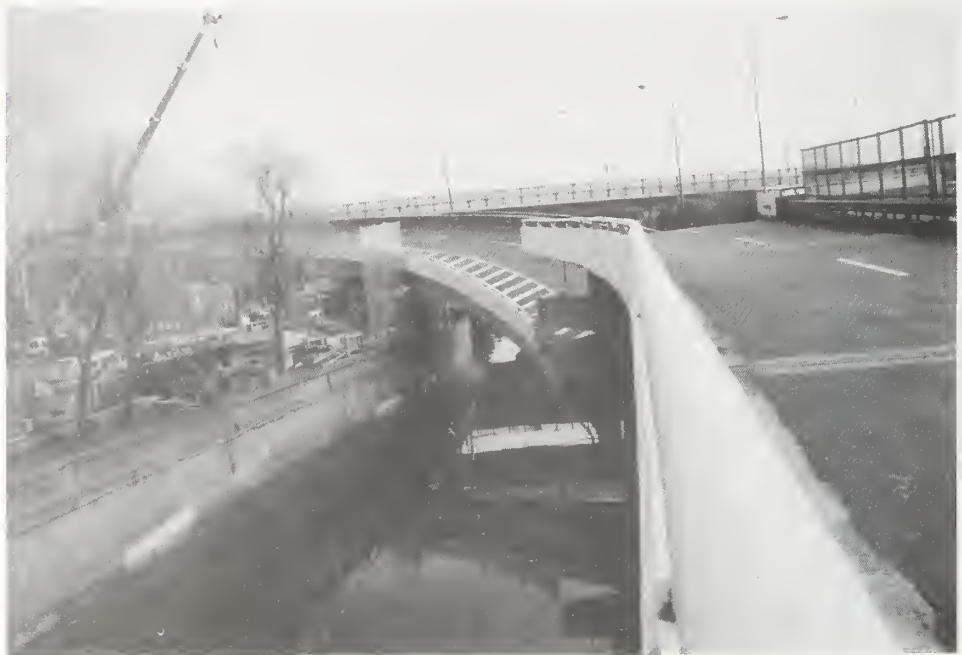
Figure 4.2.28 Collapse of Northeast Ramp at the Minatogawa Interchange.

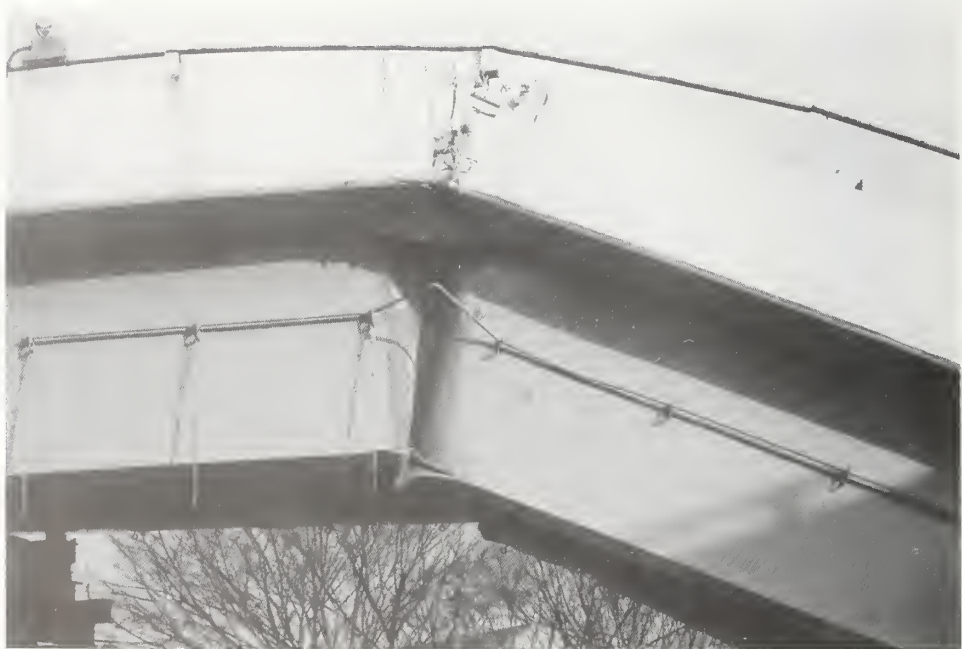
Figure 4.2.29 Girder web failure due to unseating of the Southeast Ramp at Minatogawa Interchange.

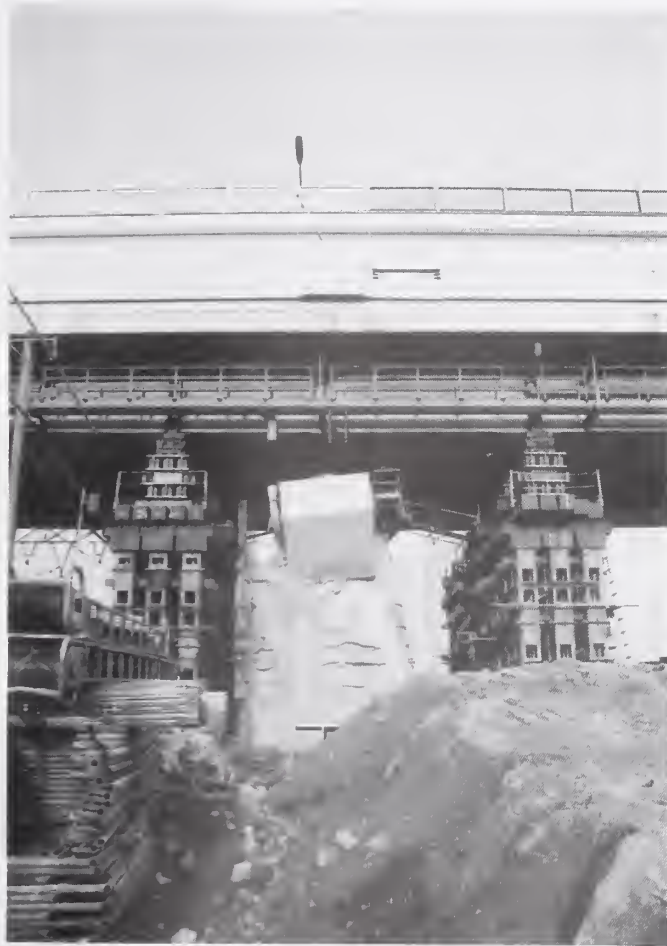
Figure 4.2.32 Side view of shear failure in Pier 688 of Route 3 near JR Sanyo Line.

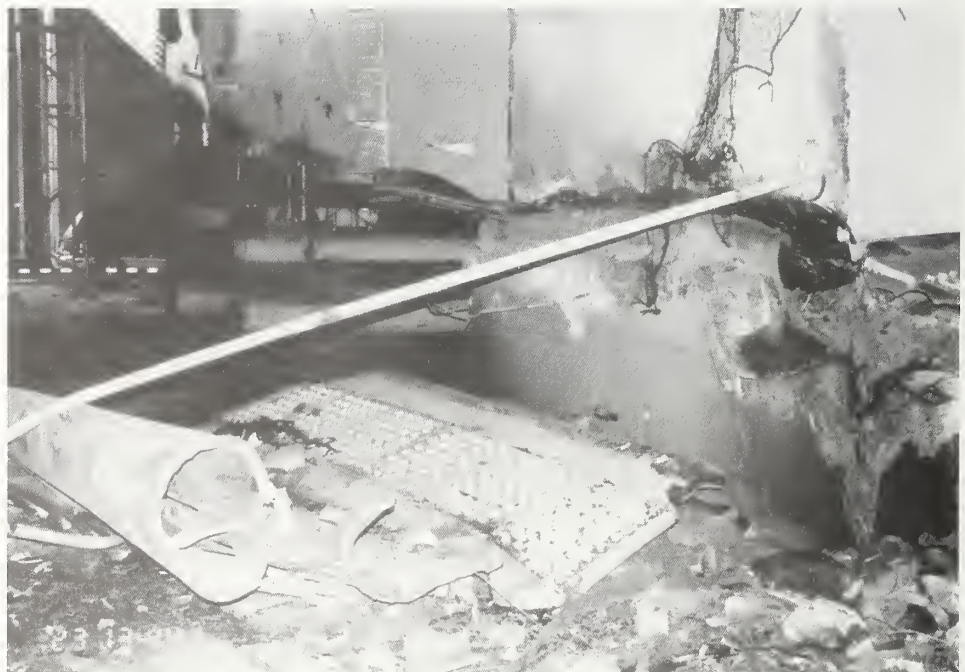
Figure 4.2.34 Pier 55, Route 3 near Tateishi showing buckled steel plate on ground.

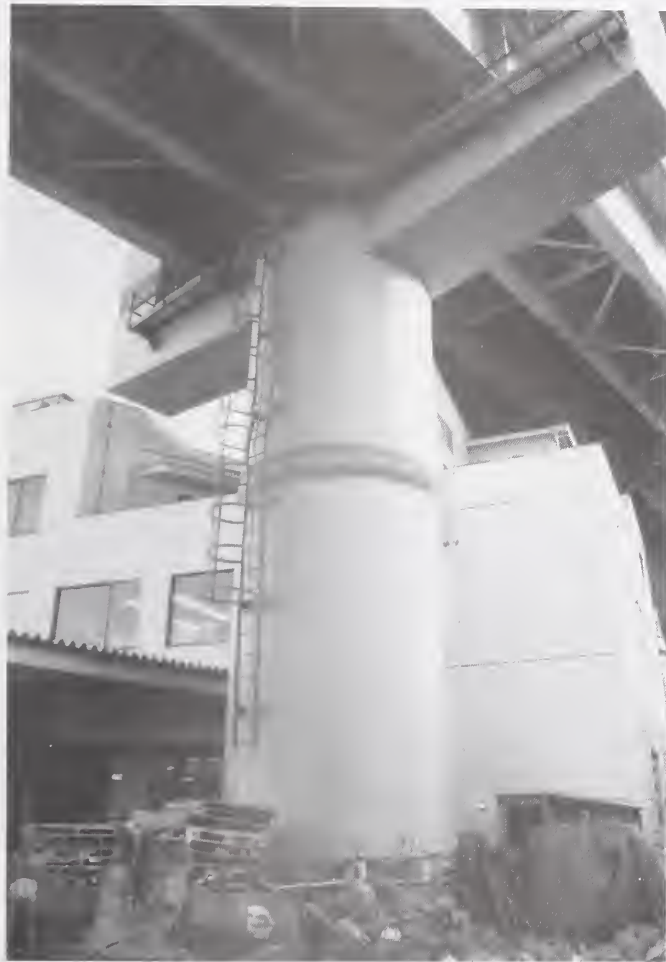
Figure 4.2.40 Buckling in steel columns at Pier 49 of the Hamate By-Pass Viaduct.

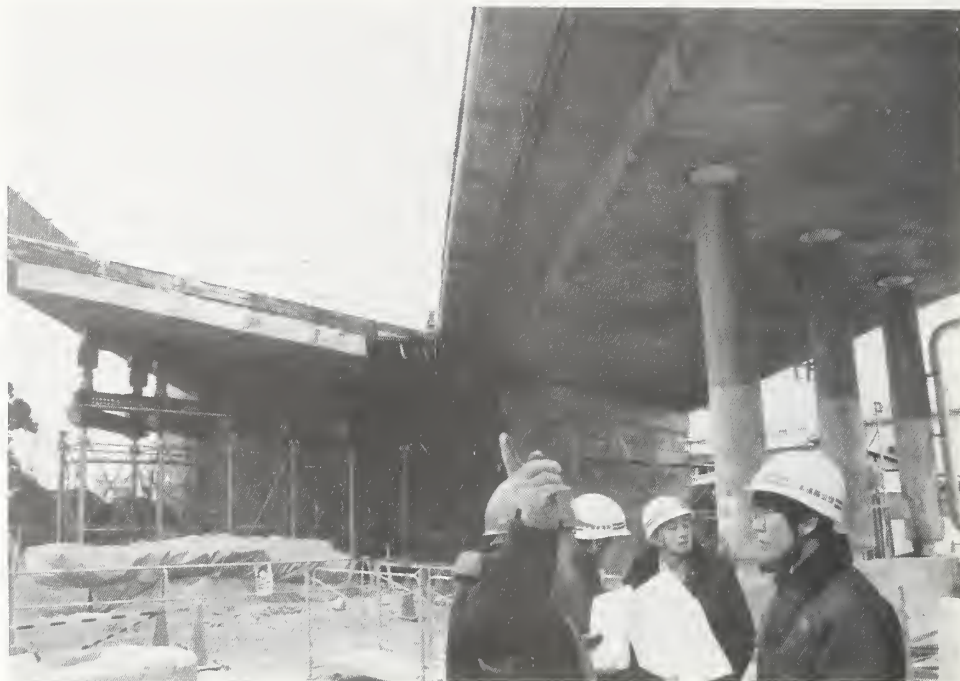
Figure 4.2.46

Pier 27 of the westbound Kawaraginishi Bridge showing shear cracking and repair by injection grouting.

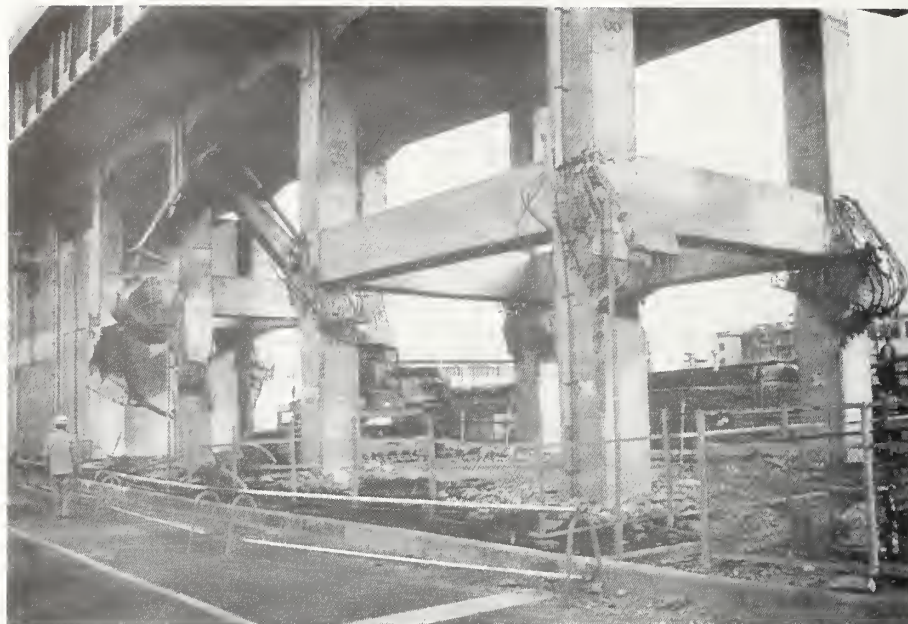
Figure 4.3.6 Column repair - Shinkansen.

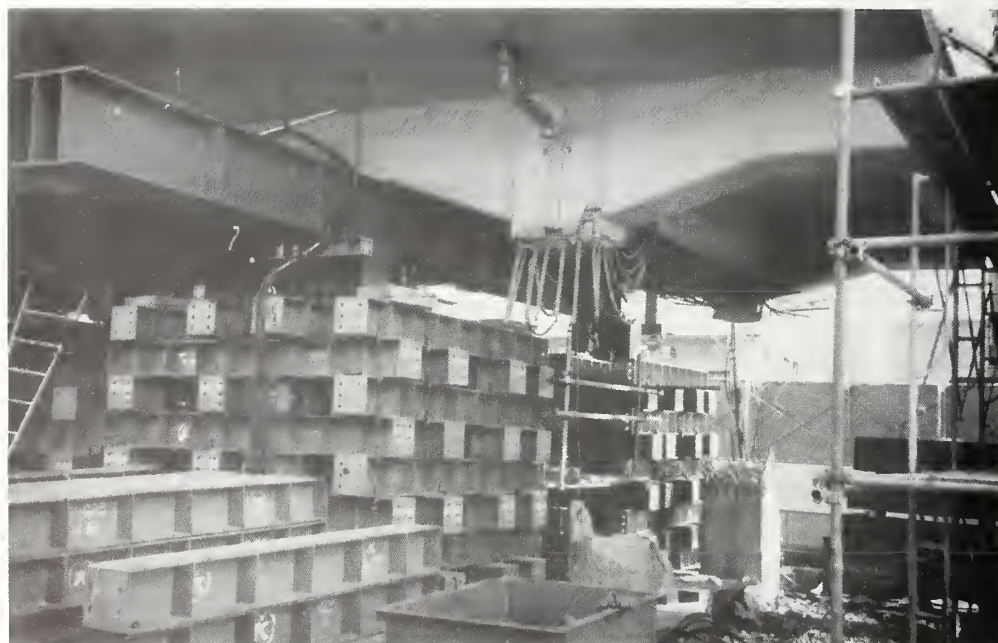
Figure 4.3.7 Column jacketing repair - JR Main Line.

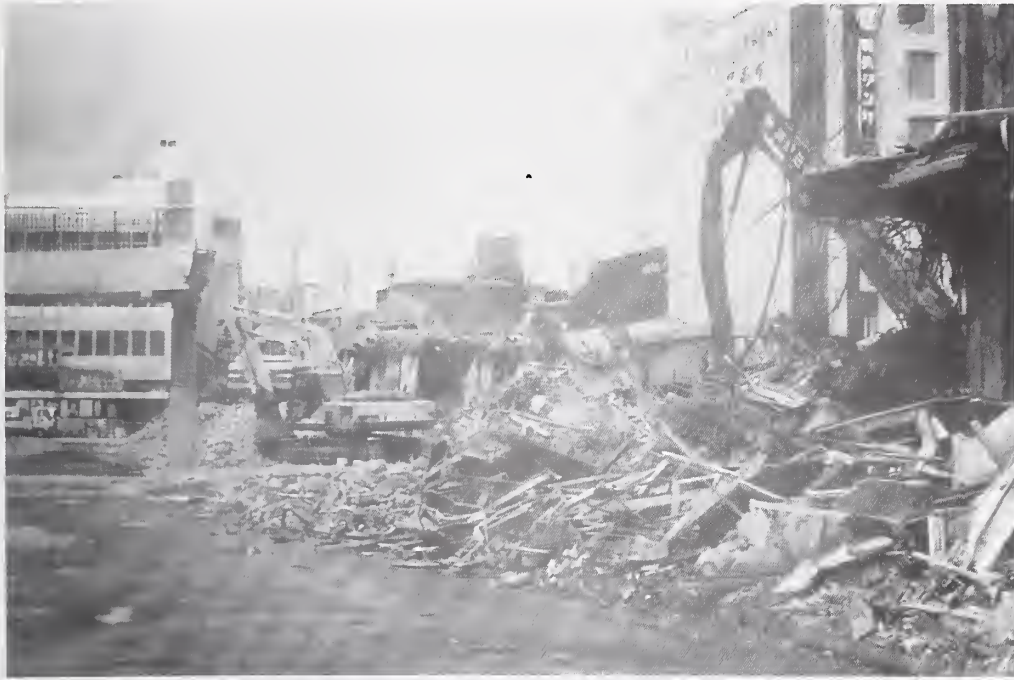
Itami Line The Shin-Itami station collapsed (Figure 4.3.11). The elevated station was at the end of the Itami Line. Railroad tracks gradually rose through a segment of elevated embankment and a series of elevated structures and ended at this station. The collapse may have been caused by a whipping action.

Figure 4.3.11 Collapsed Shin - Itami Station.

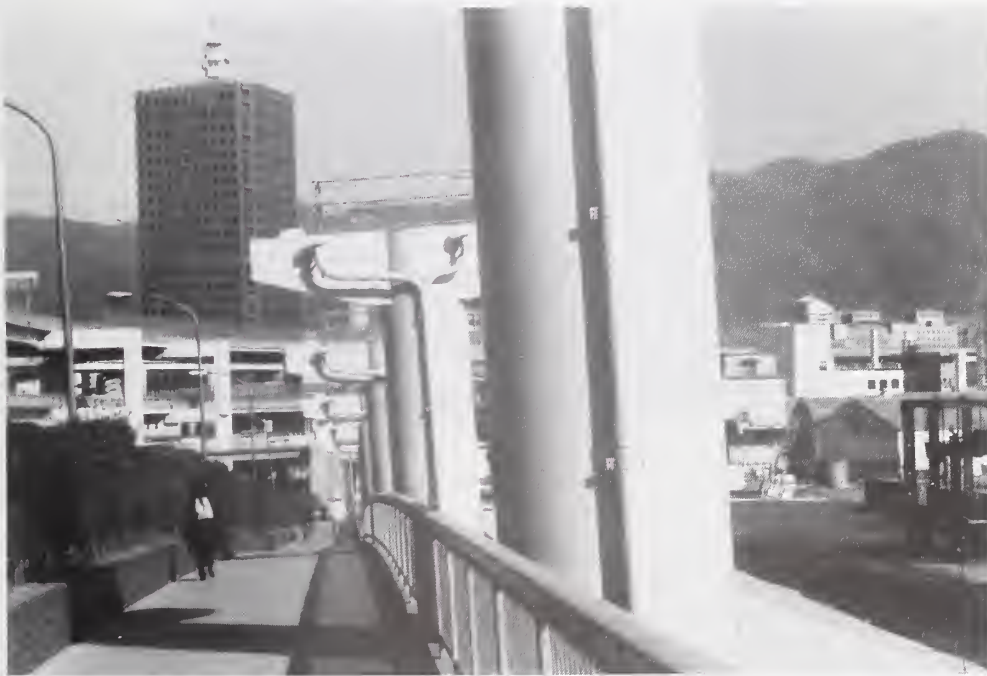
the east side of the steel box girder tore off the web of the girder. Pier 35 tilted to the north (Figure 4.3.12) and the southern span dropped off and the superstructure yielded near the bent cap. Piers 56 to 59 tilted to the west (Figure 4.3.13) which may have been caused by liquefaction in this area. The first span at the south end of the Kobe bridge offset approximately 15 cm to 20 cm. Although the whole Port Island settled approximately 0.5 m to 1 m, no columns supporting the train had suffered any damage in this area.

Figure 4.3.12 Tilted pier - Port Liner.

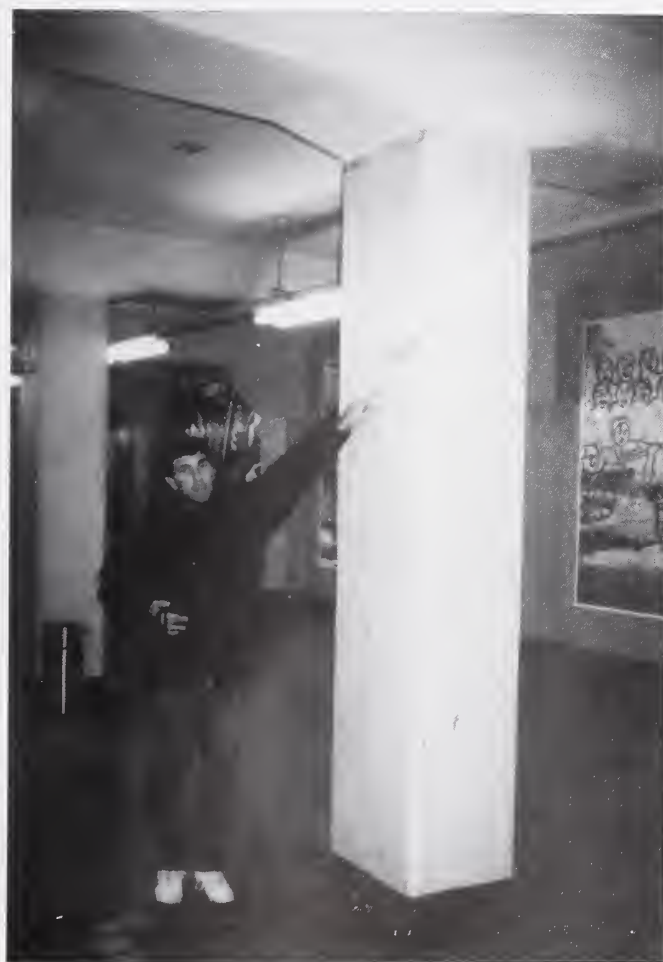
underground shopping mall adjacent to the KRTR near Shin Kaichi Station. Figures 4.3.14 and 4.3.15 show typical damage within the shopping mall. There was severe damage of the elevated rail structure near Sannomiya Station.

Figure 4.3.14 Cracked reinforced concrete column at underground shopping mall near Shin Kaichi Station.

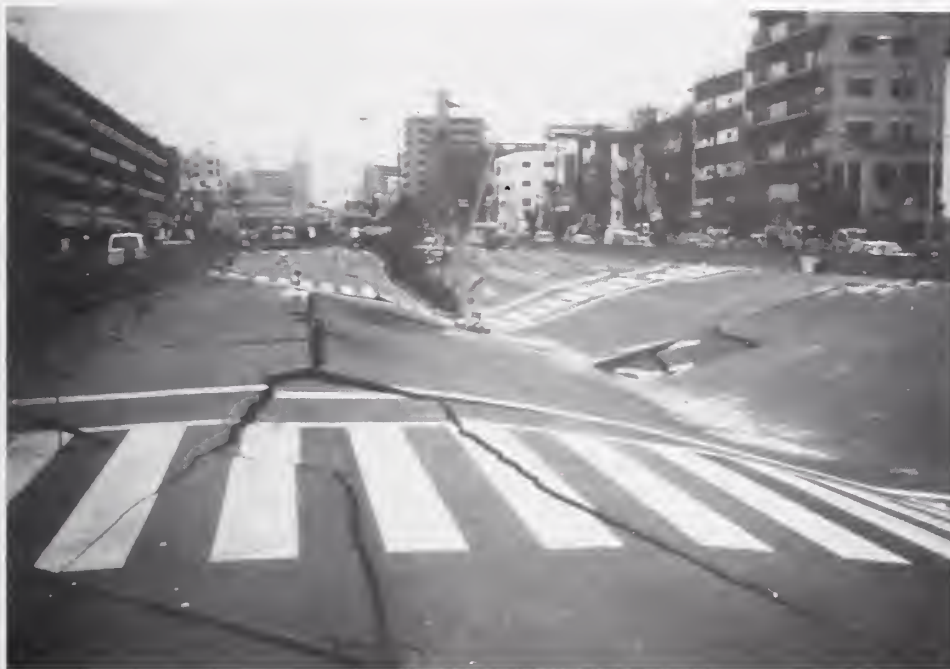
Figure 4.3.21 Subsidence of street surface over the collapsed Daikai Station.
