NIST Special Publication 901

The January 17, 1995 Hyogoken-Nanbu (Kobe) Earthquake

*Performance of Structures, Lifelines, and Fire
Protection Systems*

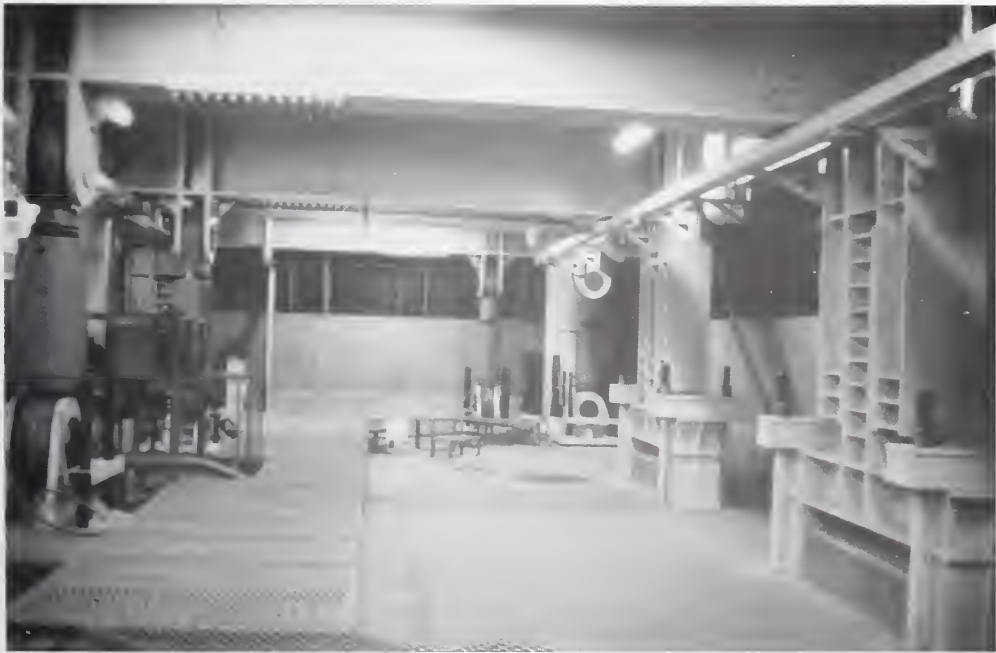
columns is not known, but there are two shear keys on each side of the tower (Figure 4.4.9). These shear keys are detailed to carry lateral load parallel to the foundation wall, including torsion of the building, but no vertical axial load (Figure 4.4.10). The lower end of each ram is supported by the foundation pad and the upper end is connected to a stiff diaphragm, consisting of the deep beams shown in Figure 4.4.11. The shear keys are configured so that they stay engaged when the rams are used to relevel the structure. It is not known if the leveling mechanism is used to compensate for differential settlement of the tower to prevent leaning, or if it is also used to maintain the level between the structure and the surrounding ground. This may be needed to prevent damage to utility lines that enter the building.

The leveling system provided in the basement of the Kansai Airport Control Tower appears to be an innovative approach to provide for the possible uneven ground settlement that may be caused by liquefaction or consolidation.

Figure 4.4.9 Basement of the tower showing system for leveling the building and shear keys.

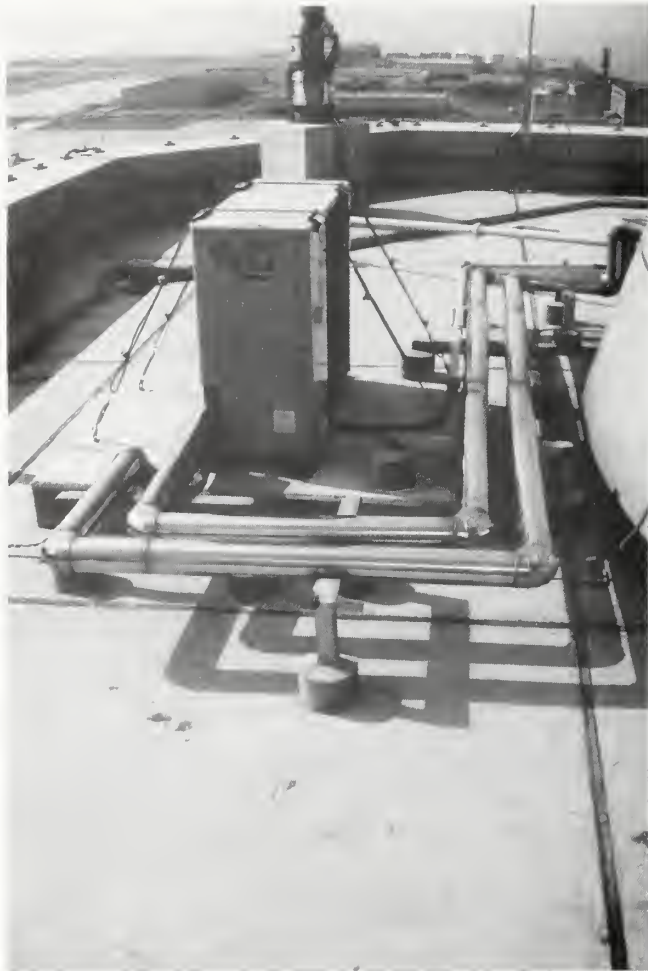
A heat exchanger on the roof was well anchored, as was most equipment observed (Figure 4.4.18).

Figure 4.4.18 Roof-mounted heat exchanger braced with cables.

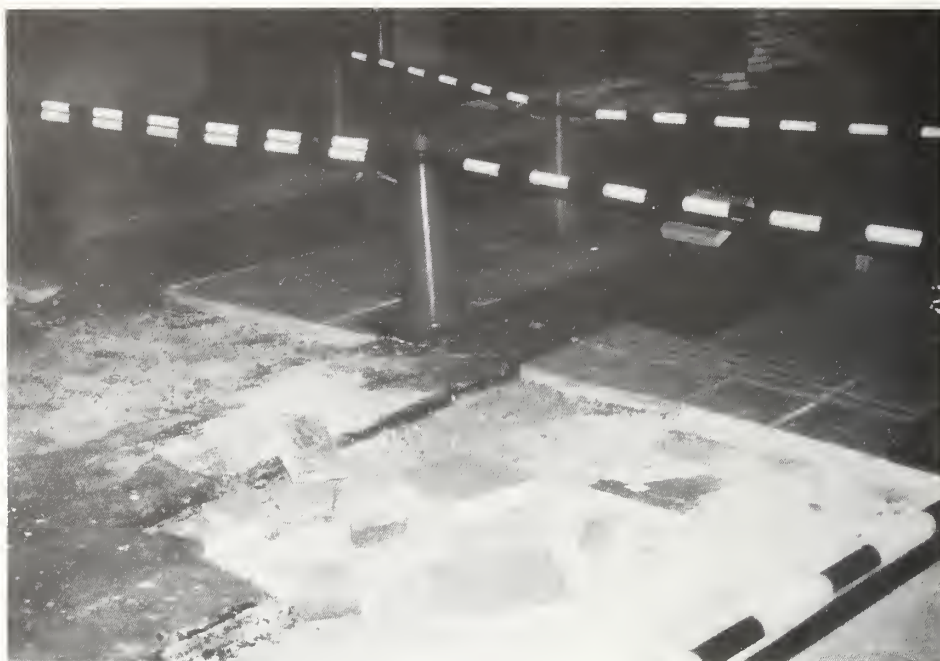
Figure 4.4.26 Subsidence in sidewalk and repaired sidewalk outside the Kansai Terminal Building.

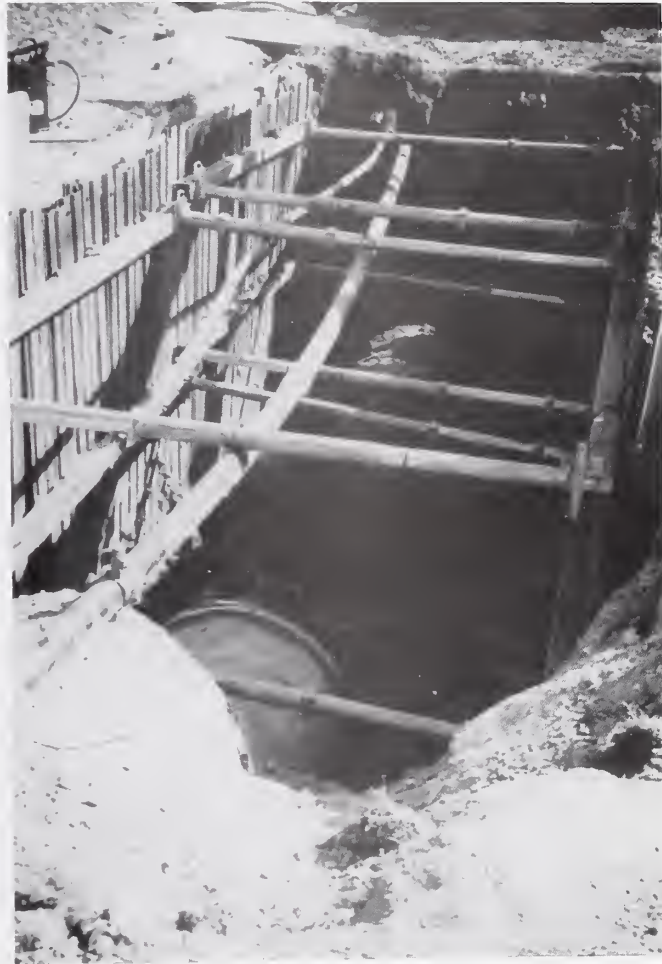
Photo 10 Repair of one of the three 1.2 m treated water lines leaving the Uegahara/Hanshin Plants site.

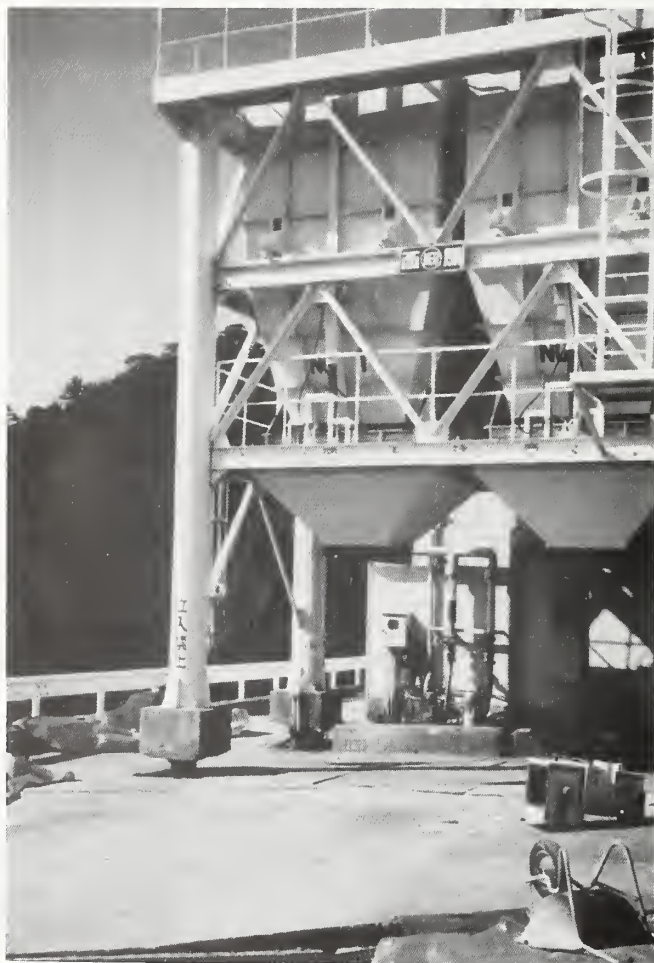
Photo 11 Subsidence (approximately 30 cm) around pile-supported sludge hoppers at Uegahara Plant.

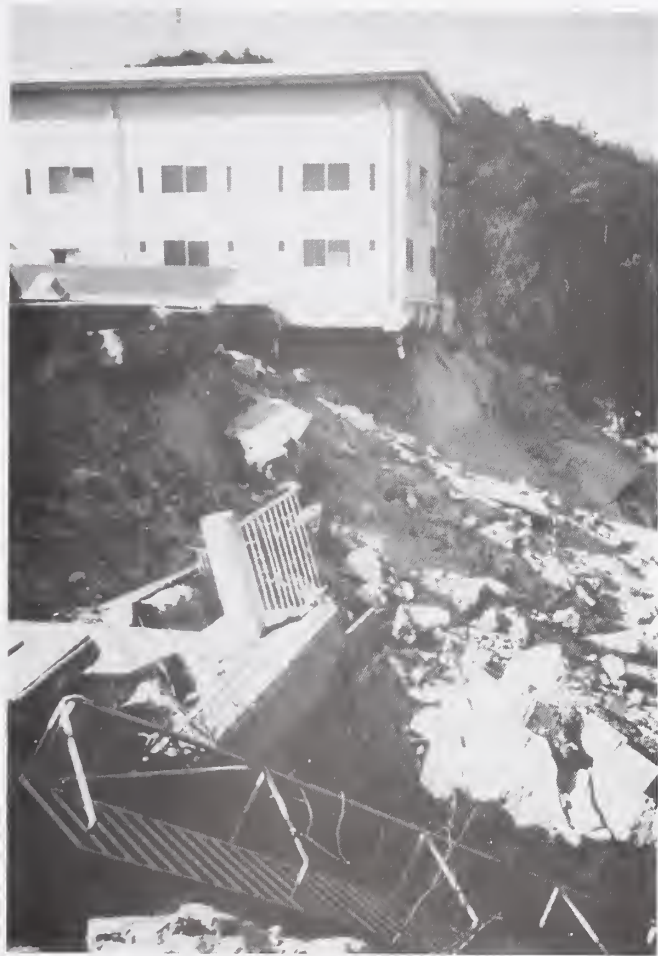
Photo 12 Landslide undermined solids handling building at the Hanshin (Kabutoyama) Plant.

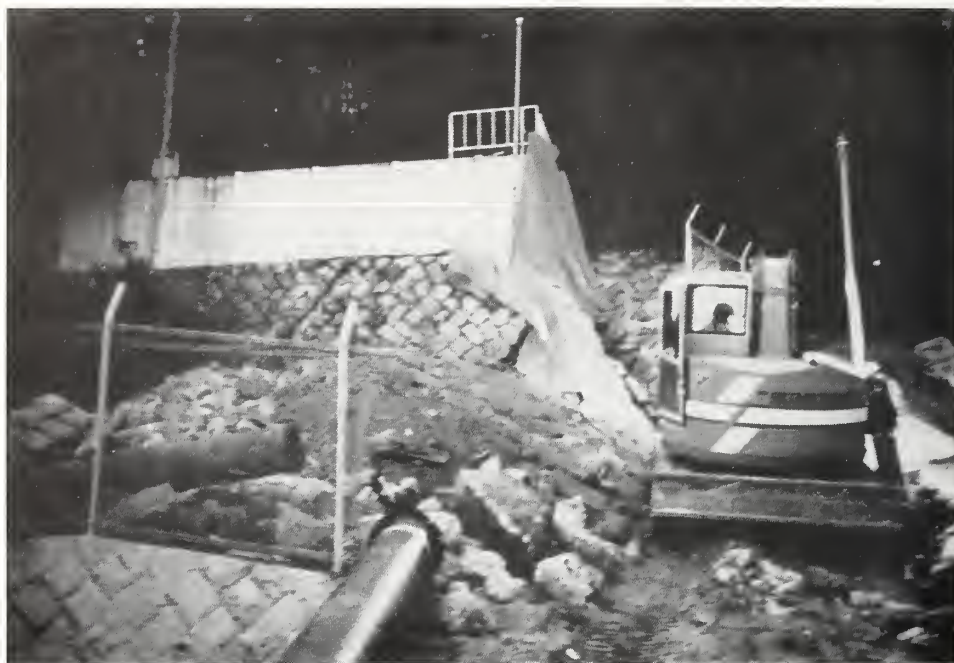
Photo 13 Broken lines to/from backwash tank at the Motoyama Water Purification Plant.

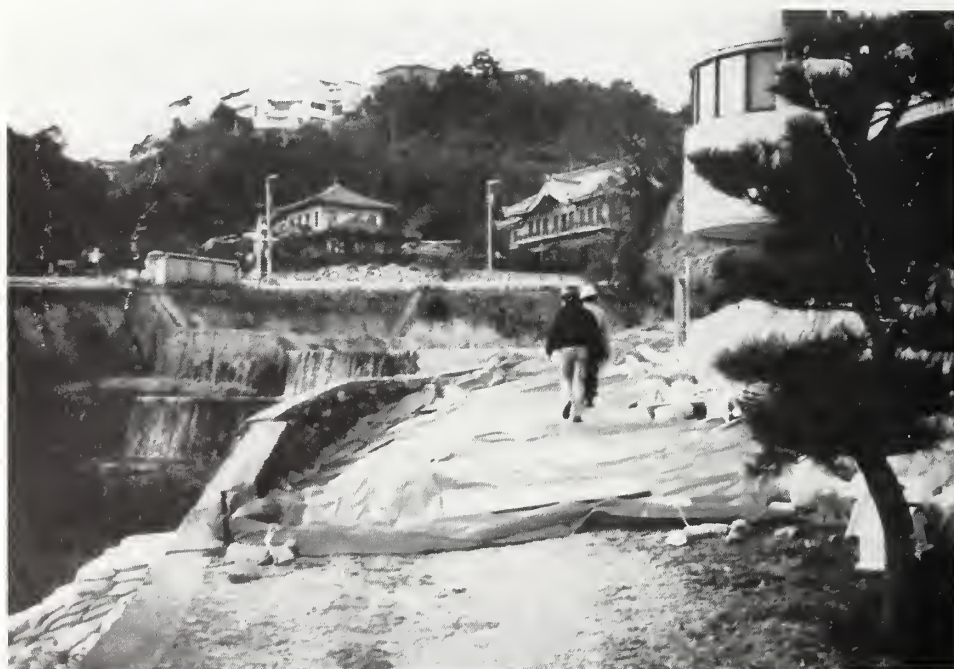
Photo 14 The retaining wall on the left cracked damaging the overflow line from the Motoyama Plant's intake box.

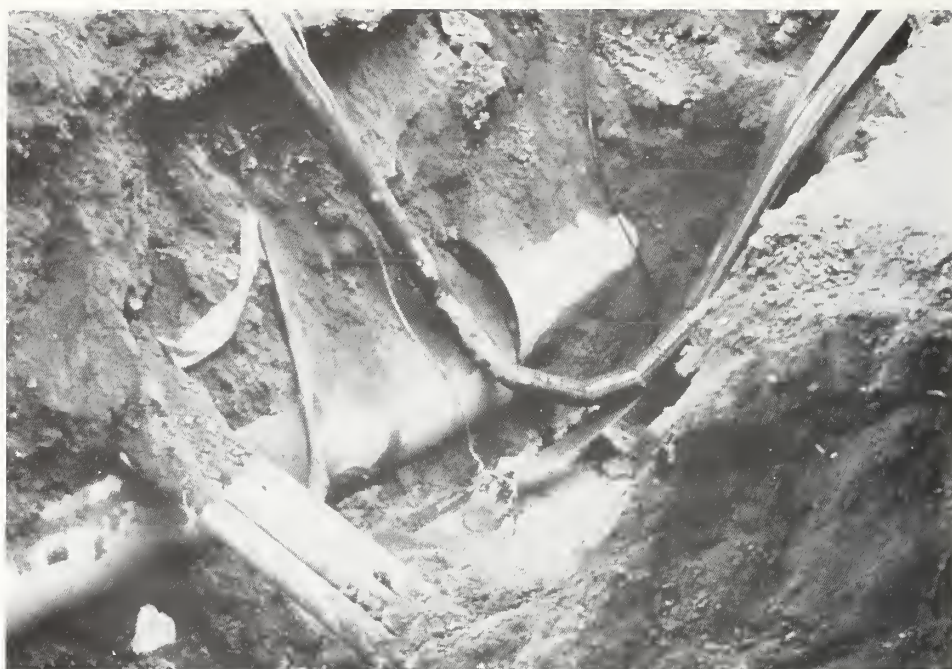
Photo 16 Repair of 700-mm welded steel pipeline which ruptured at a weld on the north side of Port Island in an area affected by liquefaction induced lateral spread. This line carries the entire potable water supply for the island.

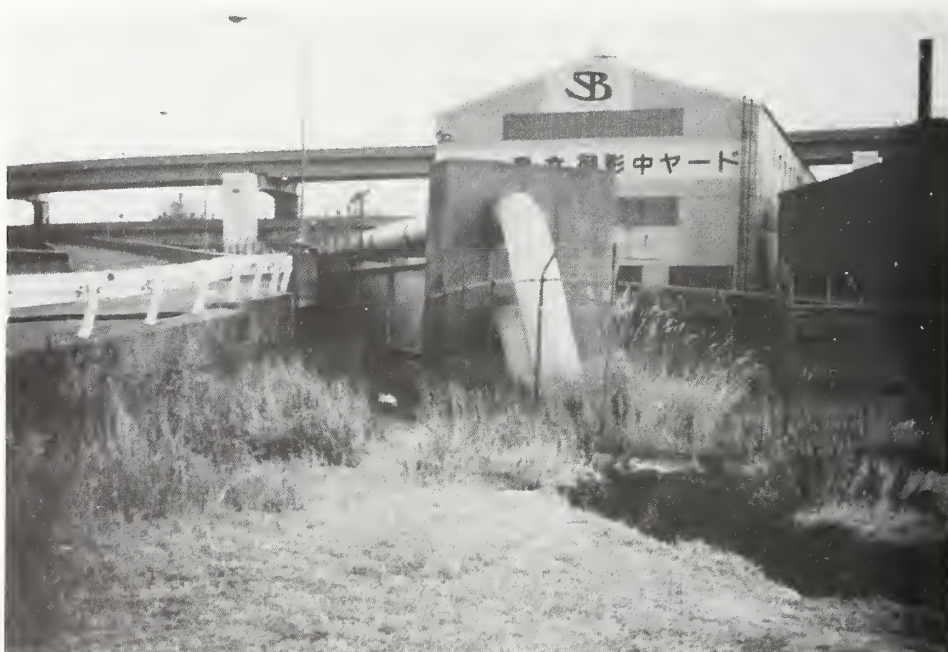
Photo 17 Ground cracking from lateral spread in fill area along a water way. Immediately behind the crack, a pipeline emerges out of the ground to be supported on the bridge.

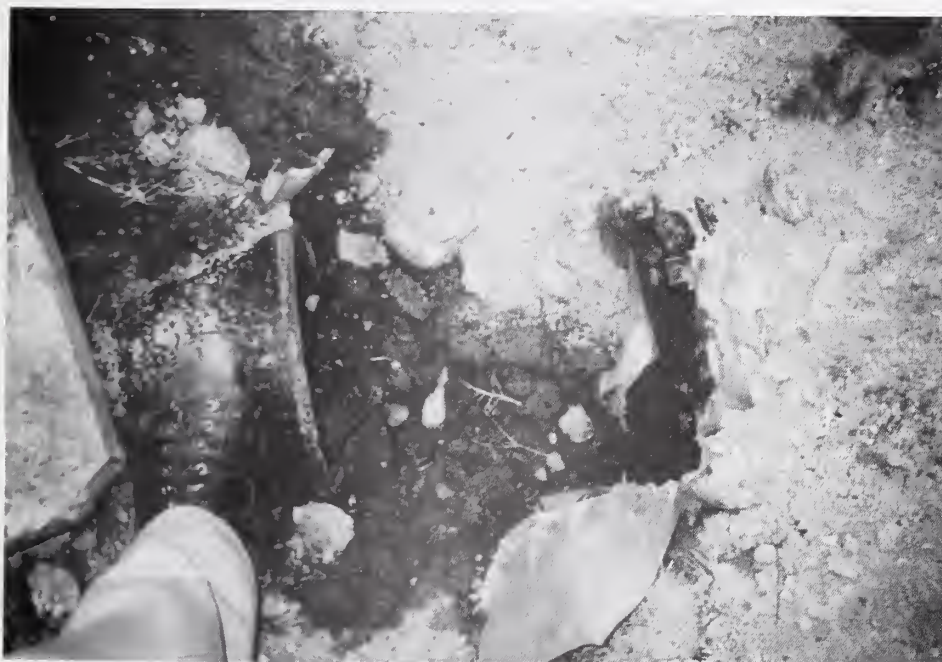
Photo 18 Shows a 300 mm diameter pipe joint in the bottom of the crack (Photo 17), where the bell (to the right) was separated from the spigot (under foot).

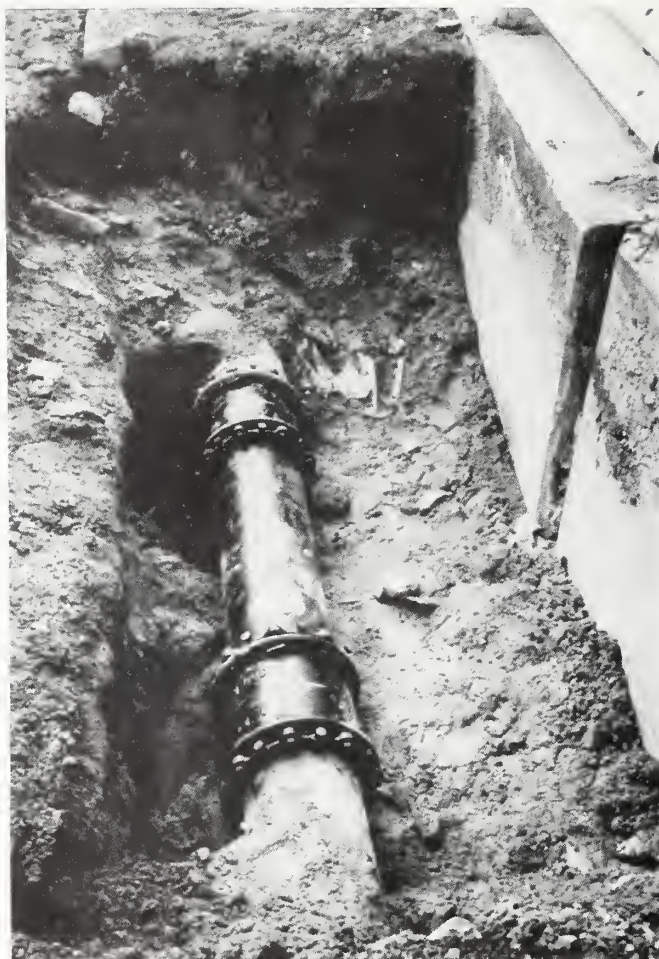
Photo 19 Pipe repair on approach to bridge to island where the wastewater plant was located. Settlement and slight lateral movement (see concrete wall on right) likely caused the pipe failure.

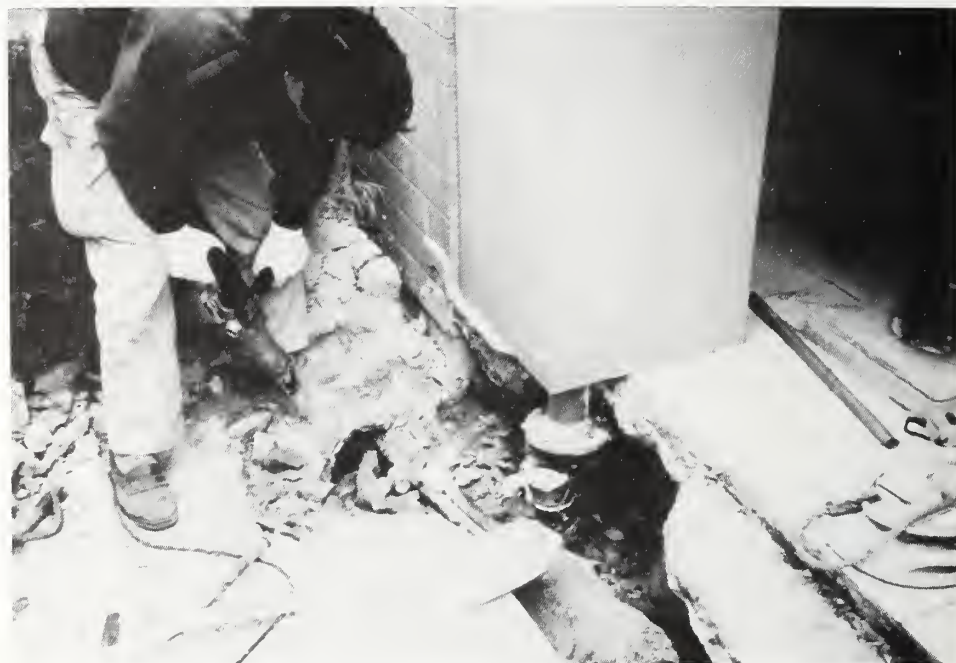
Photo 22 Repair of utility connections in mid-Rokko Island.

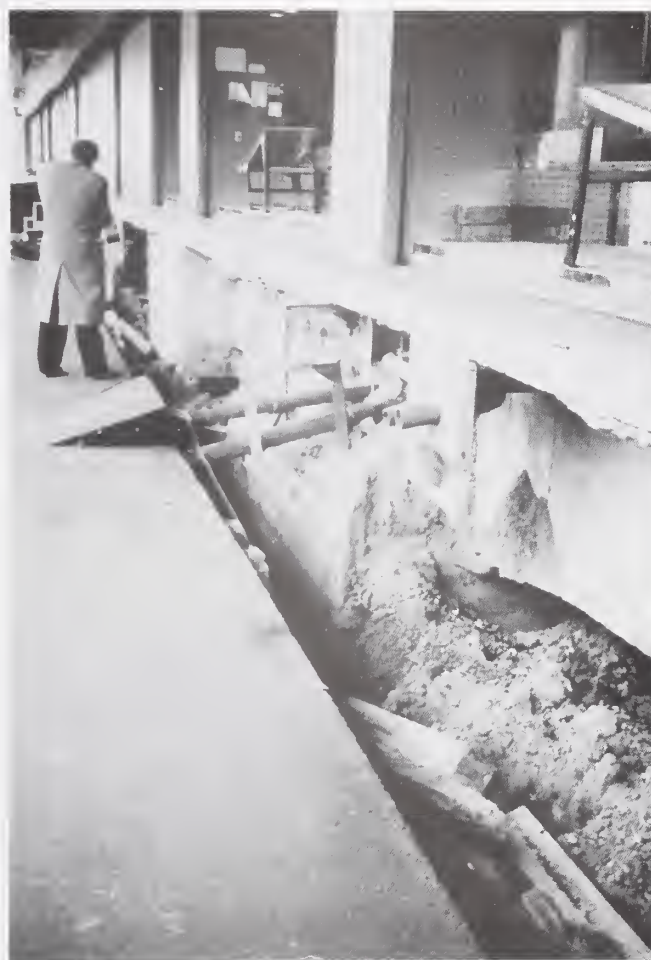
Photo 23 Differential settlement of approximately one meter along the front of pile supported ferry terminal on Port Island connecting Kobe to Kansai Airport. Utility connections were left hanging.

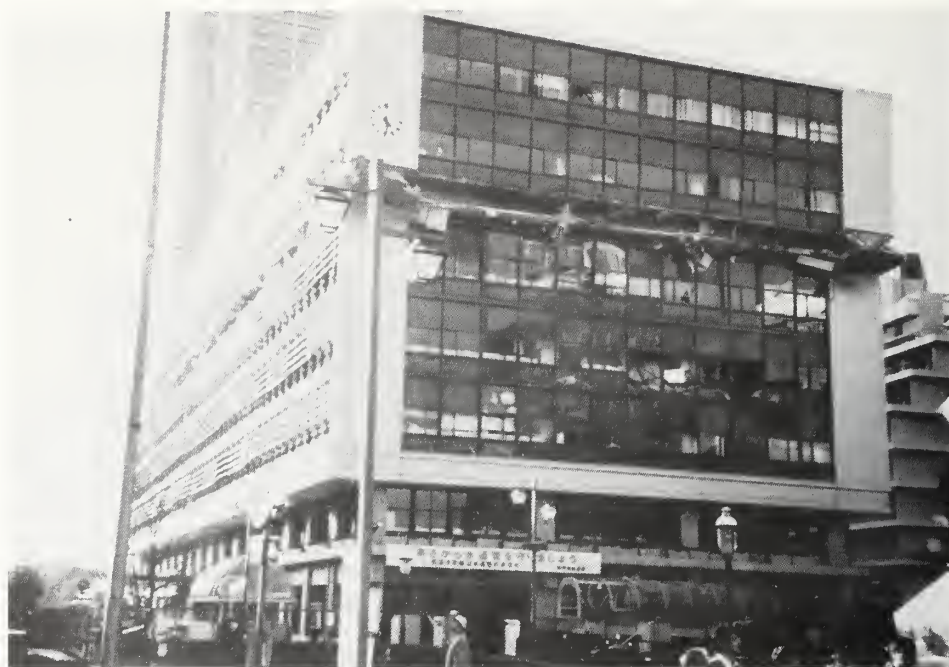
Photo 24 Pancaked sixth floor of City Hall Annex.

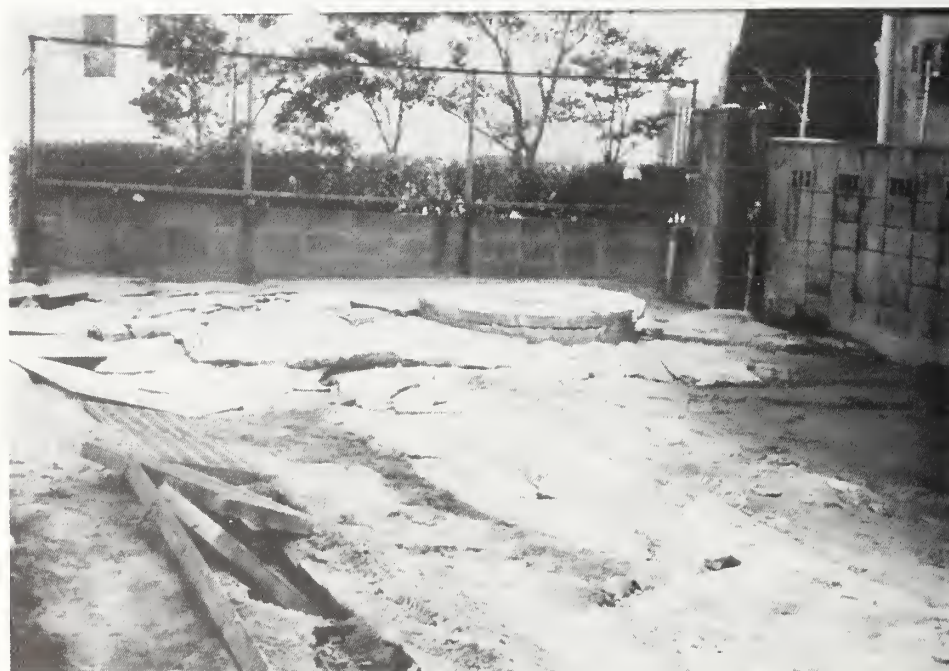
Photo 25 Manhole floated as a result of liquefaction near the wastewater treatment plant.

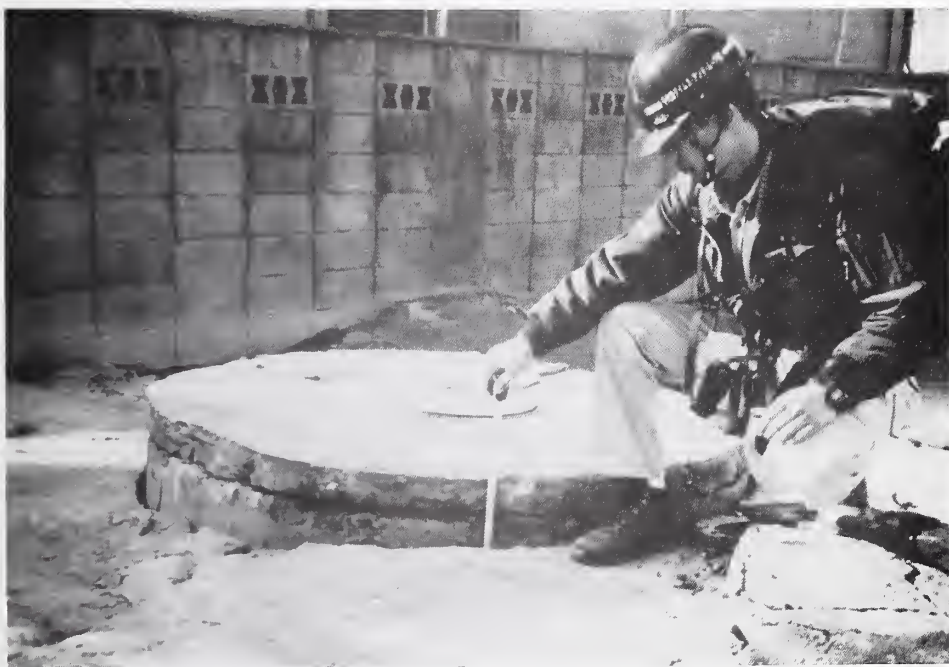
Photo 26 Same as Photo 25.

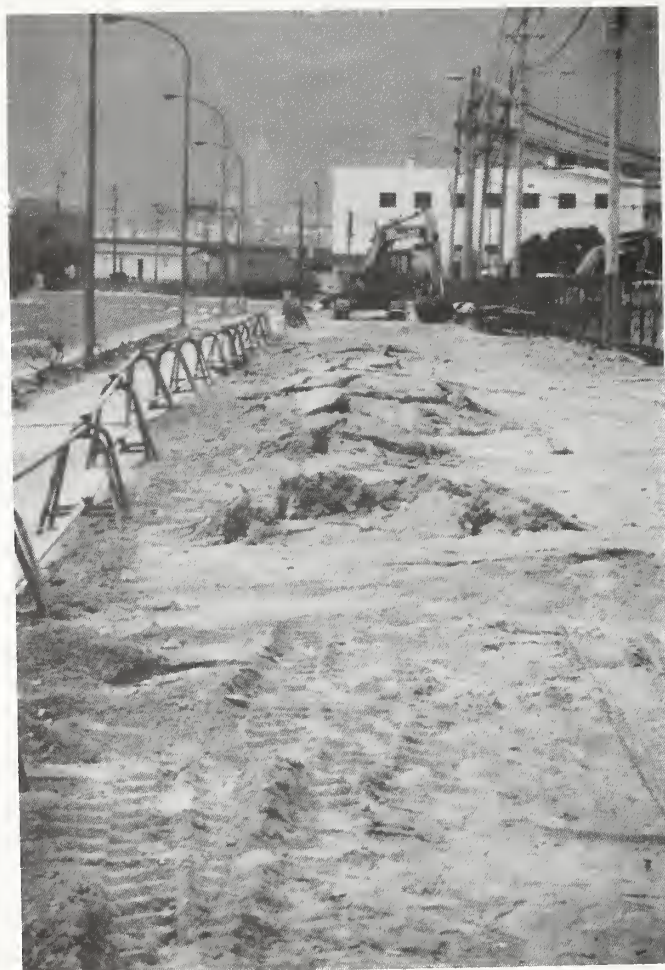
Photo 27 A 500 mm diameter sewer floated upward on Port Island, resulting in the upheaval of ground.

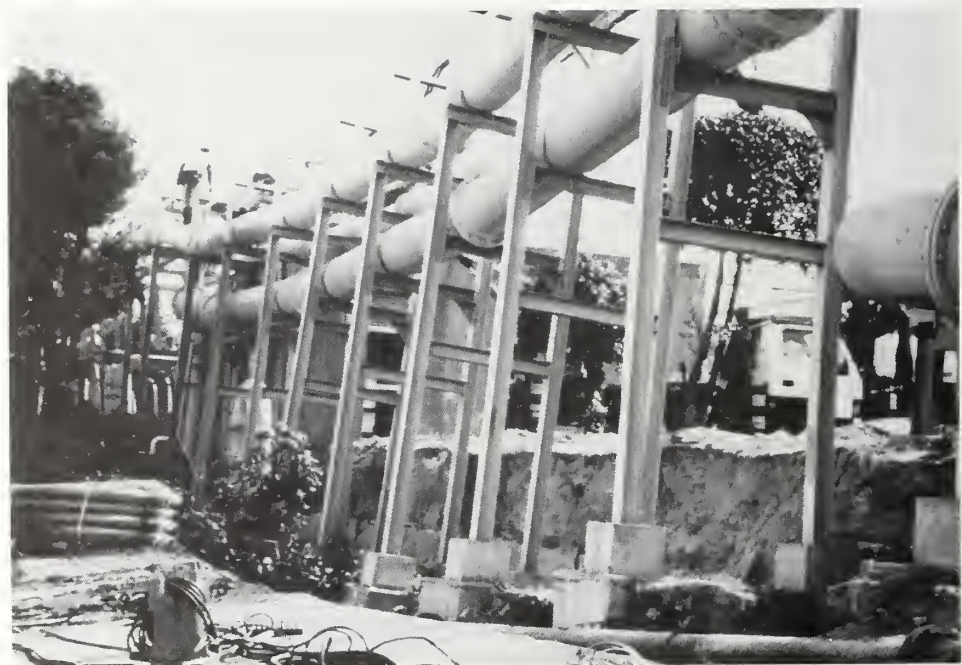
Photo 32 Pipe rack foundations adjacent to channel settled approximately one meter, distorting piping.

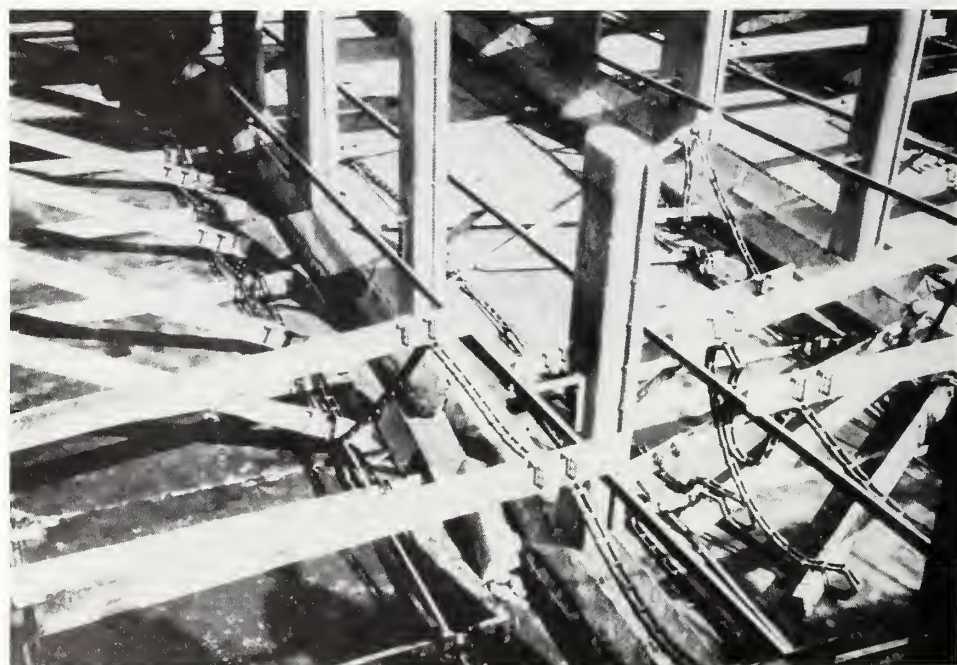
Photo 35 Sludge scraper chain came off sprockets in sedimentation tanks.

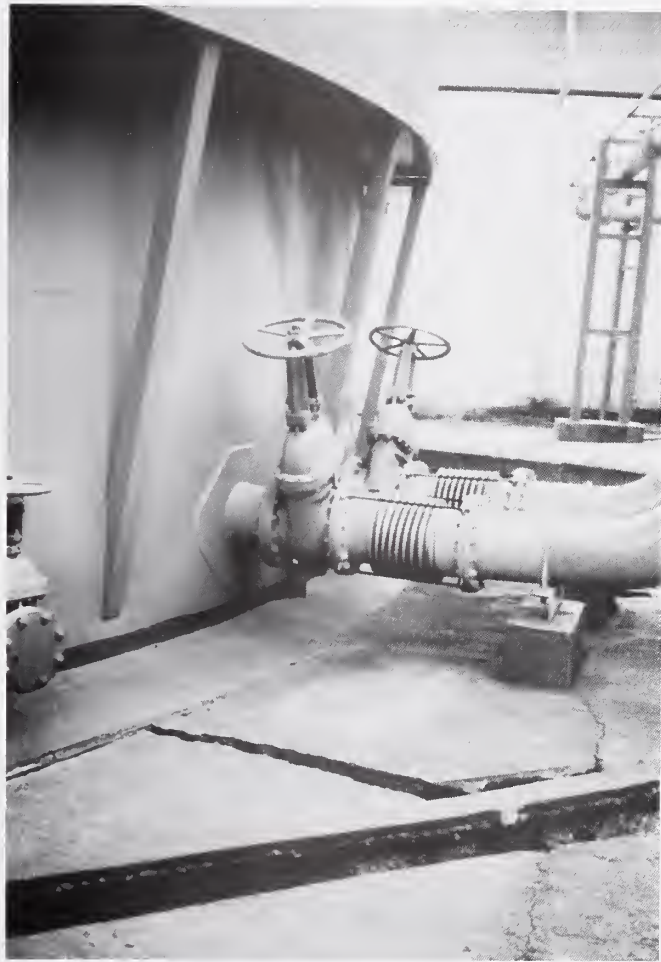
Photo 36 Differential movement from settlement between pile supported tanks and non-pile supported pipe caused flexible joint to distort.

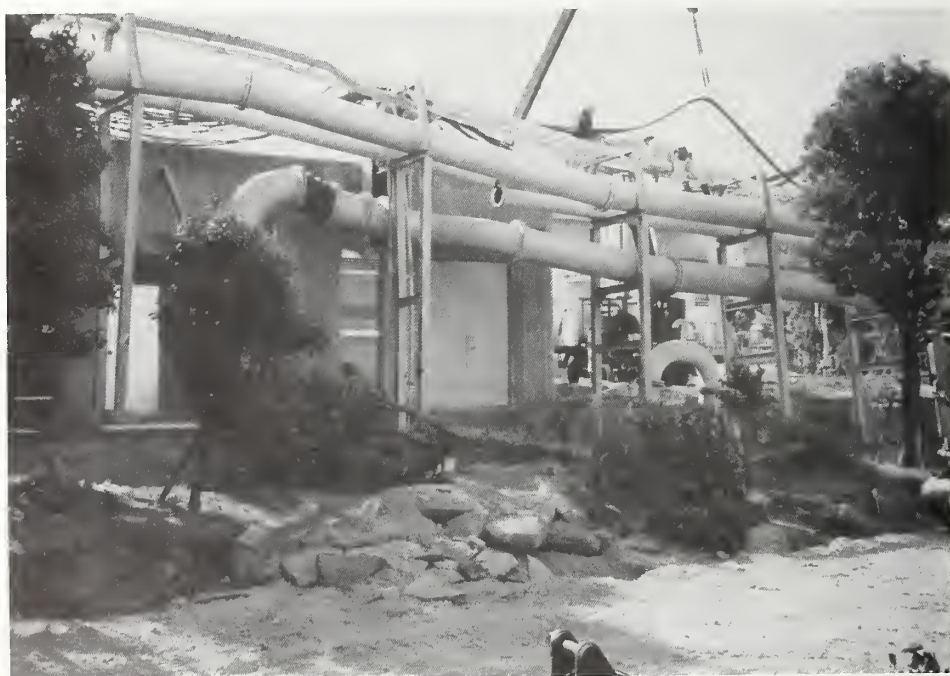
Differential settlement and lateral spreading of approximately 600 mm occurred at the filter building, as shown in Photos 38 and 39 resulting in some pile damage. The control building and the sludge thickener room moved north 60 cm (Photos 40, 41). The

Photo 38 Filter building support pipes failed allowing the building to move and settle differentially.

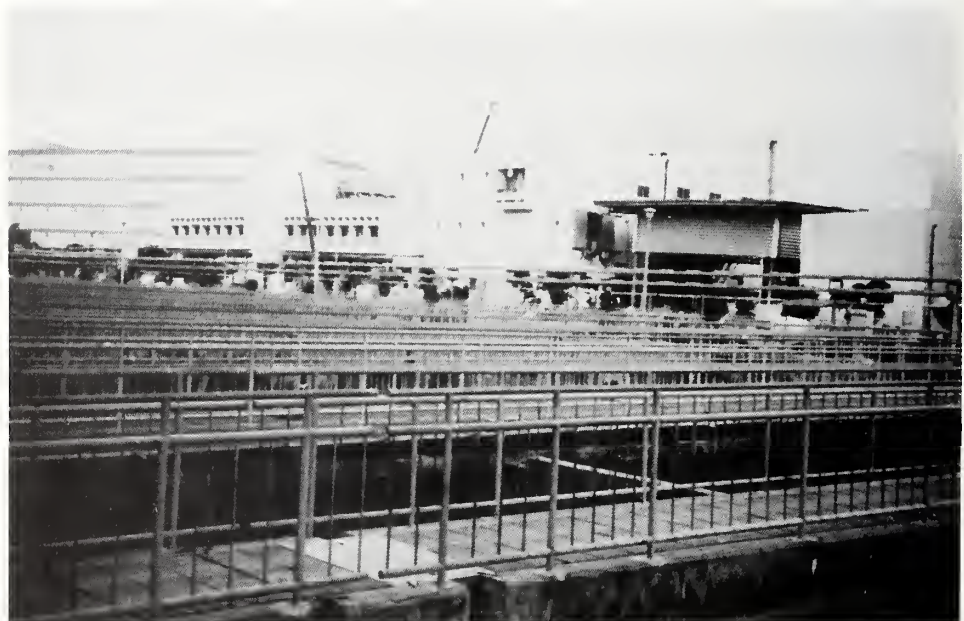
Photo 40

Control building (upper right), which is pile supported, moved towards inlet approximately 30 cm, moving away from adjacent building which had a basement.

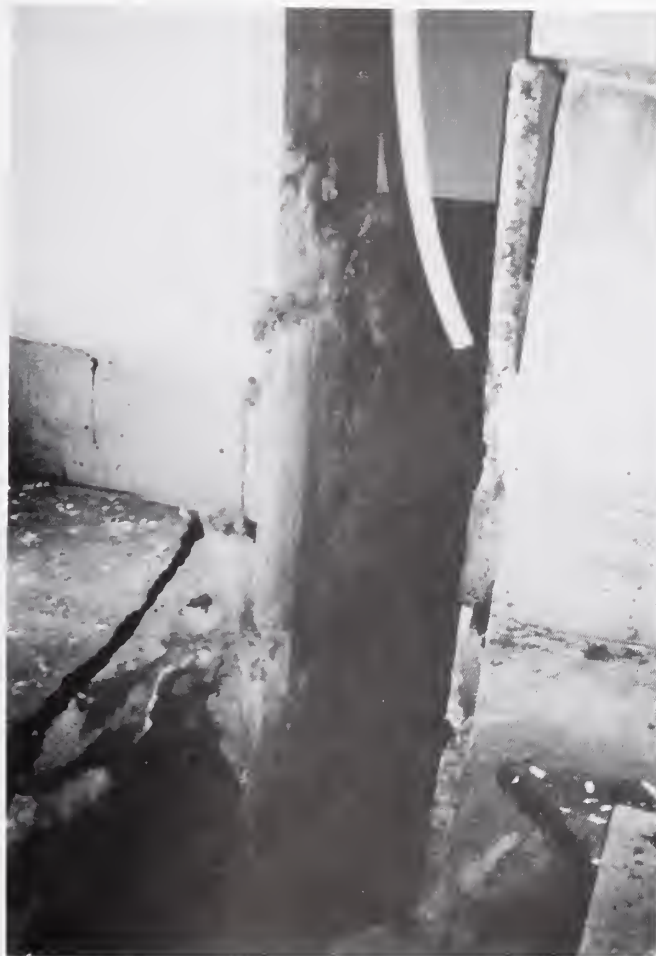
Photo 41 Shows the gap between the two buildings in Photo 40.

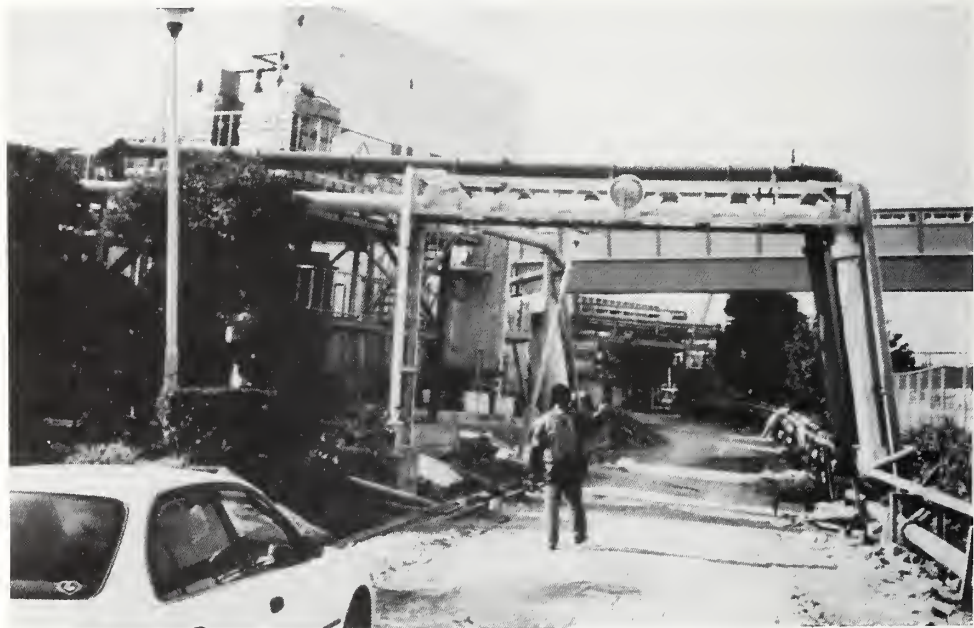
Photo 42 Piping distorted as a result of the movement.

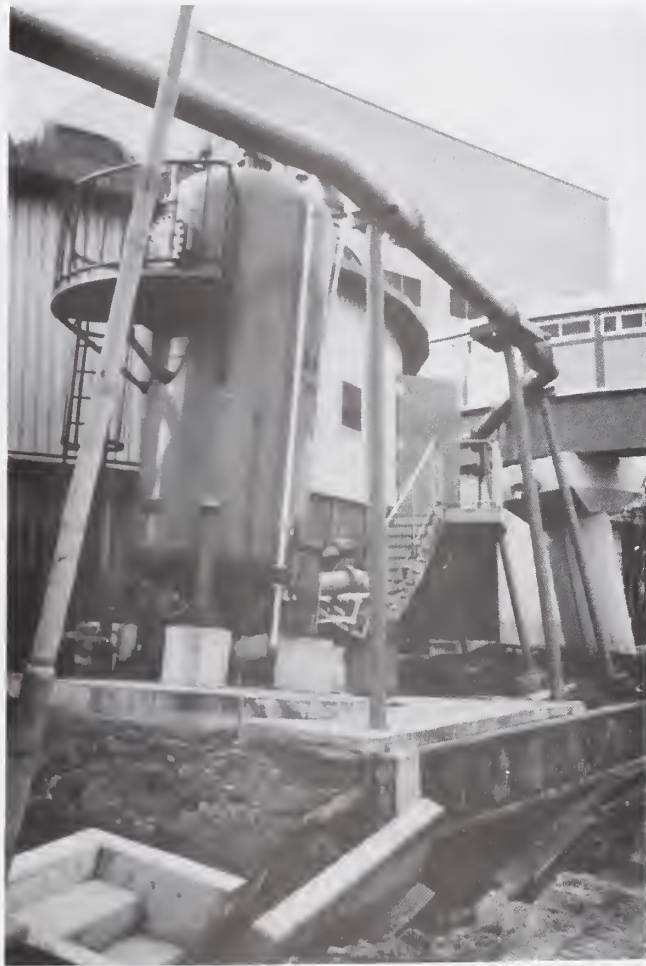
Photo 43 Piping and equipment distorted as a result of subsidence of the structures' foundation.

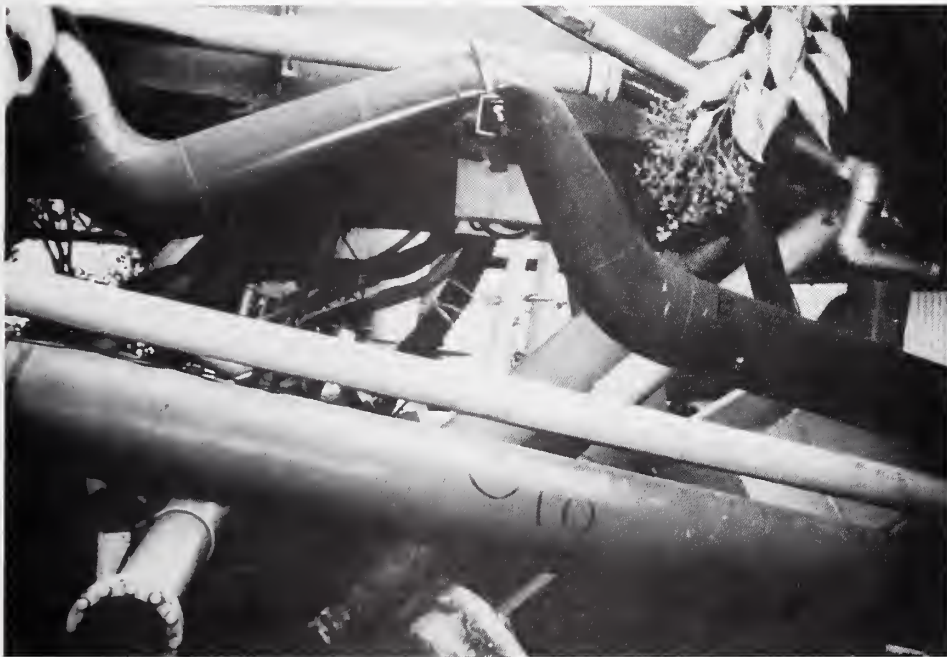
Photo 46 Welded steel pipe, approximately 200 mm in diameter folded when the foot/pipe bridge support was distorted from lateral spread.

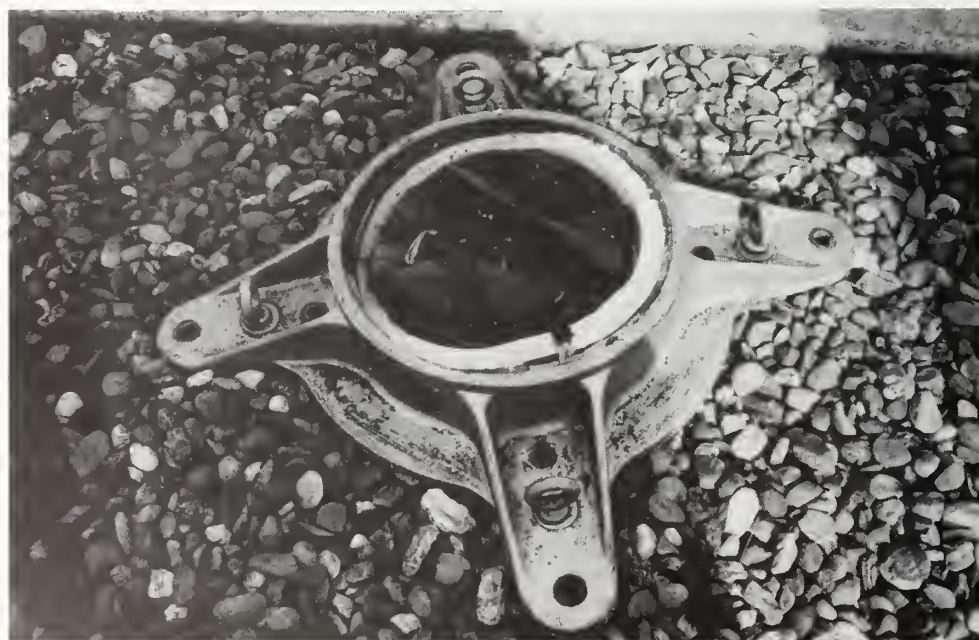
Figure 5.4.22 A cracked cast iron anchor tab on a current-voltage transformer remained in service.

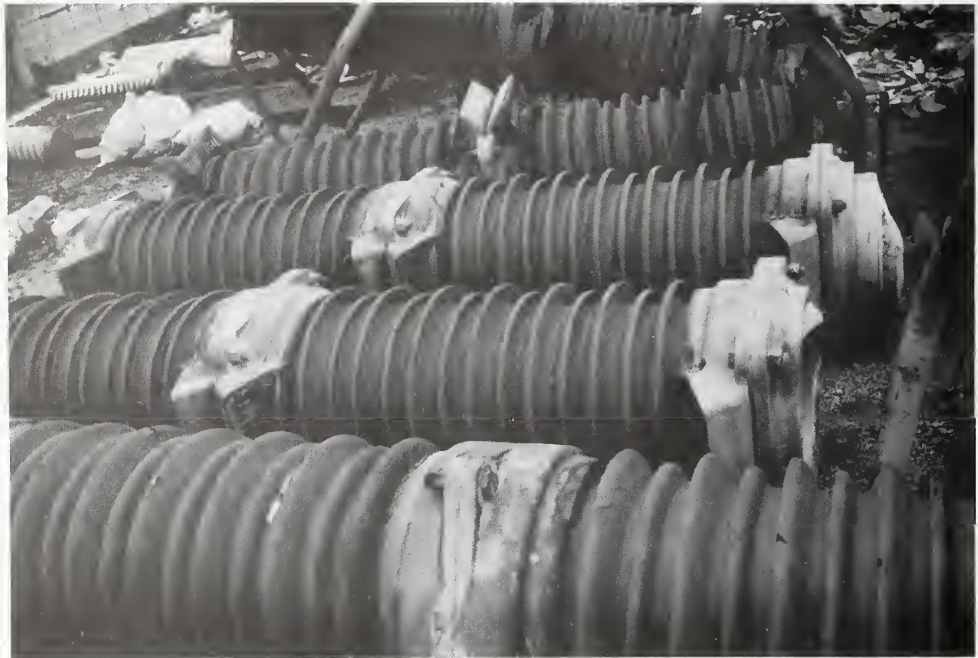
Figure 5.4.30 The standoff incorporated into the design of the base of the lightning arrester failed.

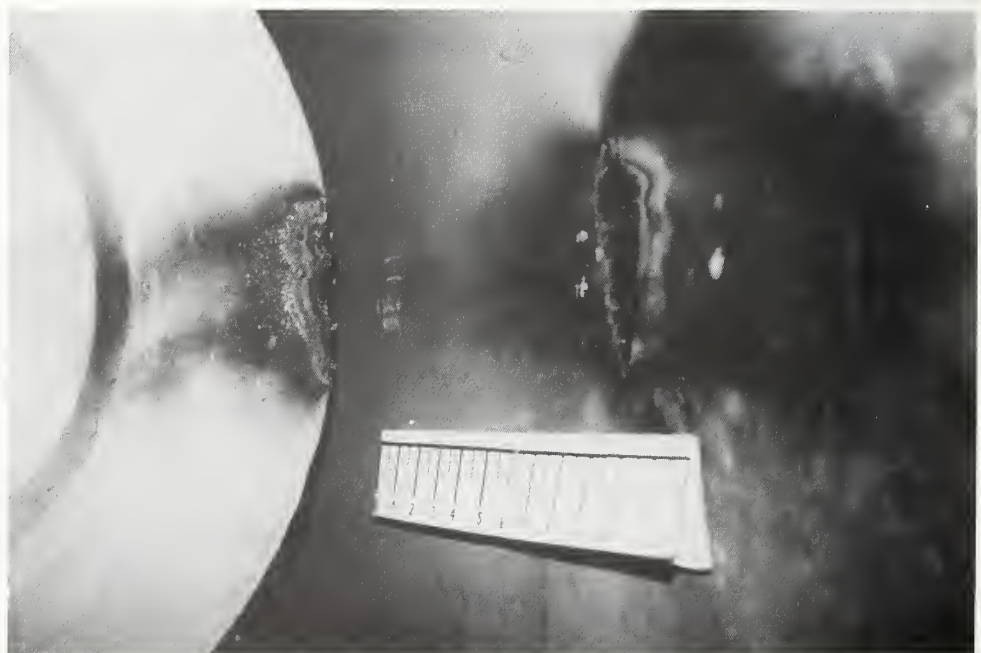
Figure 5.4.35 Transformer control cables were almost sheared off due to movement of the transformer.

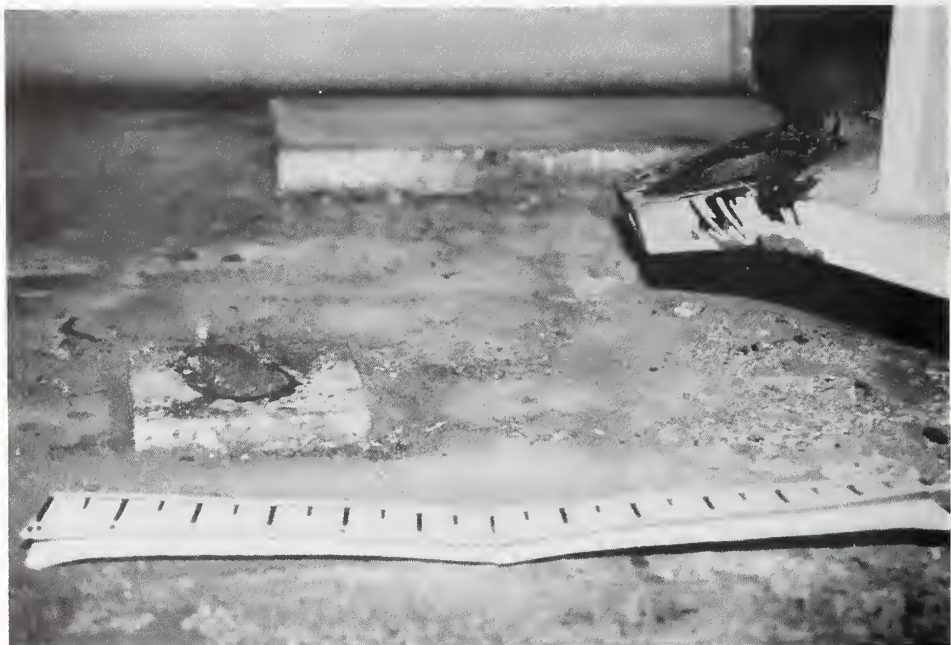
Figure 5.4.37

Transformer acoustical enclosure support was damaged and the enclosure shifted.

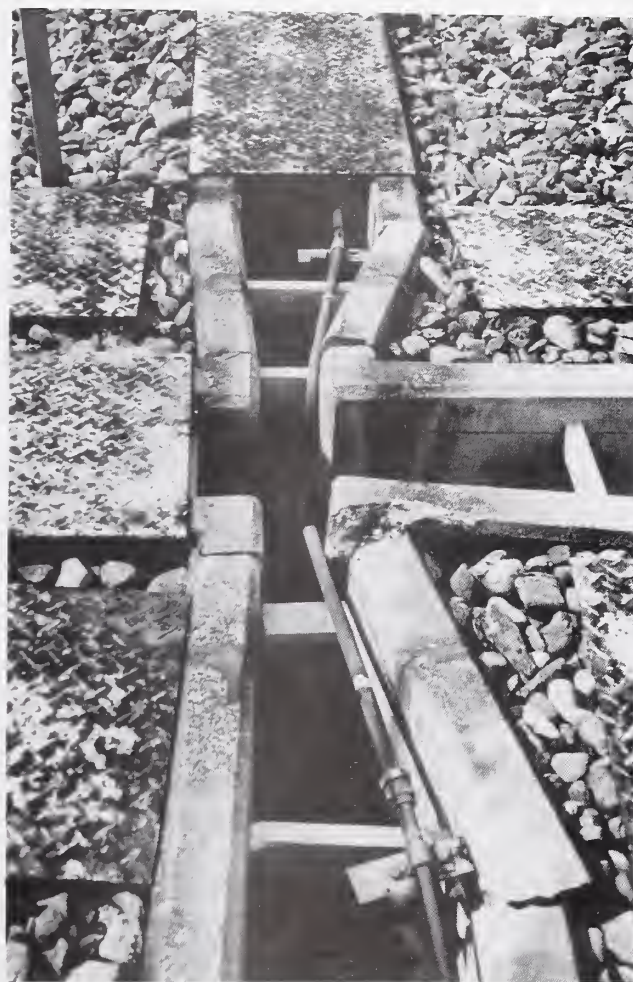
Figure 5.4.43

A long crack in the ground surface opened about 25 cm and damaged cable trenches.

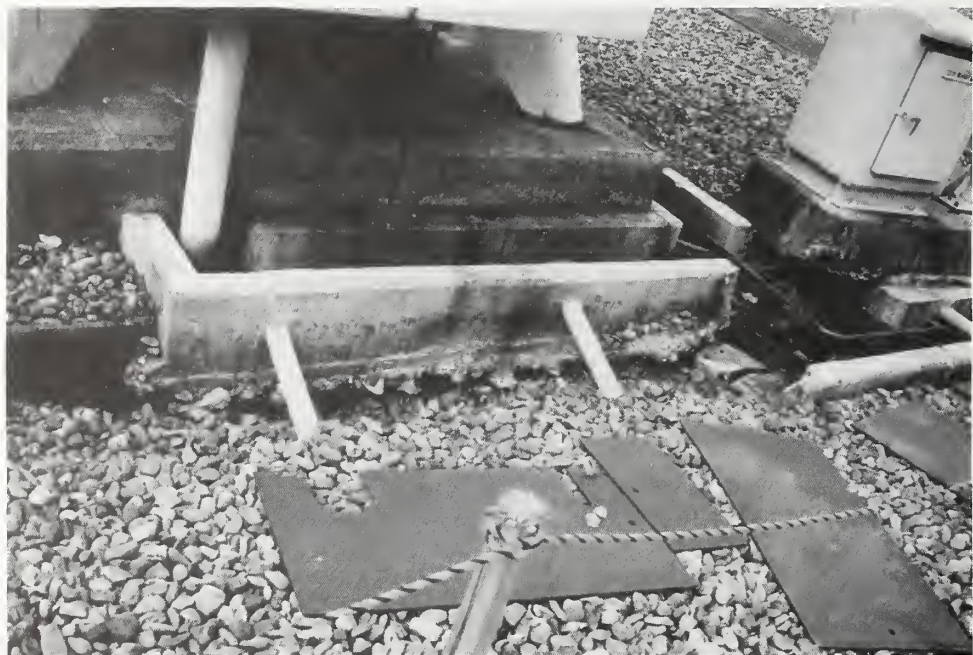
Figure 5.4.44

Cable trenches were deformed with the ground fracturing an air line
be leaving control cables undamaged.

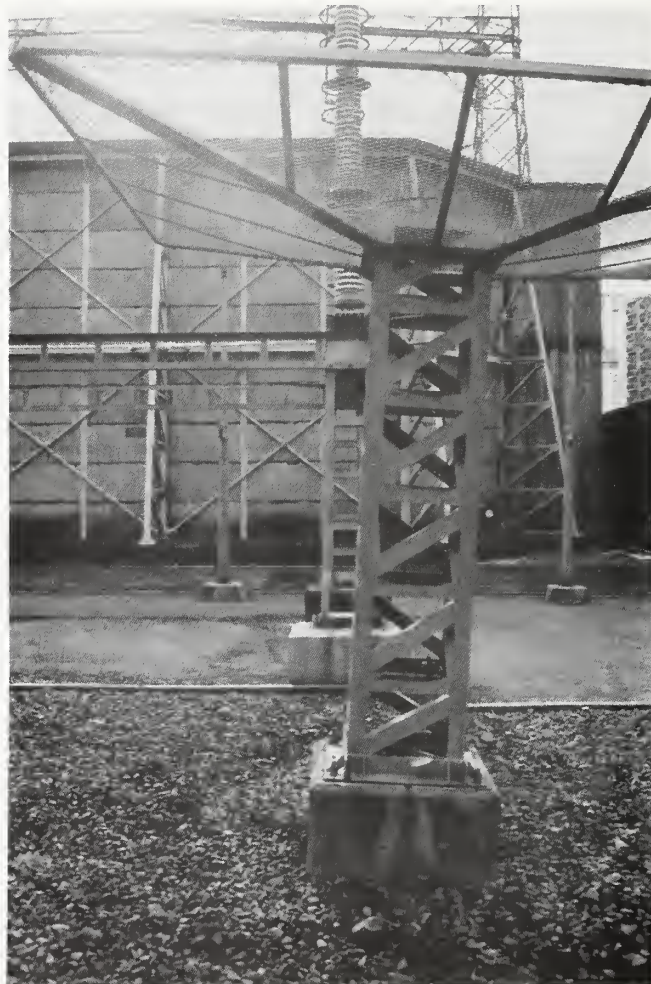
Figure 5.4.46 Foundations of conductor support structures were disturbed and individual footings rotated as much as 25 degrees.
