NIST Special Publication 901

The January 17, 1995 Hyogoken-Nanbu (Kobe) Earthquake

*Performance of Structures, Lifelines, and Fire
Protection Systems*

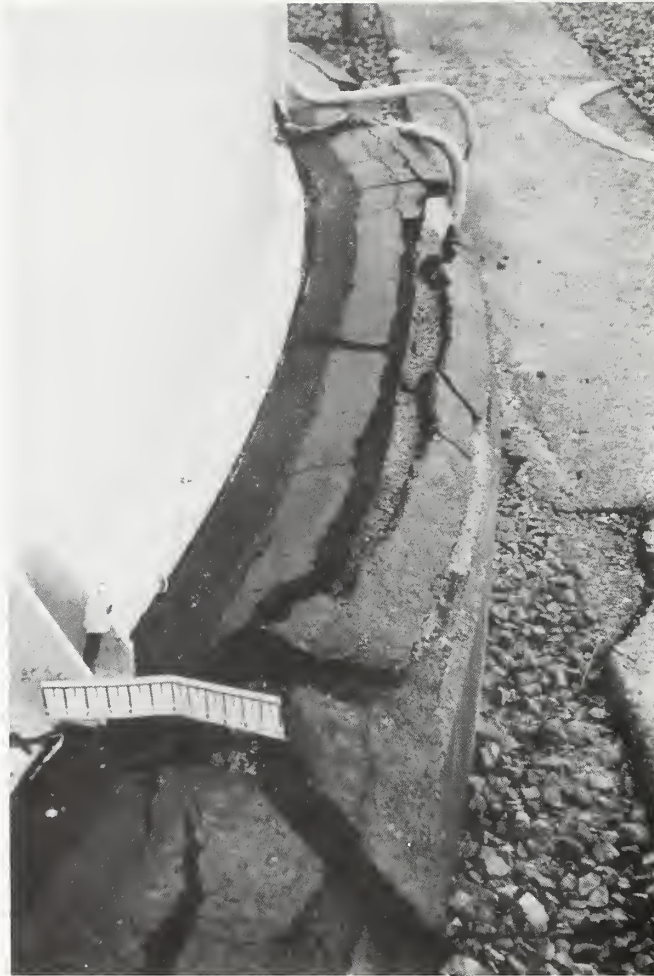
Figure 5.4.48

A new monolithic disconnect switch pad replaced individual footings that were disturbed by a surface crack in the soil.

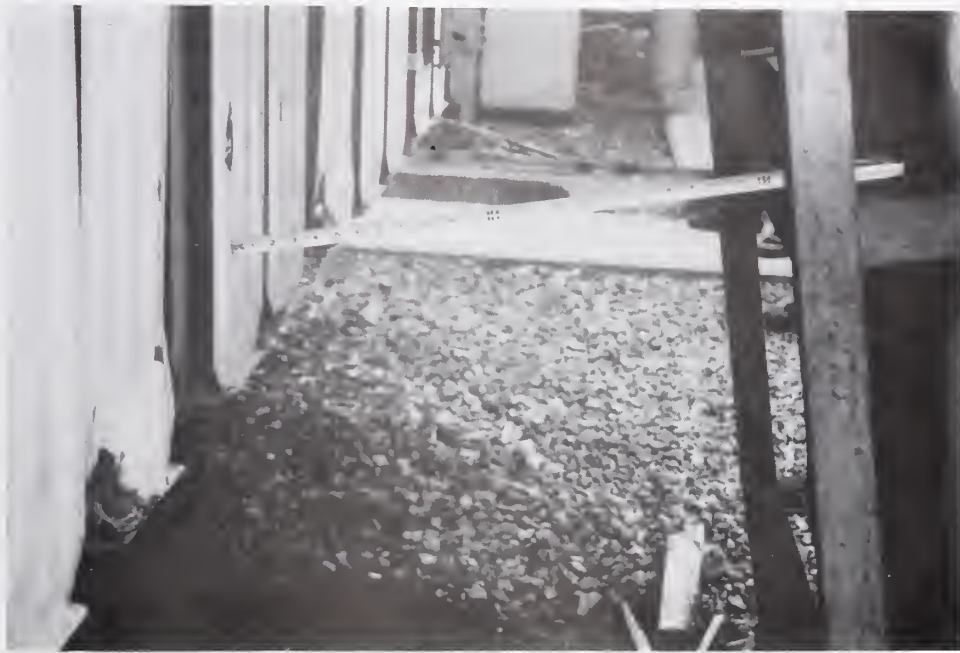
Figure 5.4.64 Movement of the transformer after its anchorage failed allowed the radiators to hit a nearby structural support causing a leak.

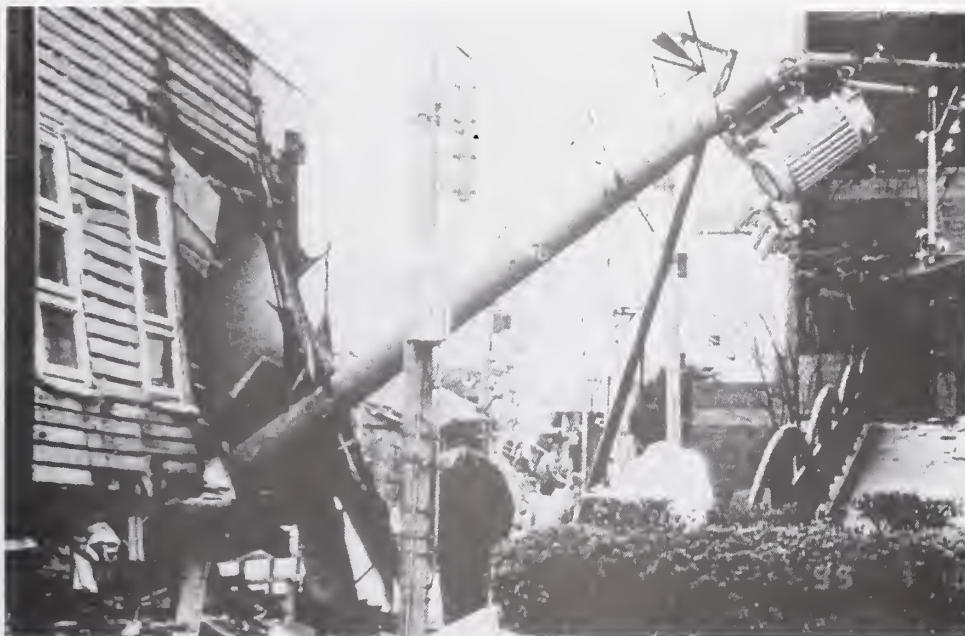
Figure 5.4.68 Fallen housed pushed over some distribution poles.

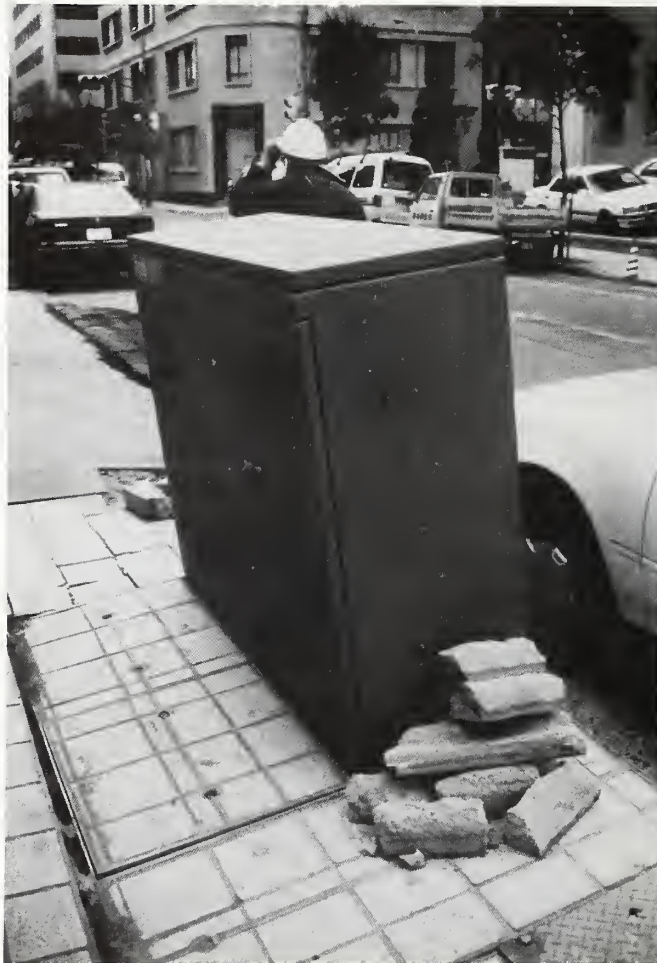
Figure 5.4.72

The conduit and the foundation pad under this transformer pad was disrupted in down town Kobe due to soil liquefaction.

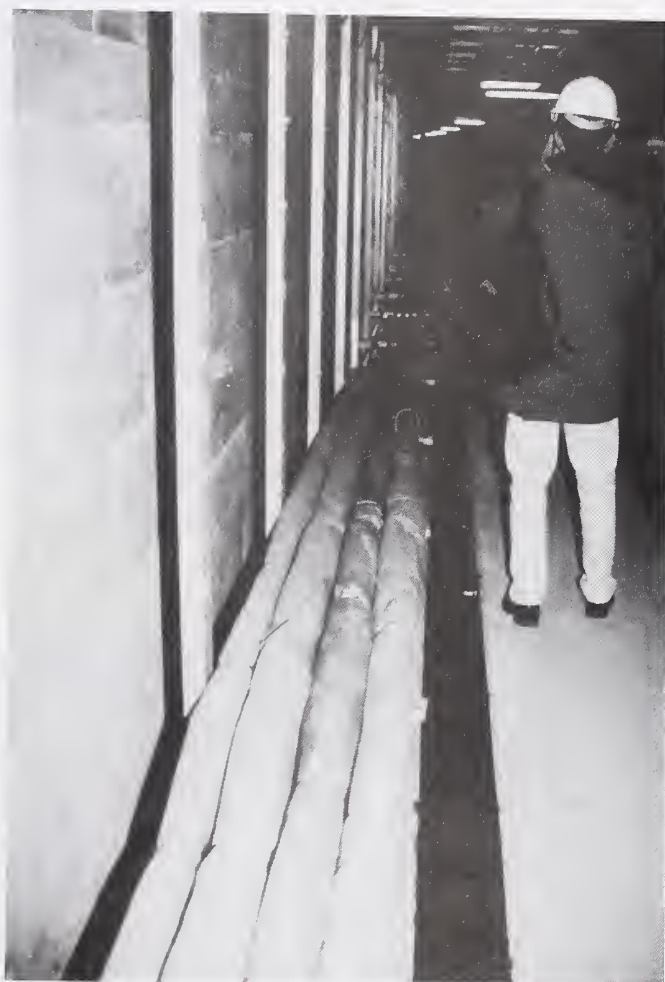
Figure 5.5.4

the tunnel settled about 7 cm relative to the building and shifted about 7 cm laterally; however, there was no damage to trunk lines. Figure 5.5.2 shows a schematic diagram of the tunnel-building connection and a post-earthquake repair used to stop water leaks. This detail was used throughout Japan. There was minor damage to the Joint Utility Tunnels, primarily slight movement at construction joints resulting in leaks (Figure 5.5.3). Communication cables in the Joint Utility Tunnel had fire resistant covers near entrances and staircases, but were generally unprotected (Figure 5.5.4).

Trunk lines in the joint utility tunnel had fire retardant covers near entrances and stairways.

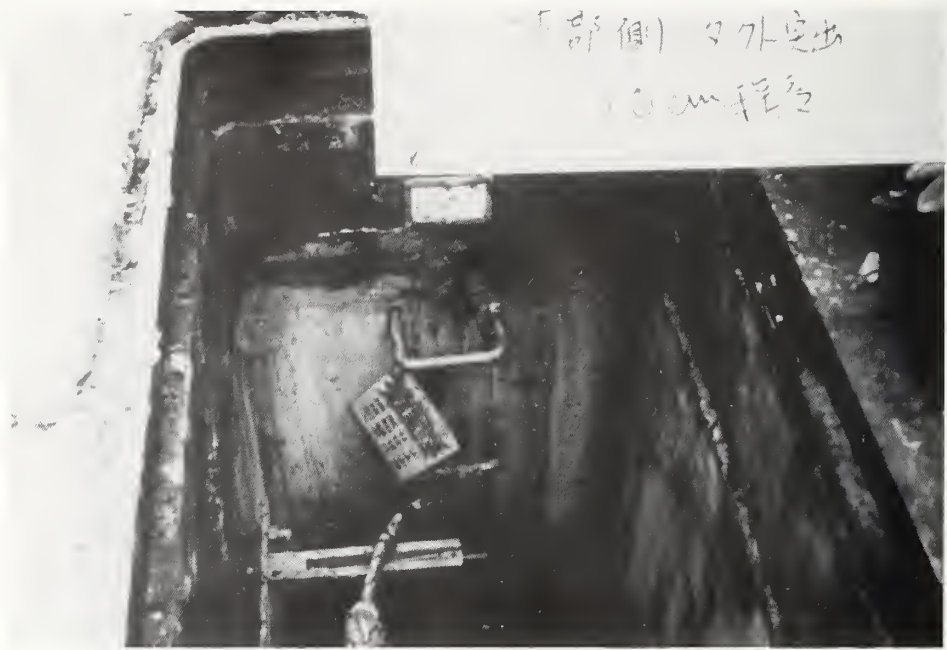
Figure 5.5.5

At many manholes, the conduits were pushed into the manhole boxes by up to 30 cm. This can exceed the available cable slack and cause a cable failure (Figure 5.5.5). The relative motion also can damage the manhole-conduit seal, and water seepage can also damage the cables. In older conduits, cable slack was 2 cm at the manholes, and some of these broke. At new conduits, cable slack was up to 15 cm, and these did not break. It appears that there can be large variations in slack provided to cables at manholes. In an earlier visit to Tsukuba City, an NTT Outside Plant research group proposed service loops of about 8 cm diameter before each splice joint. However, a tie-wrap to secure the loop to a tray or shelf was also recommended, so that the deployment of the slack may be impeded. Liquefaction and soil movement also moved junction boxes (Figure 5.5.6). Figure 5.5.7 shows a schematic diagram of a 4 cm offset of plates used to form the manhole entry. Subsidence of soil around manholes also caused conduit failures (Figure 5.5.8). Conduit carried on bridges were also damaged due to motion of the bridge deck (Figure 5.5.9). Subsidence in roadways caused extensive damage (Figures 5.5.10 and 5.5.11). Telephone booths were also severely damaged by soil

Cables were pushed into manhole boxed breaking water seals and in some cases damaging cables.

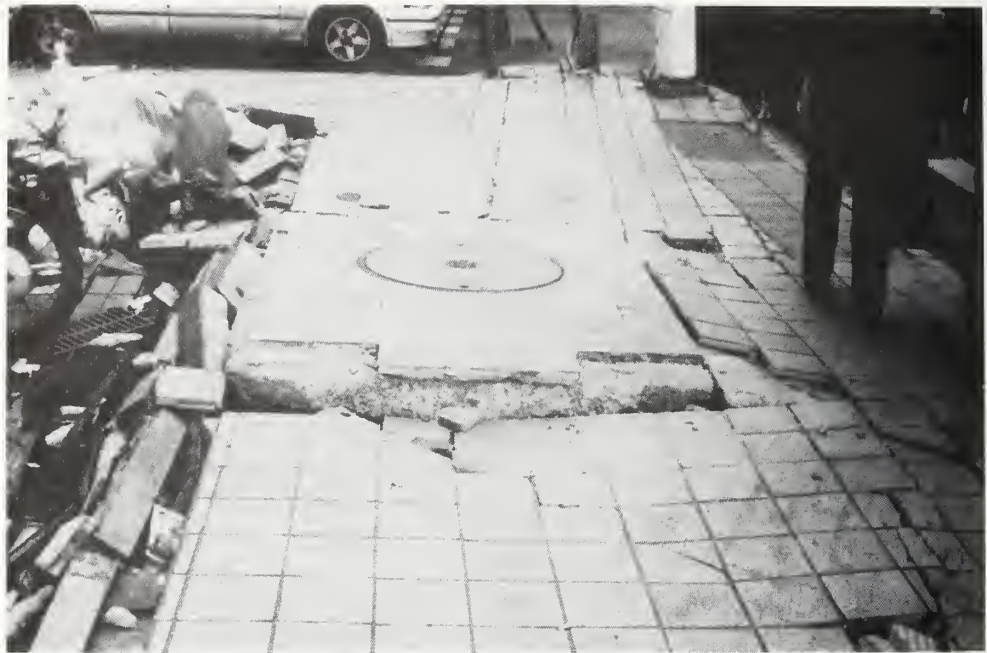
Figure 5.5.8 Subsidence around manhole can damage conduit and trunk lines.

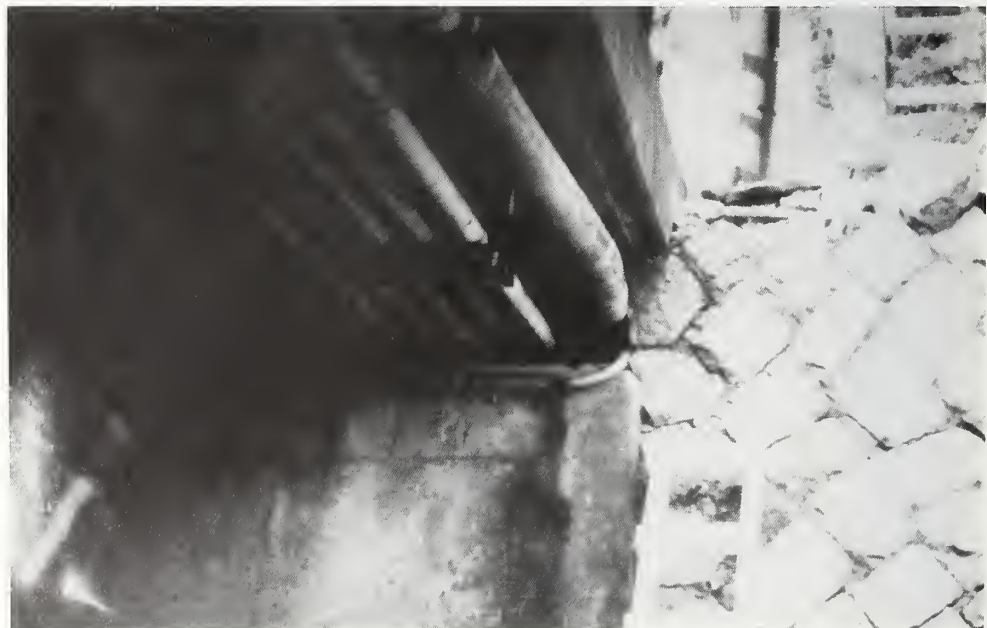
Figure 5.5.9 Conduits carried on bridges were damaged when bridge deck moved.

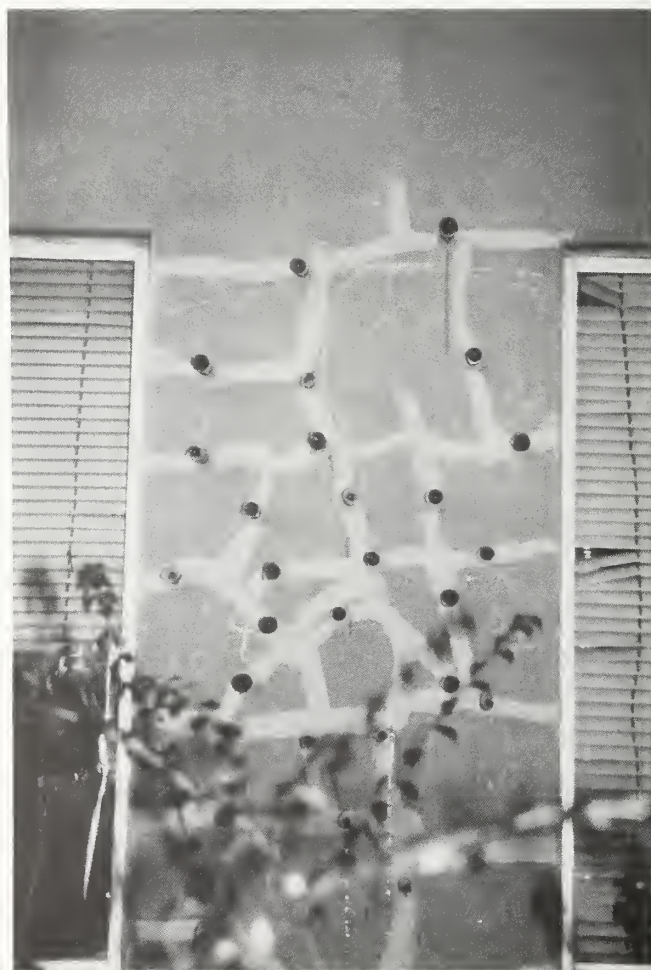
Figure 5.6.1

Column on the first floor of the old hospital being repaired with epoxy injection.

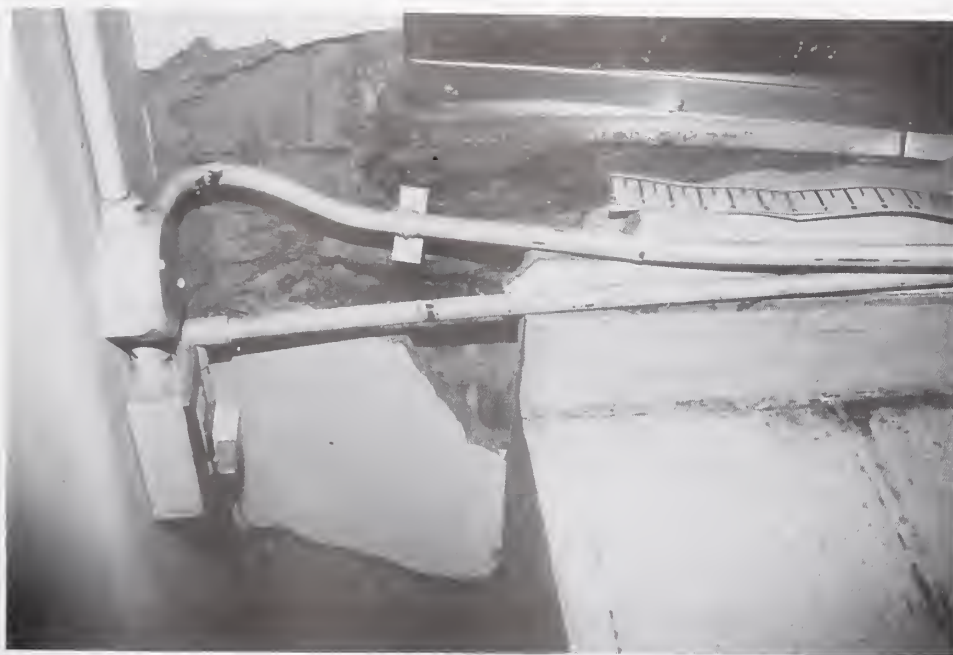
Figure 5.6.2

Beam shattered due to interaction between the two wings of the hospital at cross walks connecting the buildings.

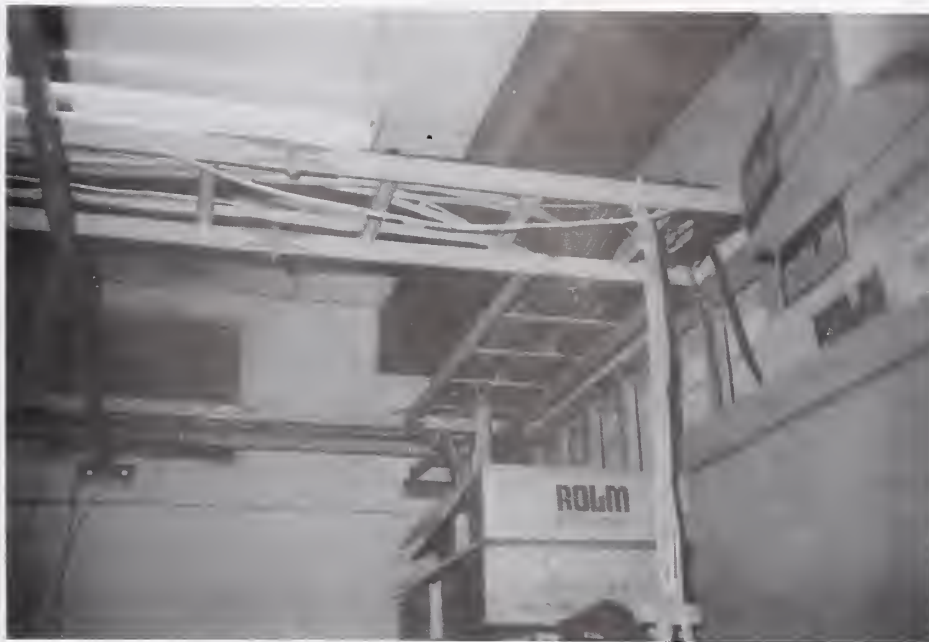
Figure 5.6.13

Typical, low tensile strength, friction-clip type communication cable tray hardware used to join tray sections in the U.S.

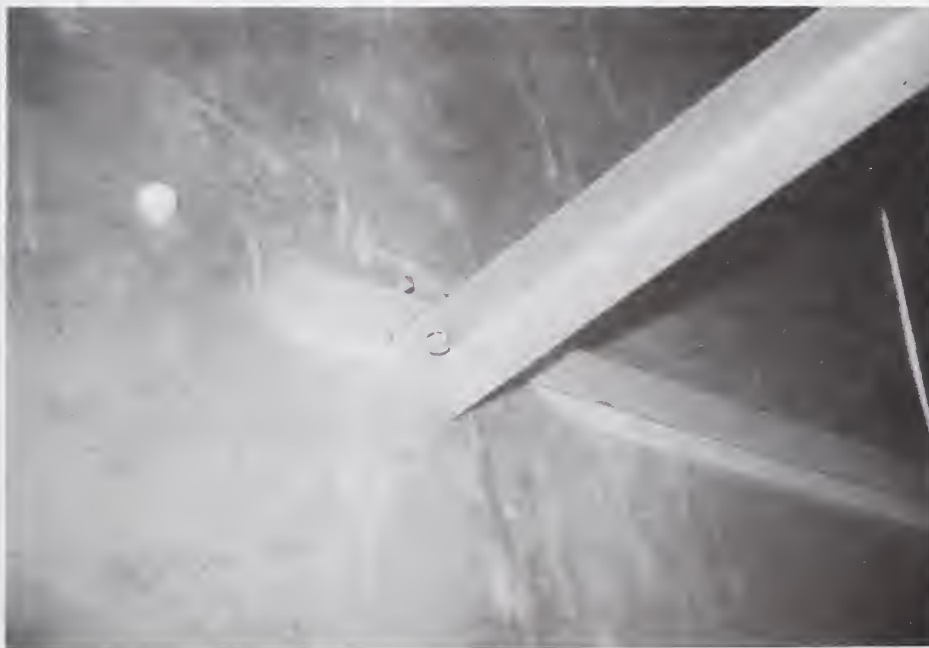
Figure 5.6.14

Bolted connections are used to anchor cable trays to structural walls.

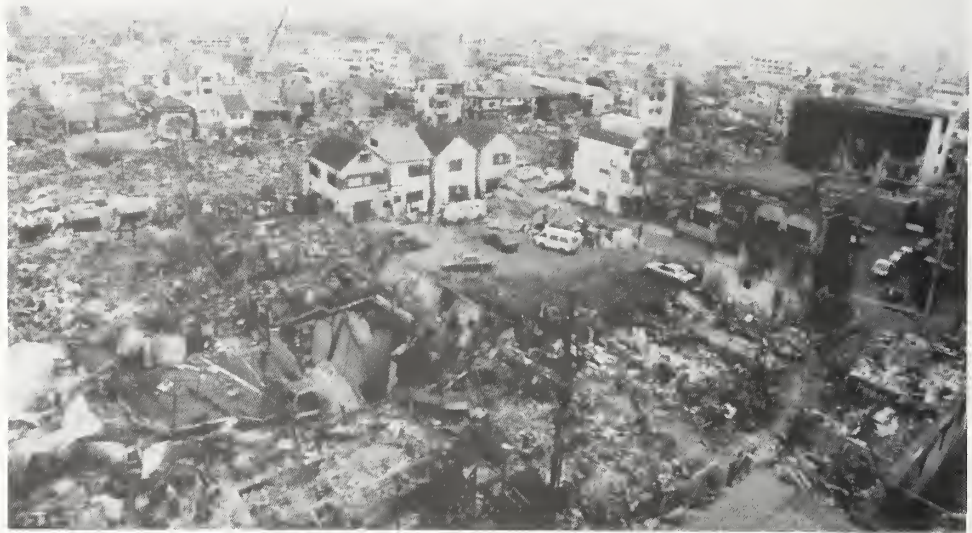
Figure 6.2.3 View of post earthquake fire damage in Nada Ward, Kobe (Site No. 8).

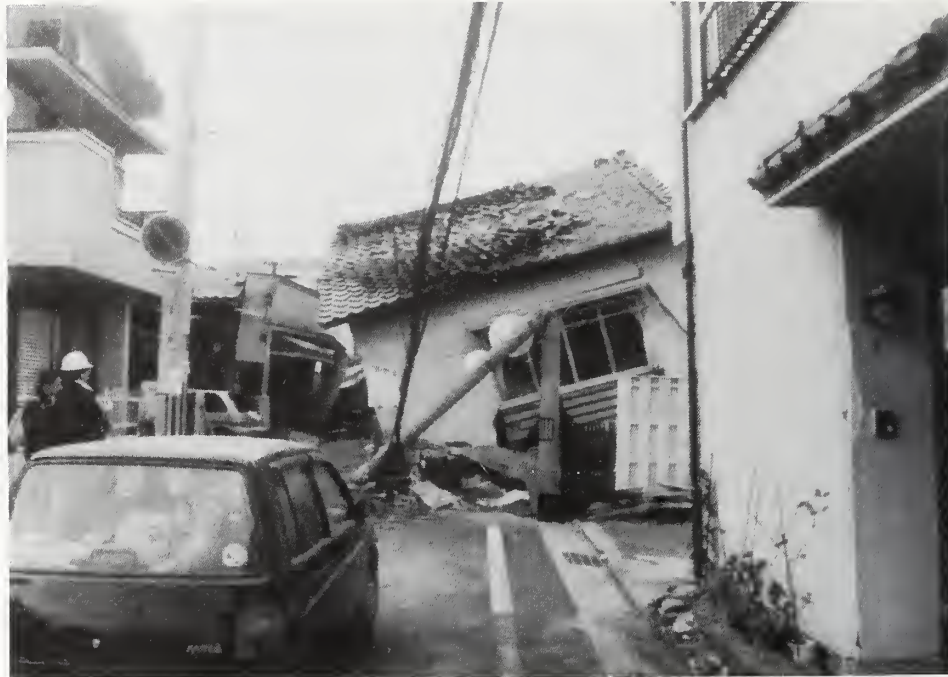
knocked down by the earthquake or torn from collapsed buildings creating potential arcing situations. Some electric lines were still connected to partially collapsed buildings (Figure 6.2.7). These lines may have stretched, creating a reduced cross sectional area of the wire, which could cause

ignition of a fire due to overheating. Insulation may have pulled away from the wires making short circuits or ground faults more likely. The majority of the fire damage occurred in areas of predominantly wooden construction which provided fuels to sustain and spread fires which ignited.

Figure 6.2.7 Example of electric power lines connected to a damaged house.

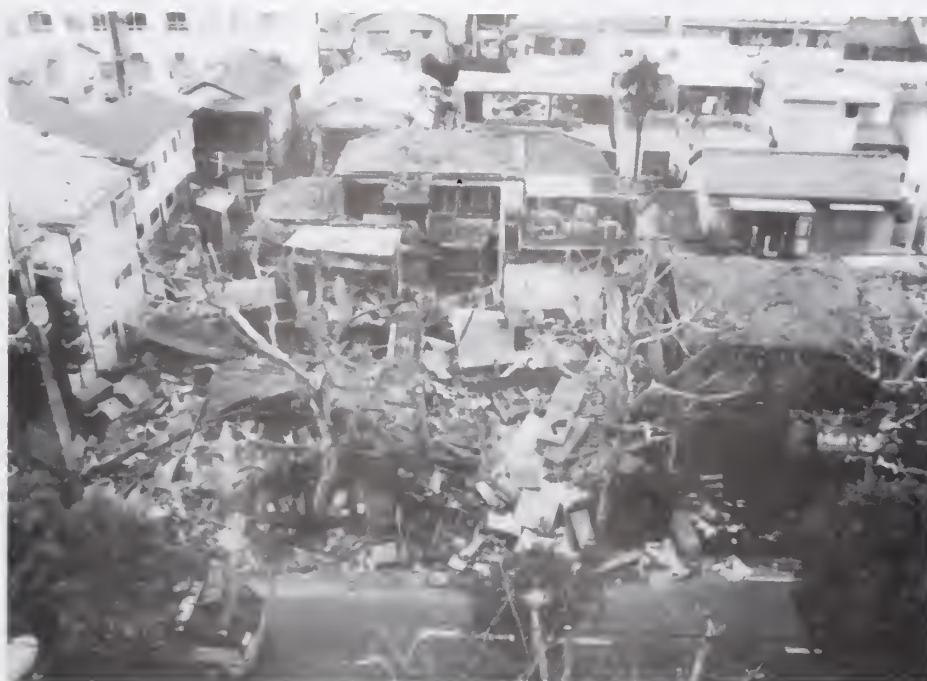
For fire to spread by flame impingement, the flames must be in contact with unburned fuel, i.e., the fire can only spread along a continuous fuel chain. In the earthquake damaged areas continuous fuel chains were prevalent. Rubblized structures are a good

Figure 6.2.9 Collapsed houses. Notice that the pile of debris is in contact with the adjacent houses, forming a continuous fuel chain.

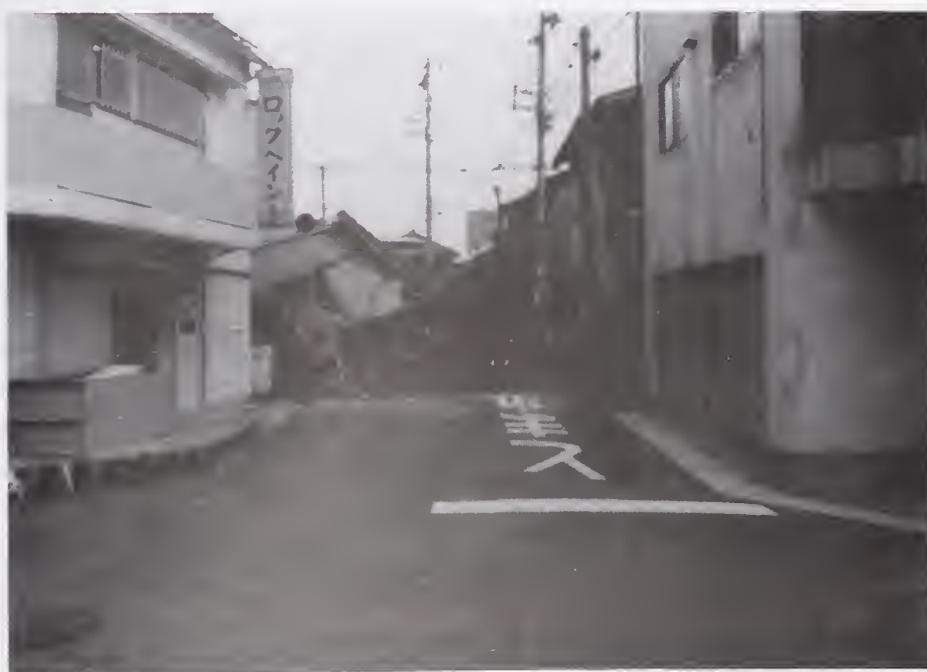
Figure 6.2.10 Collapsed structure across street.

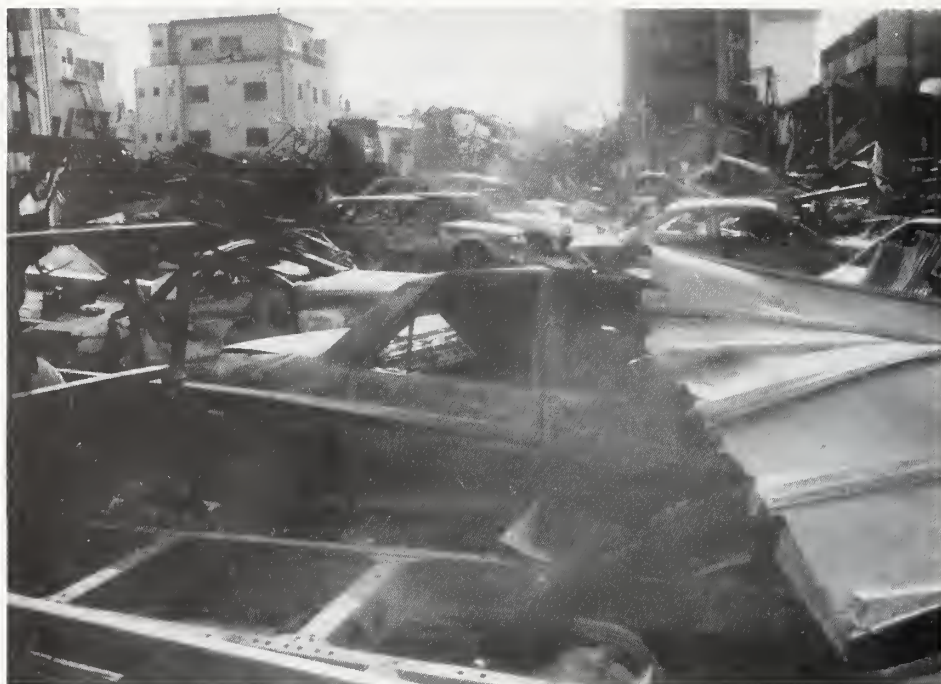
Automobiles were identified by Murosaki [5] as a mechanism for fire spread. Burnt automobiles were seen in narrow alleys between burnt structures. The automobiles, serving as a source of fuel, spread fire from one building to the other. Parking areas with burnt cars were also observed (Figure 6.2.11). Without the fuel provided by the autos, the parking areas would have acted as fire breaks (Figure 6.2.12).

Figure 6.2.11 Parking area where automobiles contributed to fire spread between buildings.

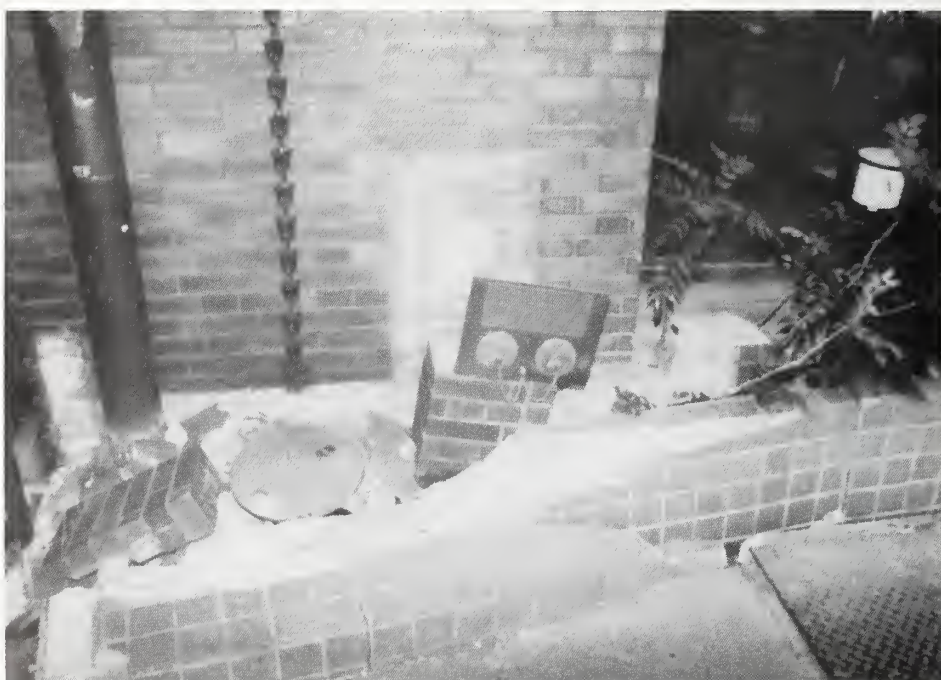
Figure 6.2.12 Standpipe connection severed at street level.

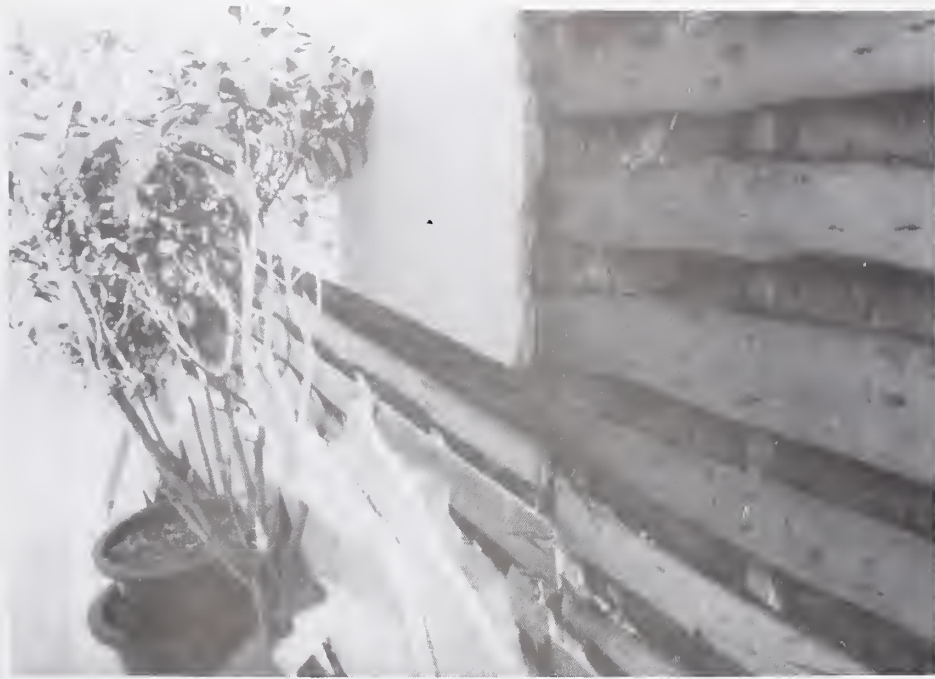
Figure 6.2.13 Example of okabe construction with portions of the fire resistive mortar displaced by the earthquake.

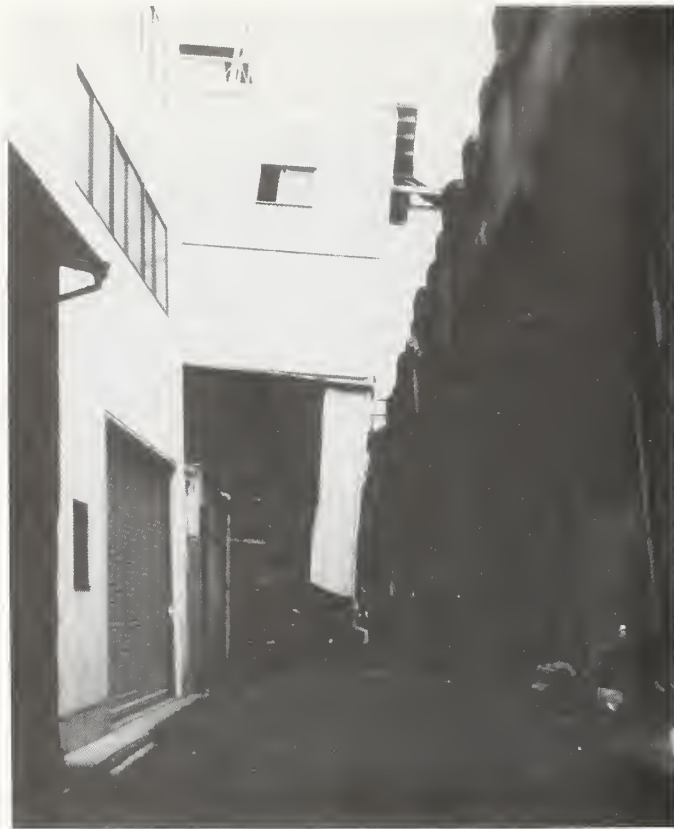
Figure 6.2.23 Road blocked by three story building.

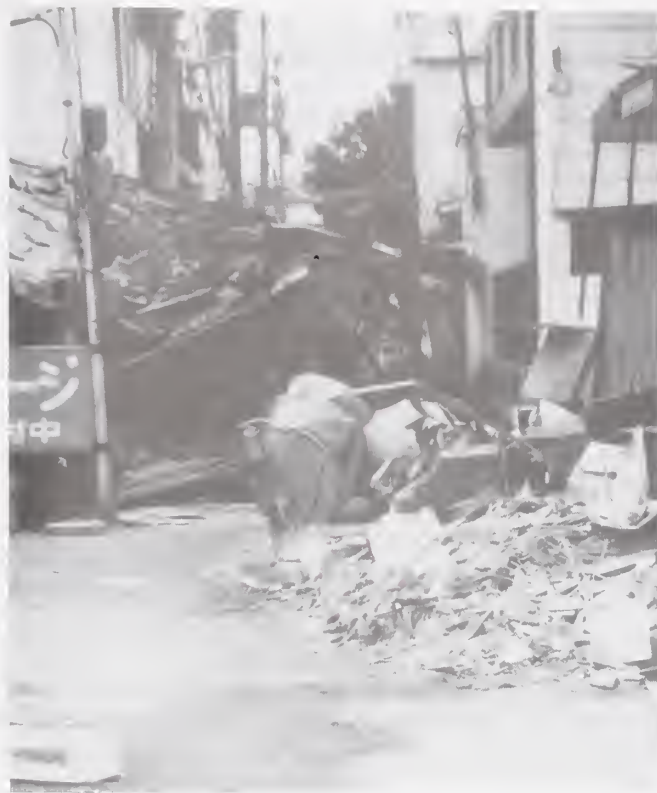
Figure 6.2.25 Road blocked by collapsed structure.
