NBSIR 82-2593

October 1982

**INVESTIGATION OF CONSTRUCTION
FAILURE OF THE RILEY ROAD
INTERCHANGE RAMP, EAST CHICAGO,
INDIANA**

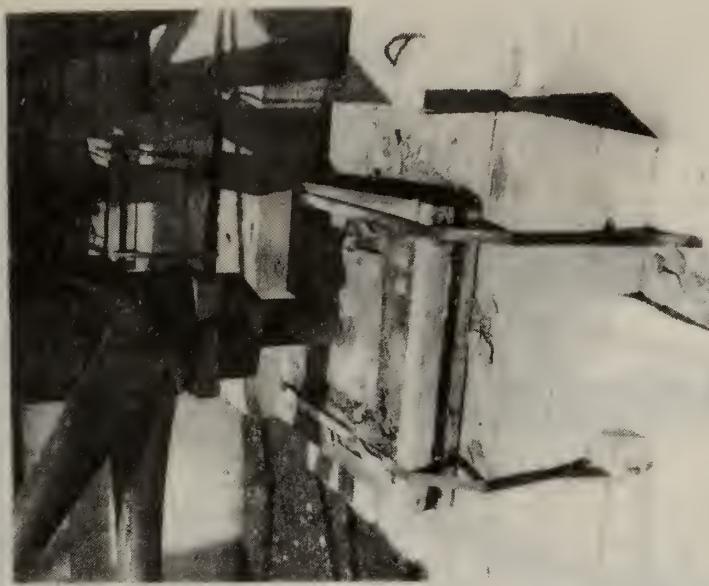
a) Lower screw jack dimensions
Figure 3.4 Typical support system for shoring tower leg

The lower screw jacks of the shoring towers did not bear directly on the concrete pads (see figure 3.4). According to the structural drawings, the jacks were to rest on circular, metal, sand boxes made of 16-in (41-mm) diameter pipe welded to a 1/4-in (6-mm) steel plate. Field inspections revealed that from tower locations 403.2 to 408.1 (N), the specified sand boxes were not used. Instead, the contractor substituted wood boxes made from ordinary 2 x 4 lumber and an aluminum sheet-metal base. Figure 3.4(b) shows a wood sand box from location 406-H. At some tower locations wood cribbing of nominal 12 x 12-in (305 x 305-mm) cross section was used beneath the boxes. The cribbing was needed to achieve the correct elevation at the top of the shoring towers.

As will be discussed in section 3.3, problems arose with the wood sand boxes and as a result metal banding, as seen in figure 3.4(b), was added as a remedial measure. Banding was reportedly used to prevent the boxes from lifting off the cribbing and to prevent the boxes from spreading laterally during loading. In cases where the sand boxes rested directly on the concrete pads, the hold down was achieved by wedging two pieces of lumber between the bearing plate and two other pieces of lumber laid across the top of the box. In the region between piers 407 and 408, it was determined that cribbing was used only at tower 407.1(S), and at the other locations the sand boxes rested directly on the concrete pads. Figure 3.5 is a view of location 407.1 as it appeared about one month before the accident. The photo was taken by an official of the Federal Highway Administration during an inspection of the construction in mid-March, 1982.

b) Example of wood sand box

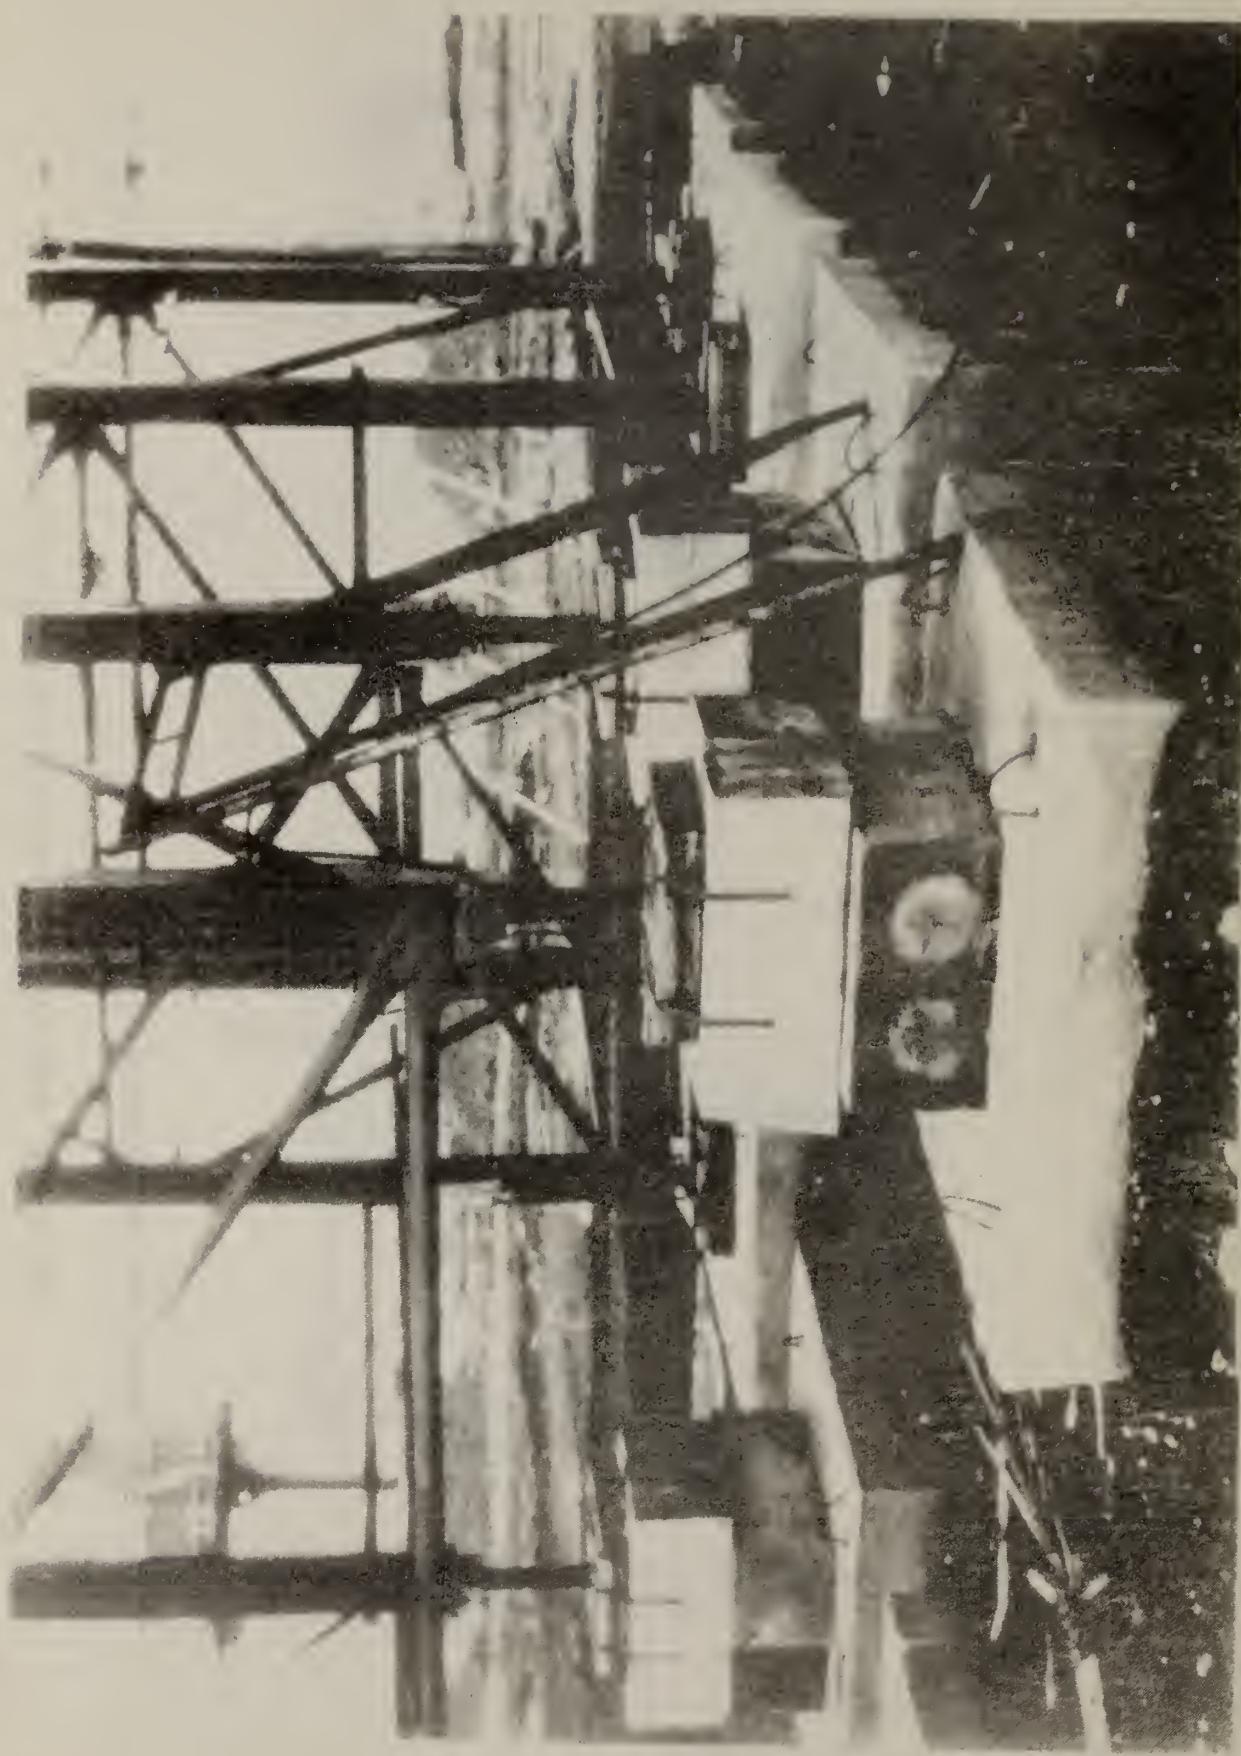
Figure 3.5 View of bottom of shoring towers at 407.1, looking from south to north

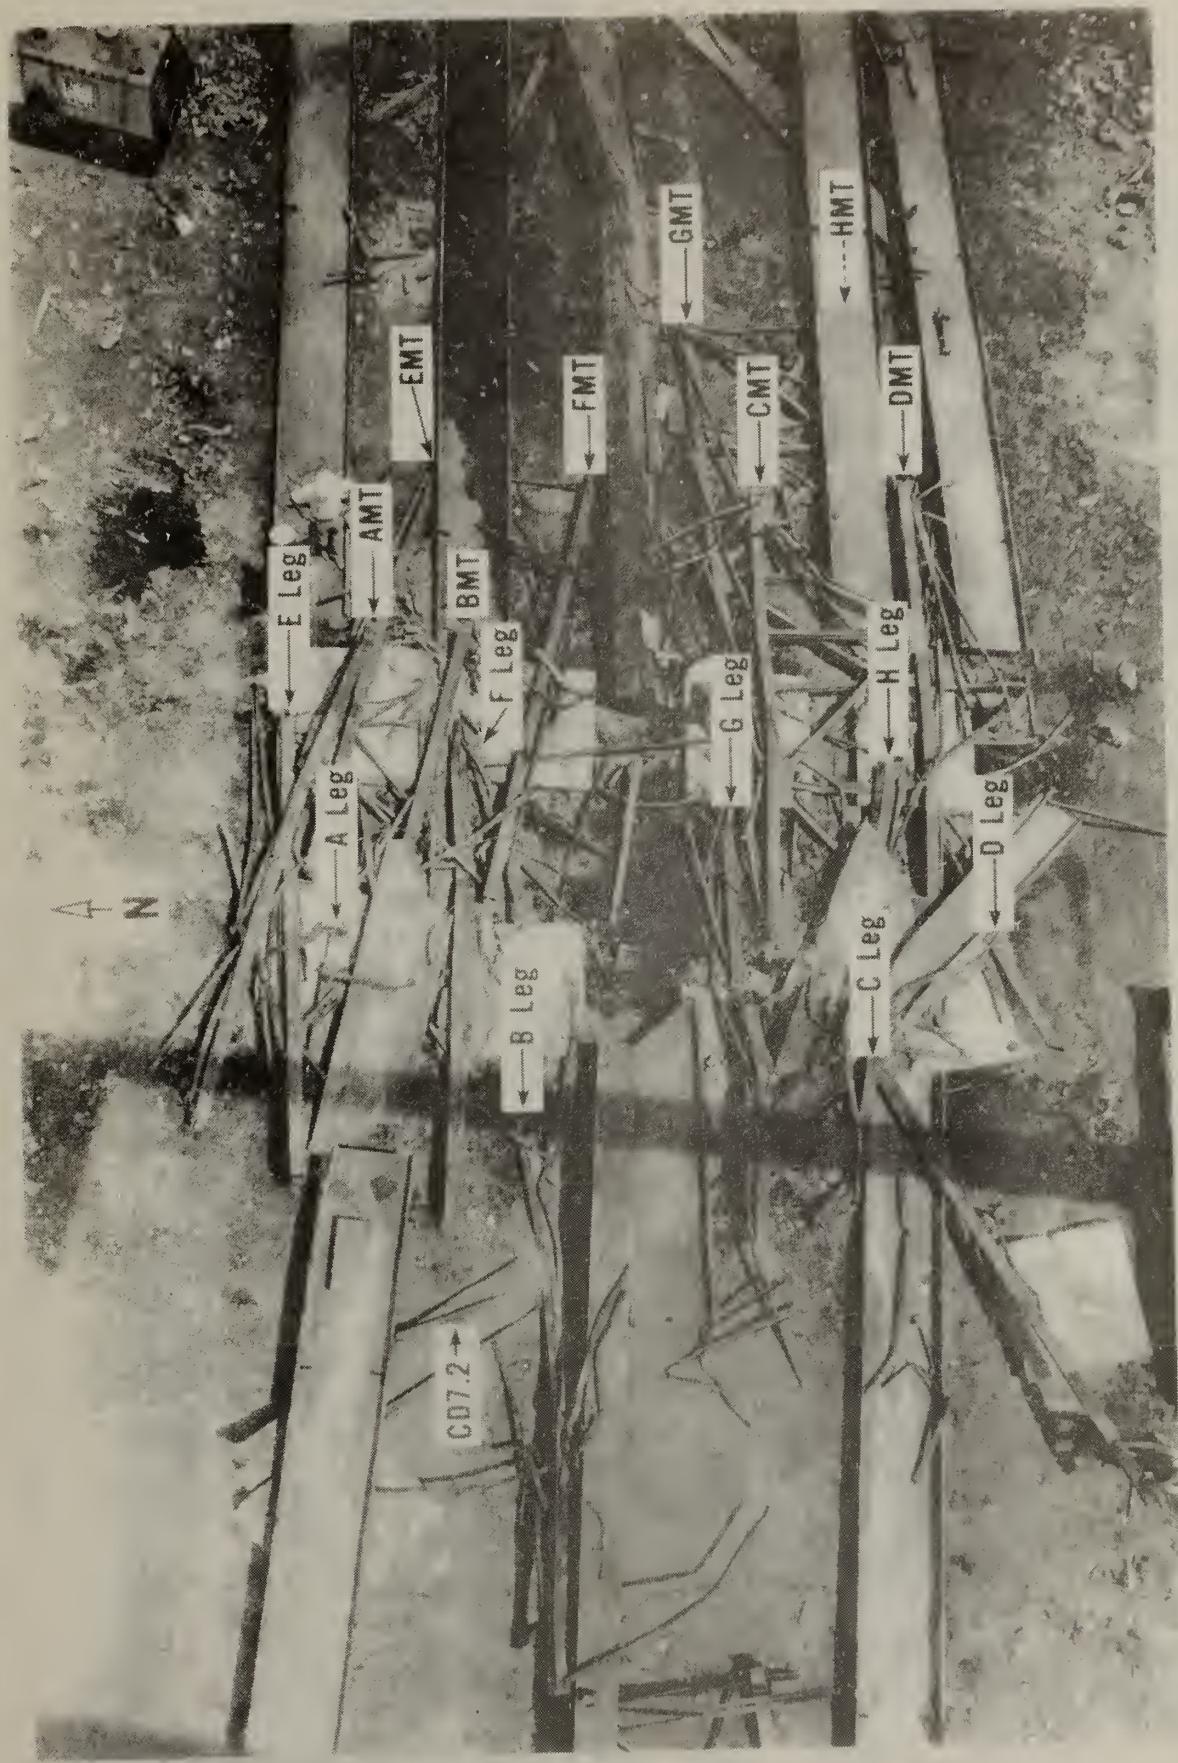
Figure 3.18 Location of various parts of the shoring towers at 407.2

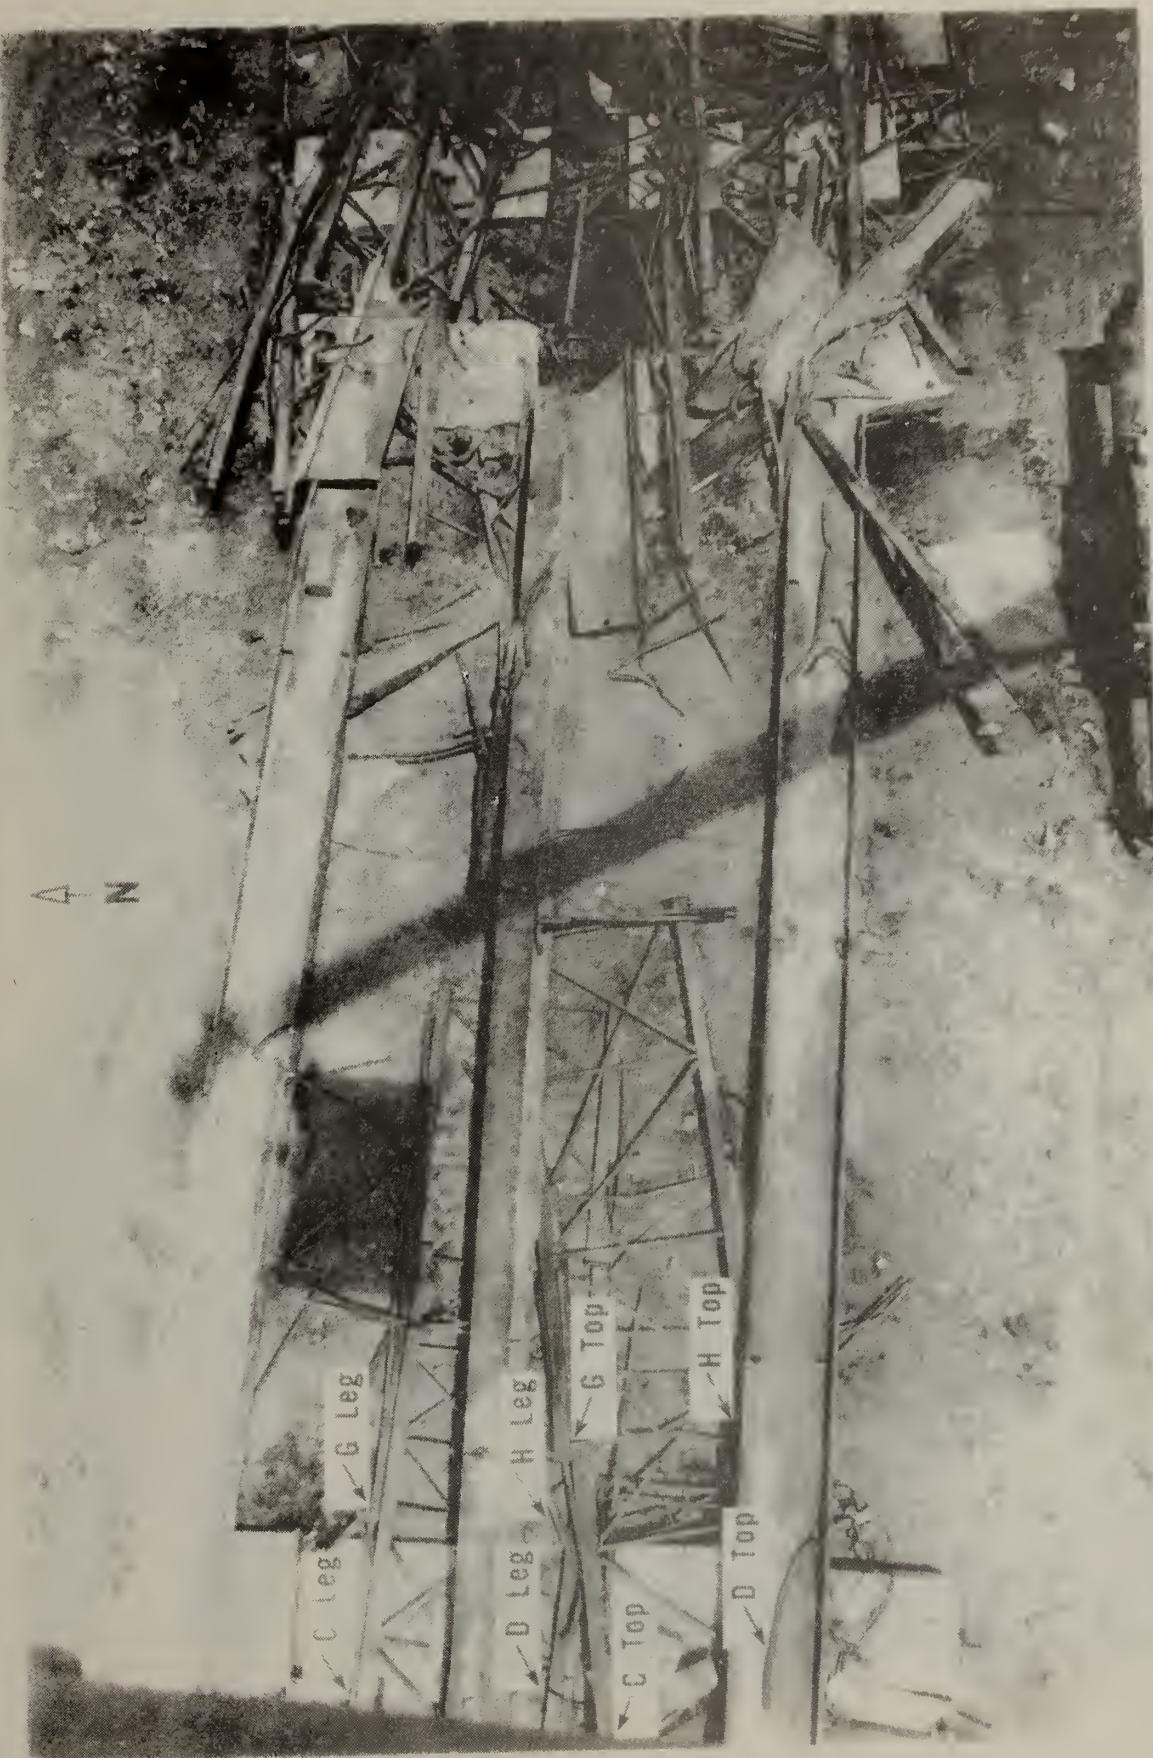
Figure 3.20 Location of parts of the south tower at 407.1

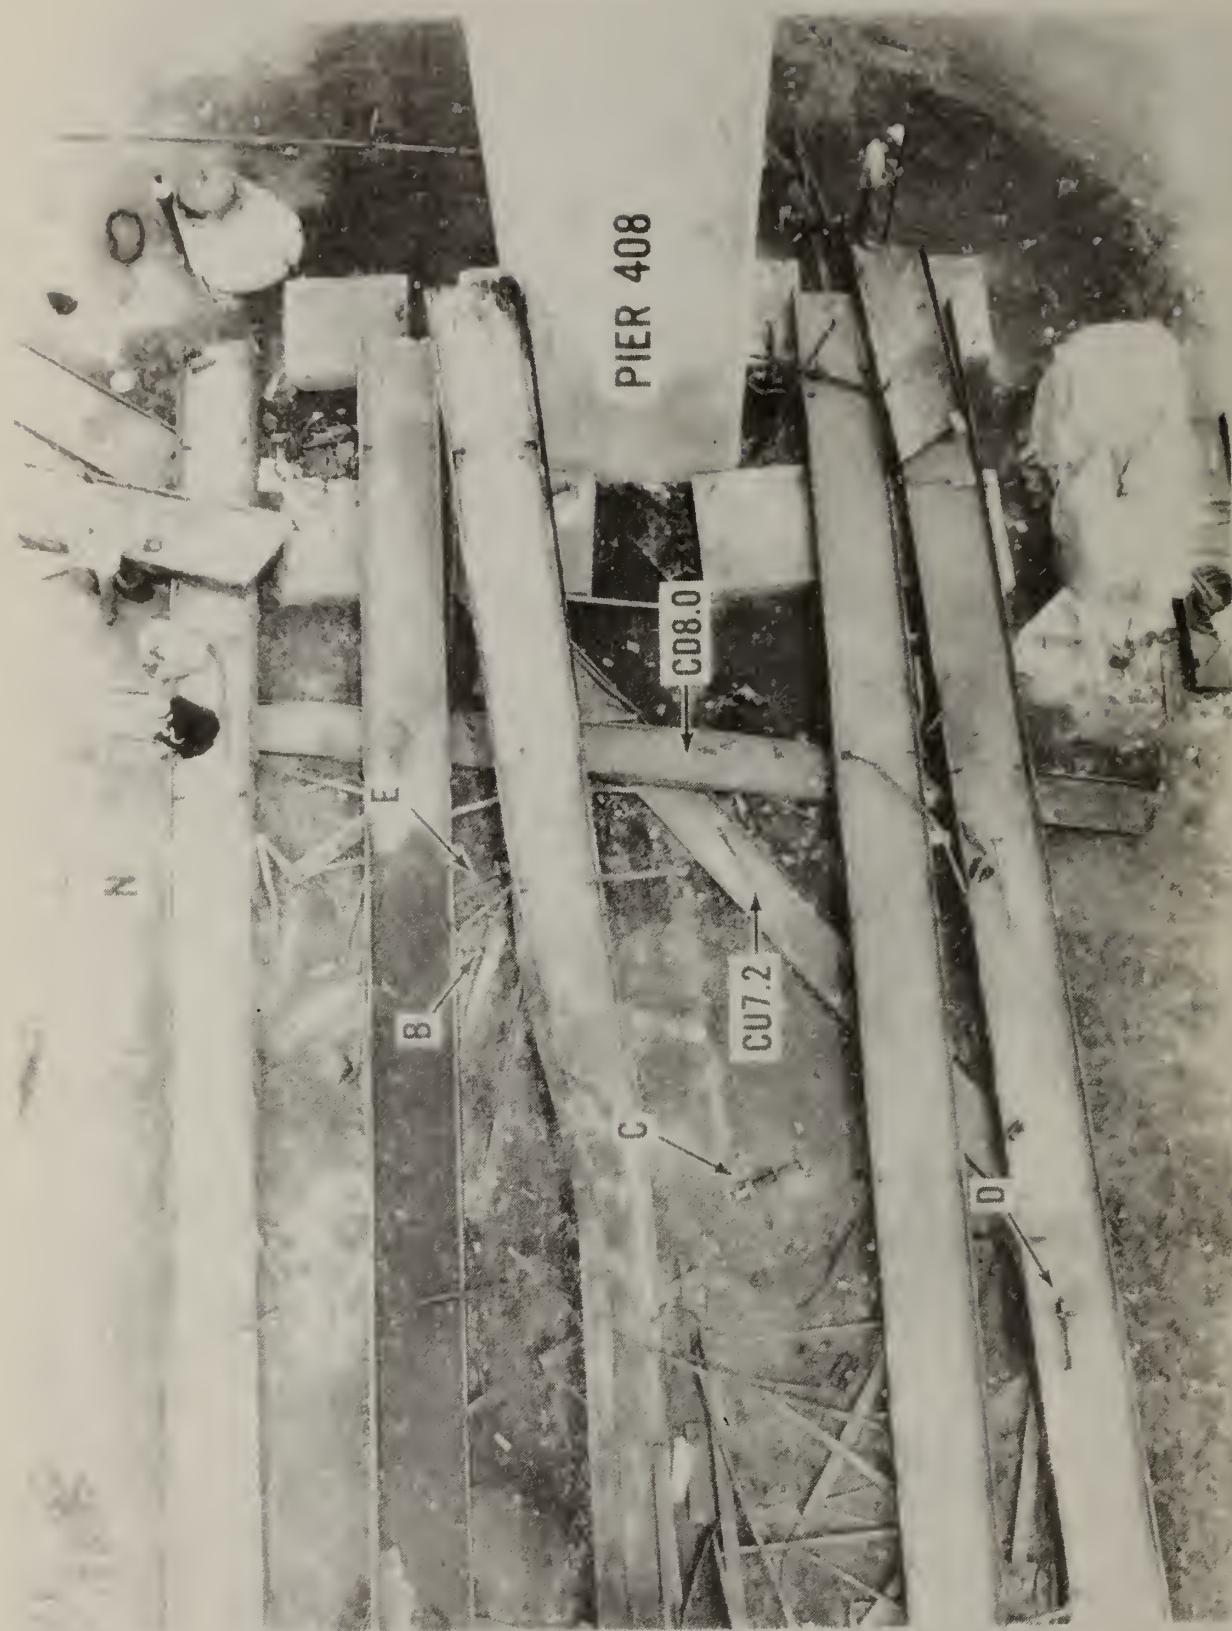
Figure 3.21 Location of top screw jacks and their probable positions in the towers at 407.2

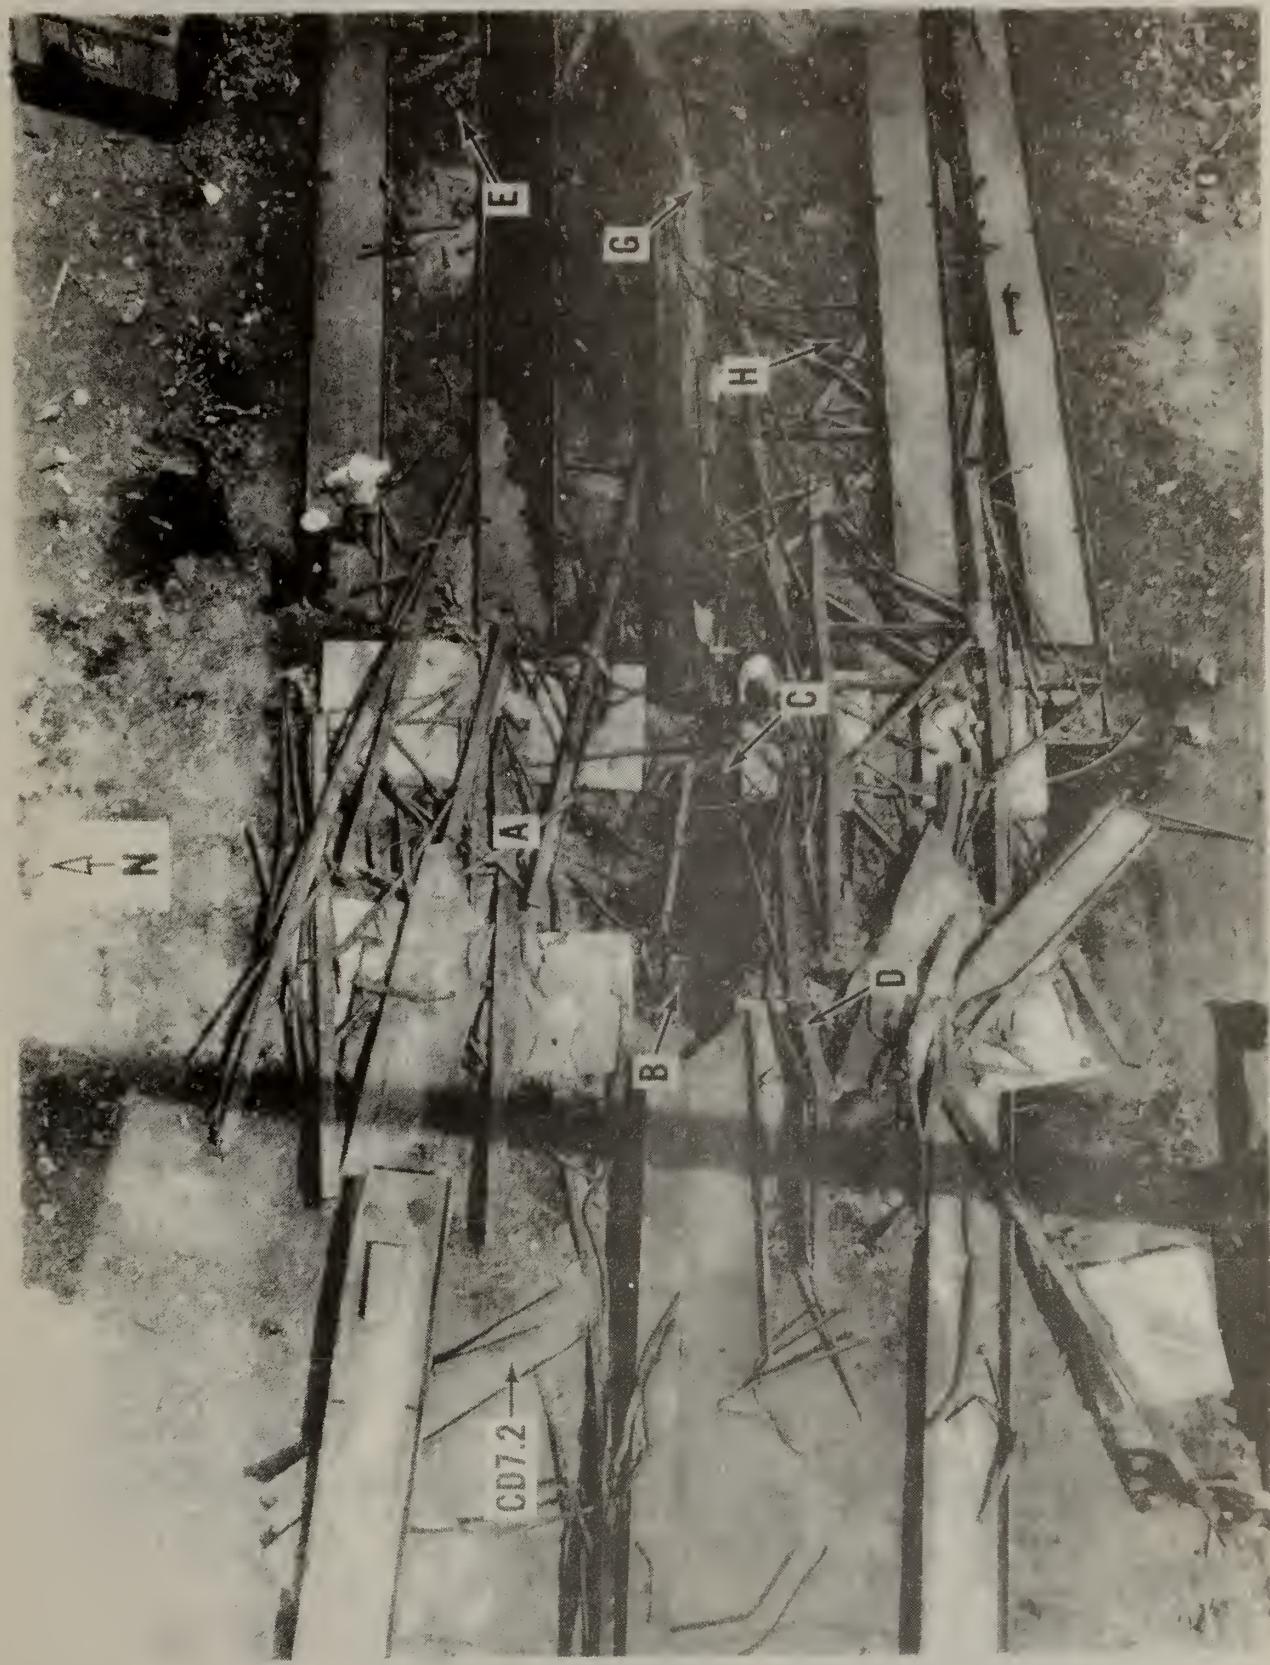
Figure 3.22 Location of tops of U-heads belonging to towers at 407.2

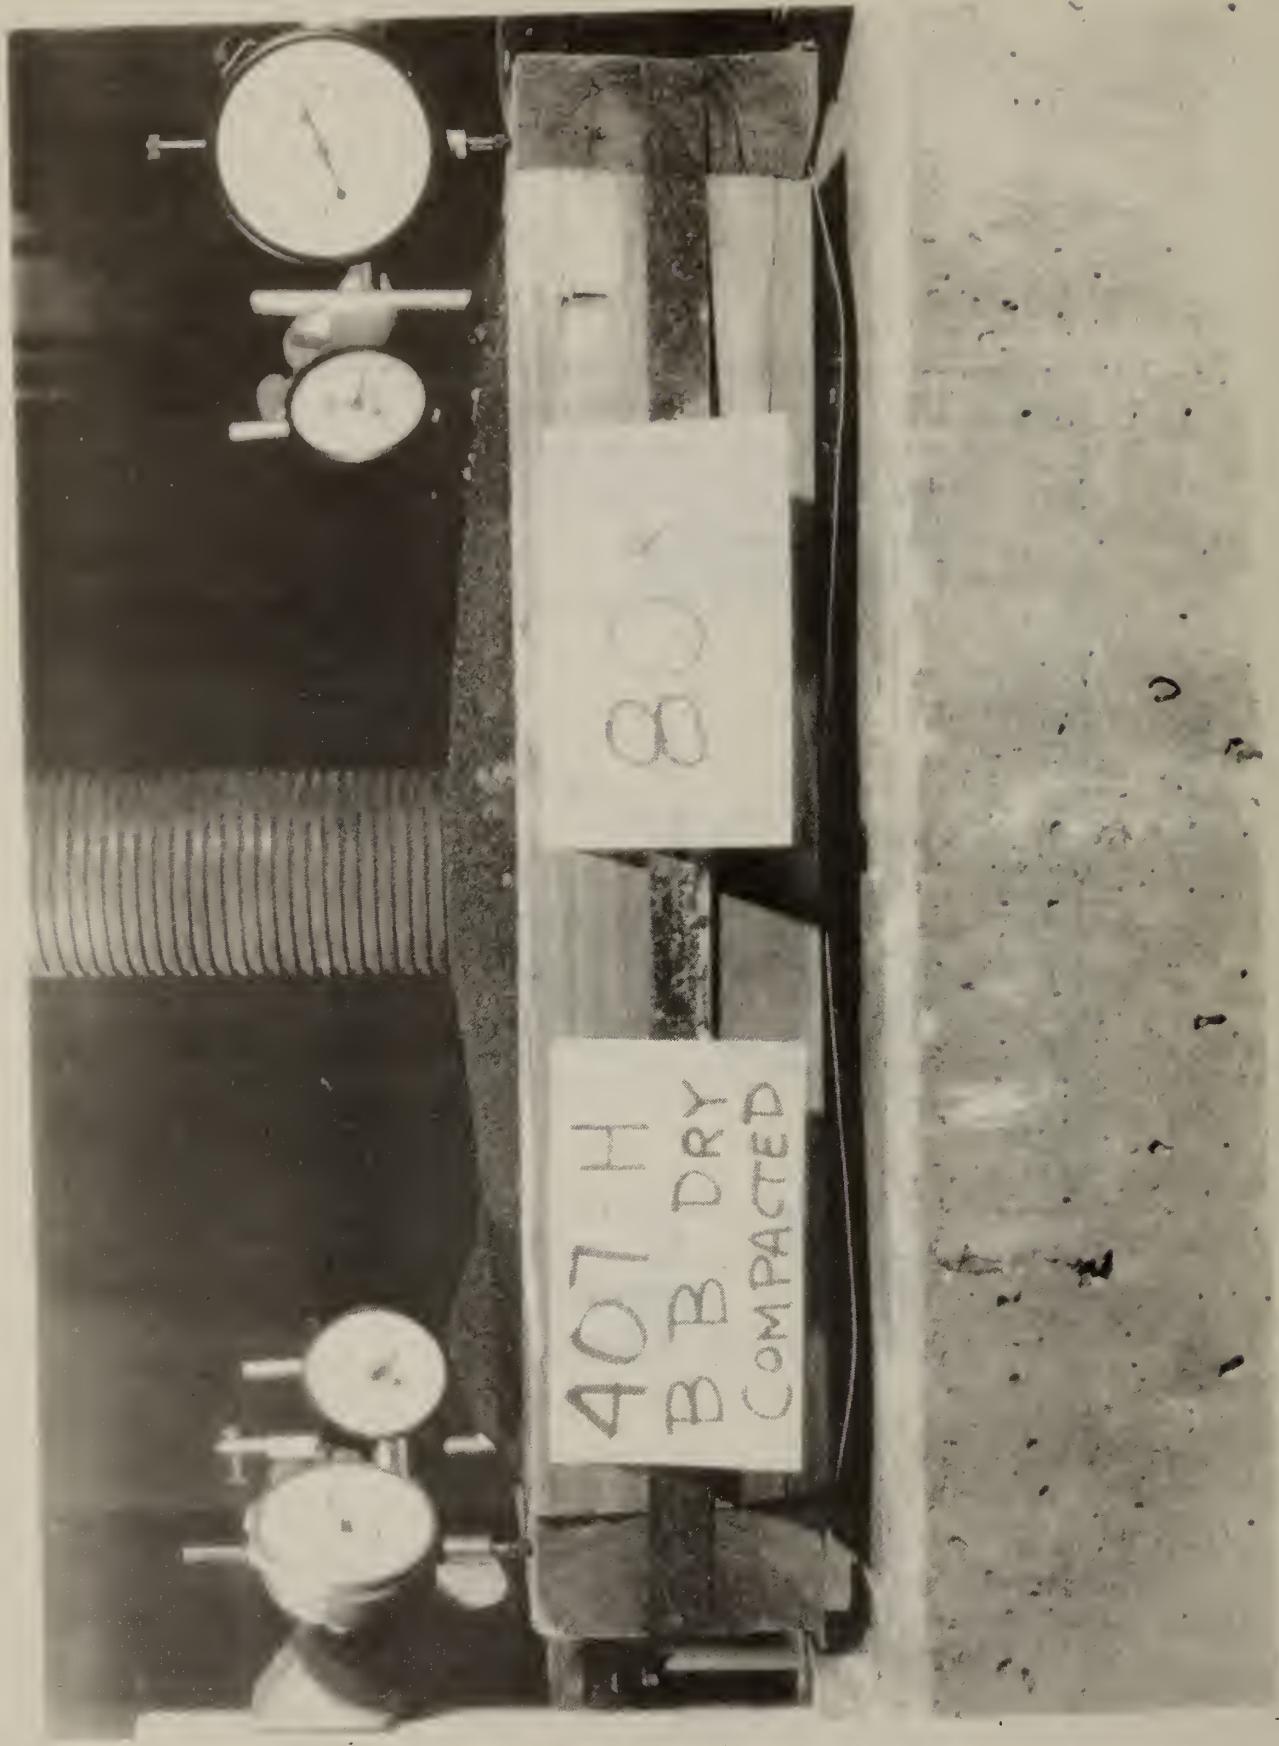
Figure 4.9 Example of uplift of sand box with boiler-slag filler

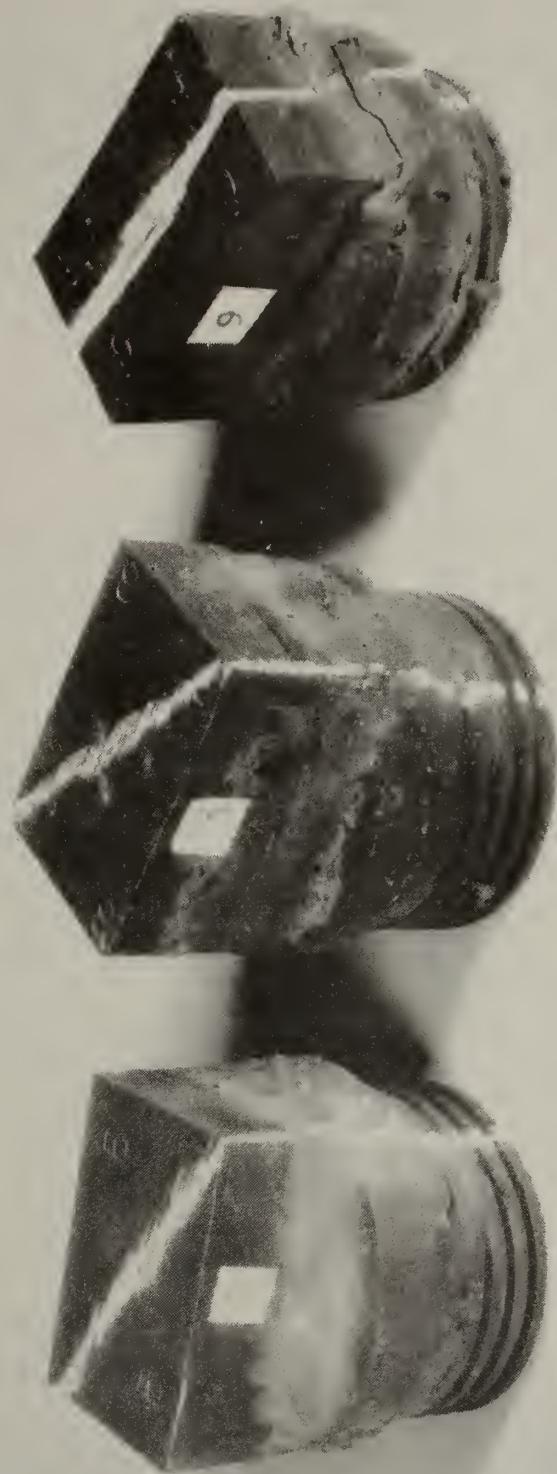
After testing, the welded portions of the screw jacks were cut and prepared for subsequent metallographic examination. Figure 4.14 shows the portions of the screw jacks prior to sectioning. Note that specimens #3 and #5 were sectioned along a diagonal of the post. After sectioning and polishing, the specimens were immersed in an etching solution to bring out differences in the microstructural features of the metal. Figures 4.15, 4.16, and 4.17 show the appearance of the specimens under no magnification. The features to note in these photographs is the weld size and the appearance of the heat-affected-zone (dark area) in the base metal. The lack of a heat-affected-zone can be interpreted as a poor quality weld in which little or no fusion occurred between the weld metal and the base metal.

Figure 4.14 Portions of unused screw jacks prior to sectioning

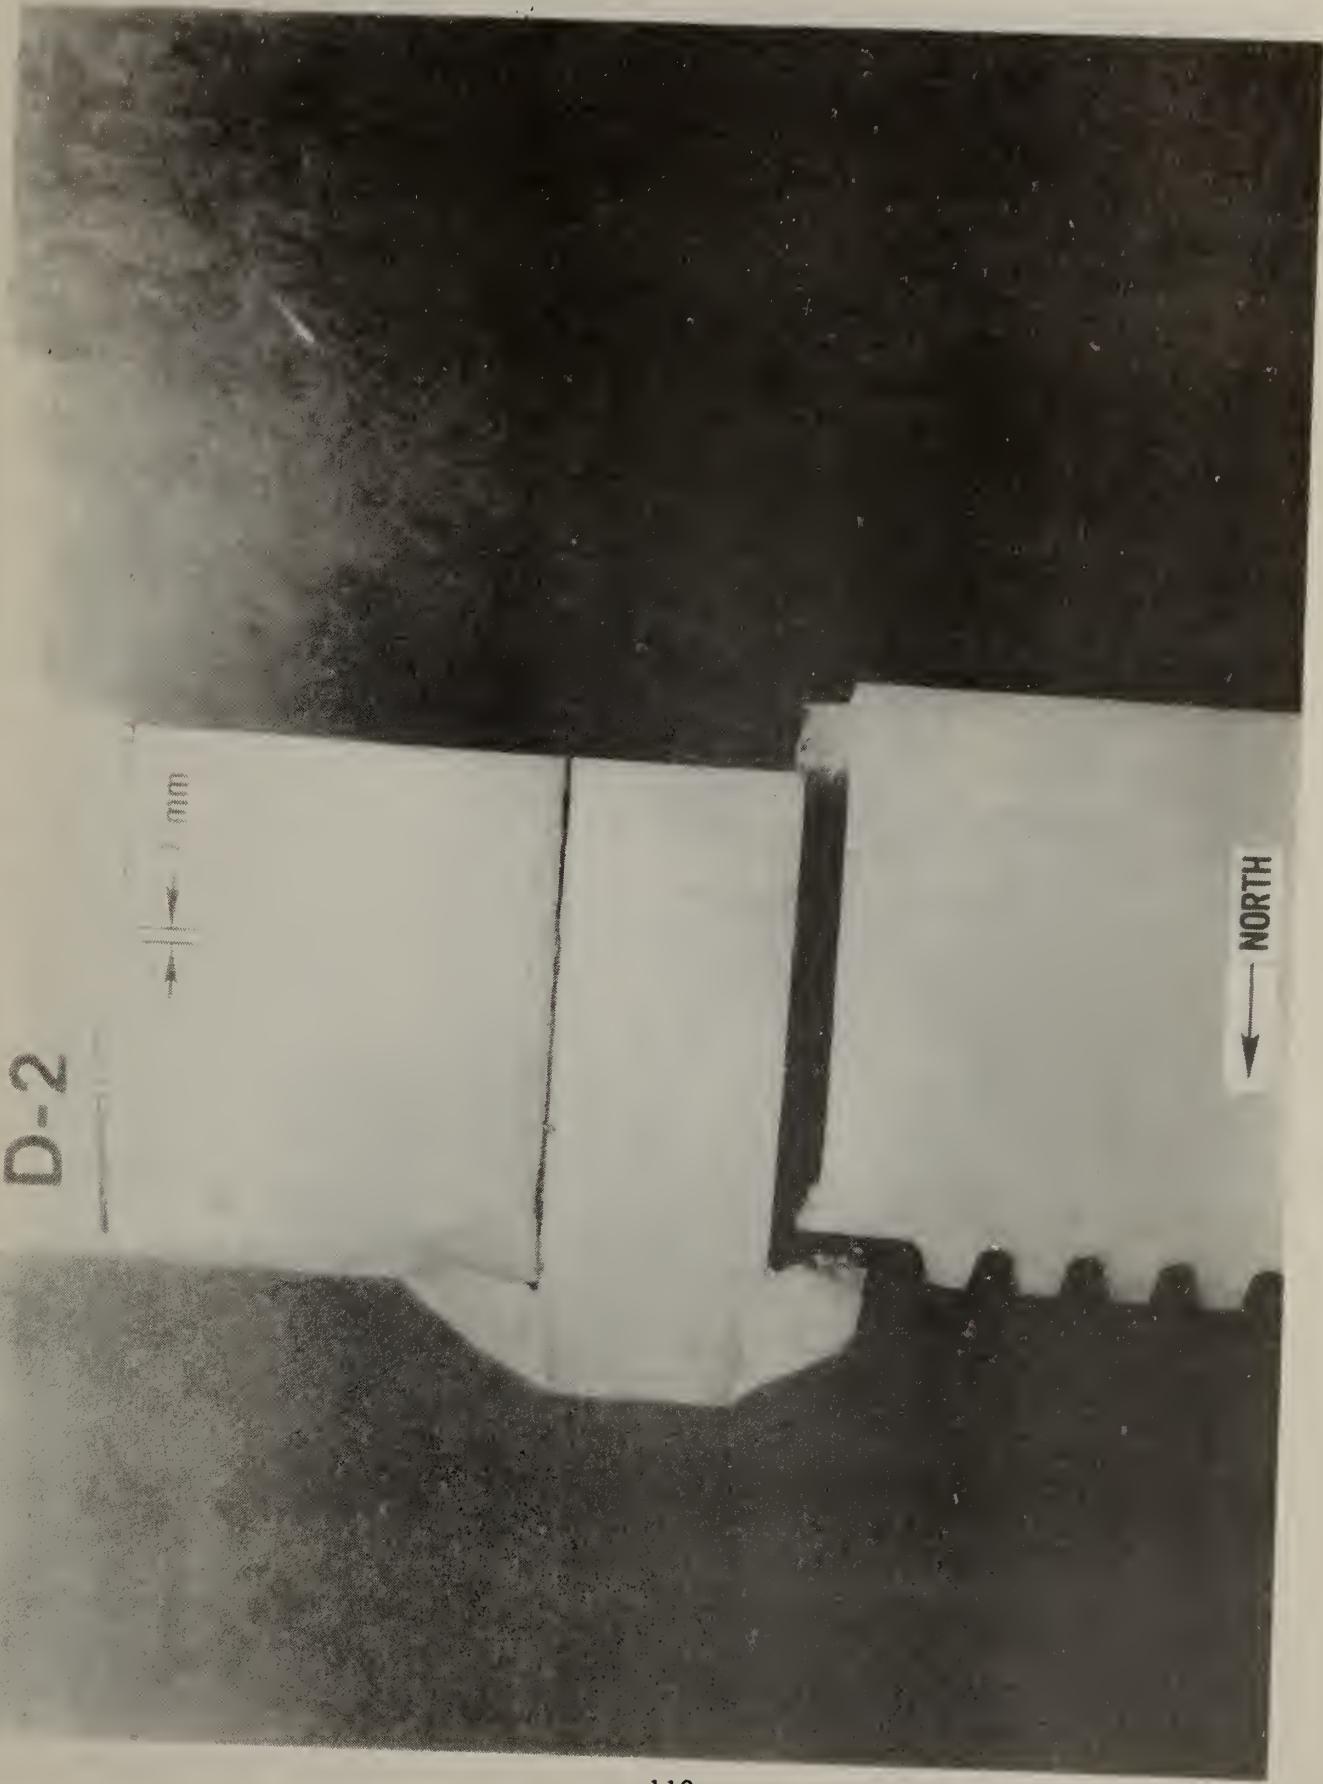
Figure 4.22 Quarter-section of screw jack from leg D in tower 407.2(S)
