Mason-Willis-Dixon House
Portsmouth Village
Cape Lookout National Seashore

Historic Structure Report

December 2015

JOSEPH K. OPPERMAN-ARCHITECT, P.A.

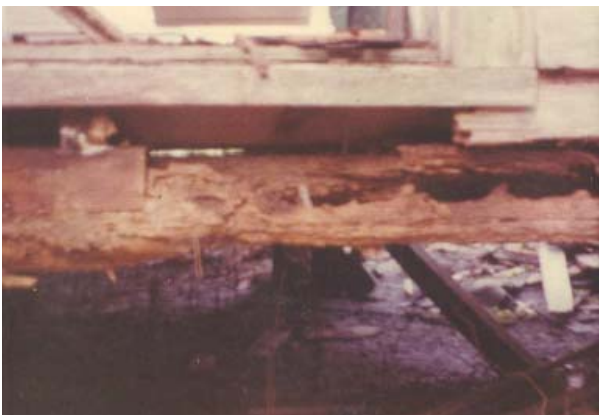
Work on the house began in 1979. An NPS album of Polaroid photographs shows the features and condition of the house at that time and some of the work underway. Like many in Portsmouth, the house suffered from severe termite damage (*Figs. 32-34*).

Figure 32. Termites in sill, 1979. (CALO Polaroid album)

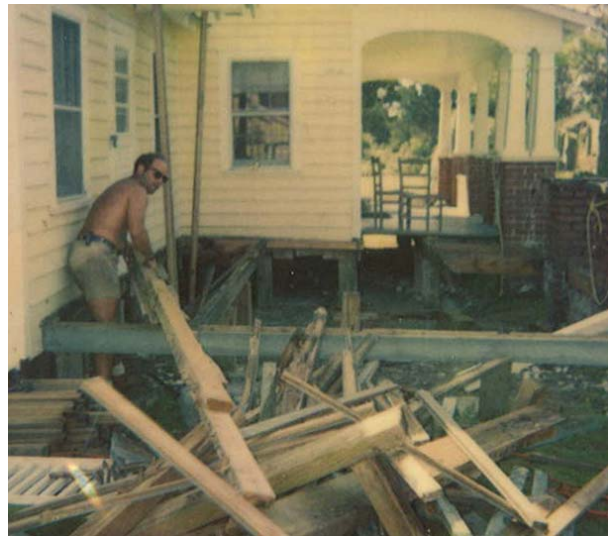
In June and July, an NPS crew replaced most wood features of the porch and deck, which suffered from the more extensive rot and termite damage (*Figs. 32-36*). The subframe of both was replaced and new floorboards installed. The rafters of Harry Dixon's engaged roof extension were replaced, and a new ceiling installed. Also replaced were the two center box columns and all arches, which photographs show were severely damaged by termites. The 1928 tripled corner posts were able to be retained, and the posts and portions of the west portico were also replaced. Some railings were reused and most others replaced, and

Figure 33. Preparing to replace kitchen deck, 1979. (blurry in CALO Polaroid album)

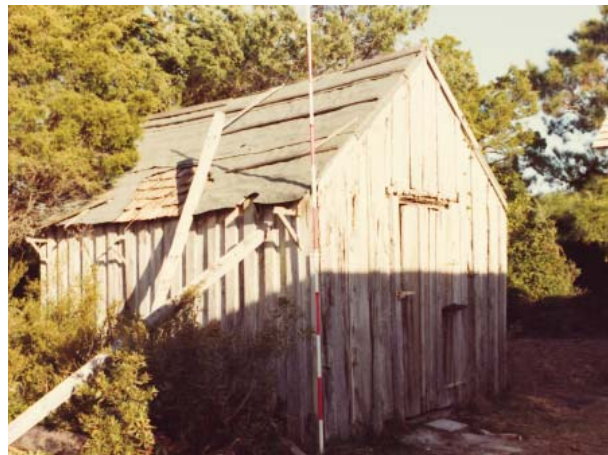
Figure 39. Front and west side of shed before work, 1979. (CALO coll. f289)

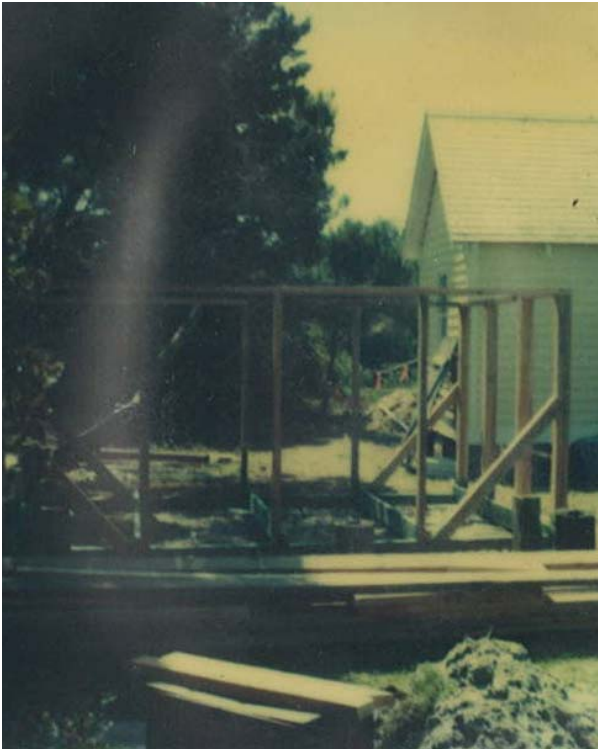
Figure 41. Reconstructed frame for rebuilt shed, 1980. (CALO Polaroid album)

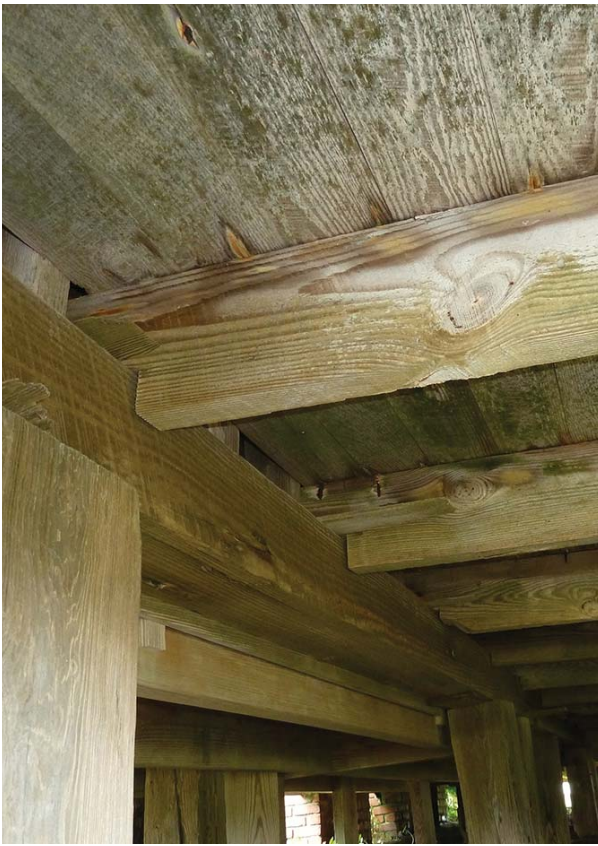
Figure 63. Typical joist/stud/sill/post connections.

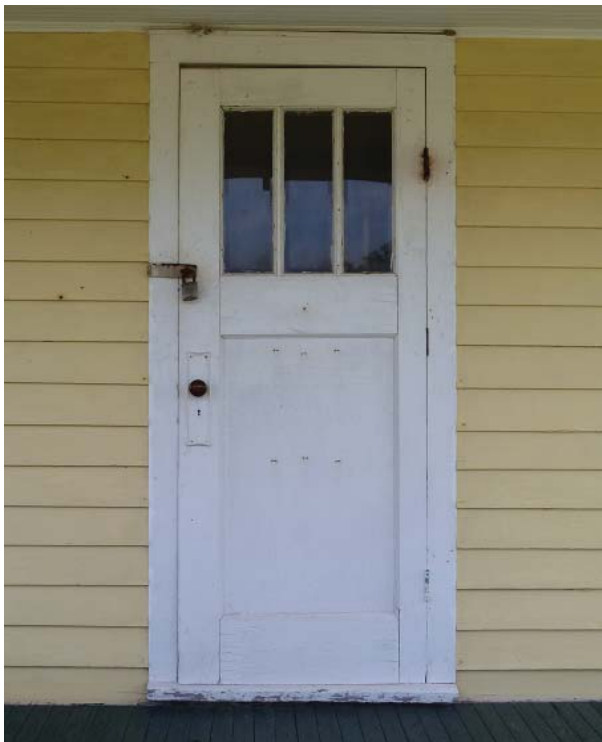
Figure 69. Front door, opening into Room 101.

The front door to Room 101 remains in generally good condition. The door to Room 106 is

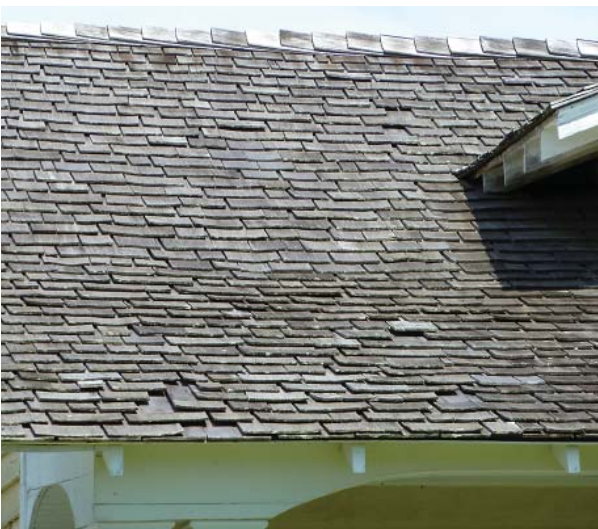
Figure 80. Typical roofing.

The roofing is in fair condition and there are no apparent leaks. A few shingles are missing or loose. As with most of the historic structures at Portsmouth, no gutters or french drains are present.

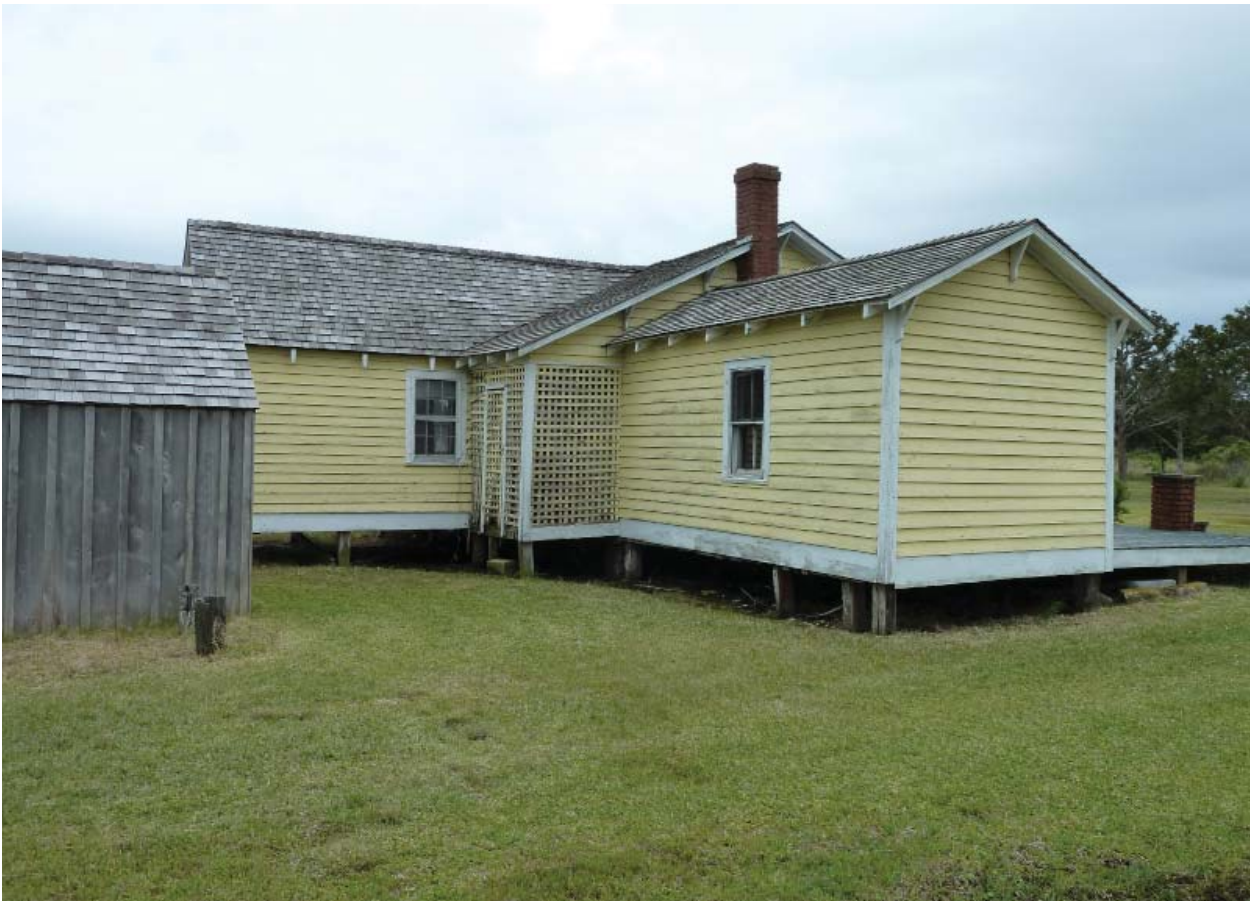
Figure 89. Northwest oblique.

The lattice on the lower portion of the north wall is badly damaged as is the painted finish on the entire porch. The door steps are missing entirely.

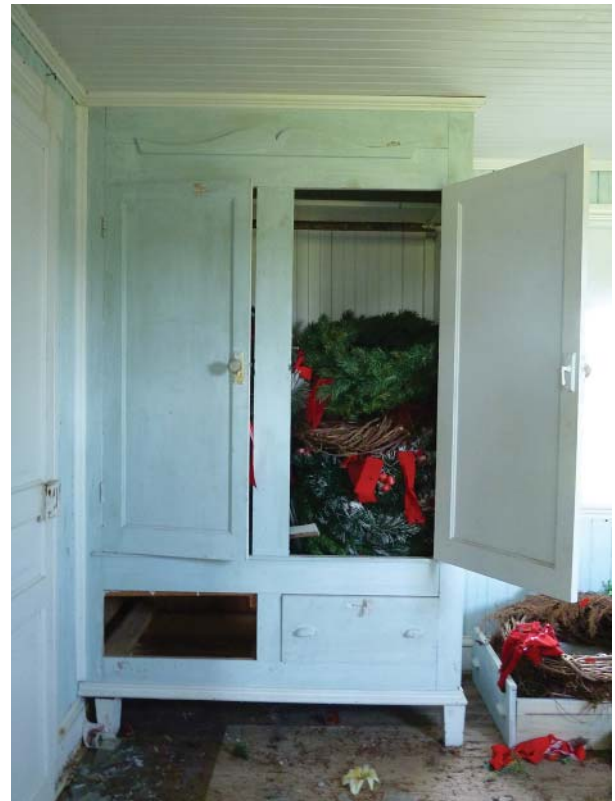
Figure 112. Wardrobe in southwest corner of Room 105.

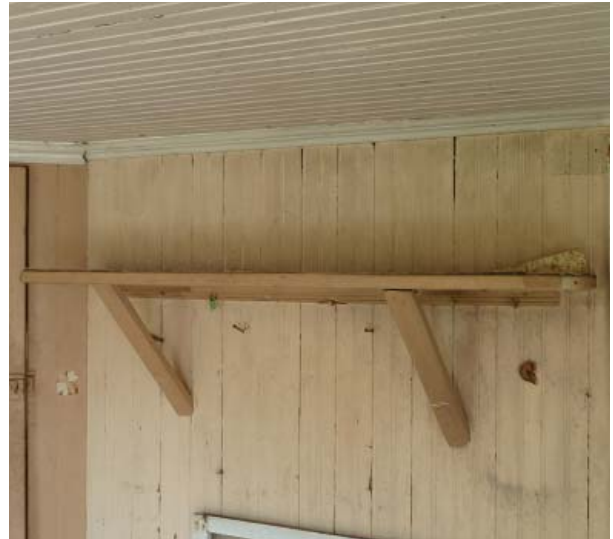
Figure 116. Shelf on north wall of Room 106.

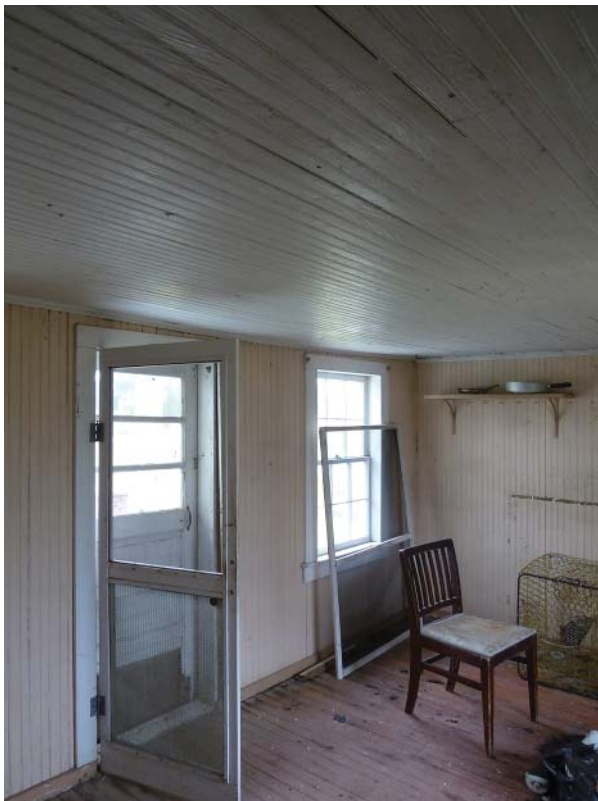
Figure 115. Southwest oblique, Room 106.

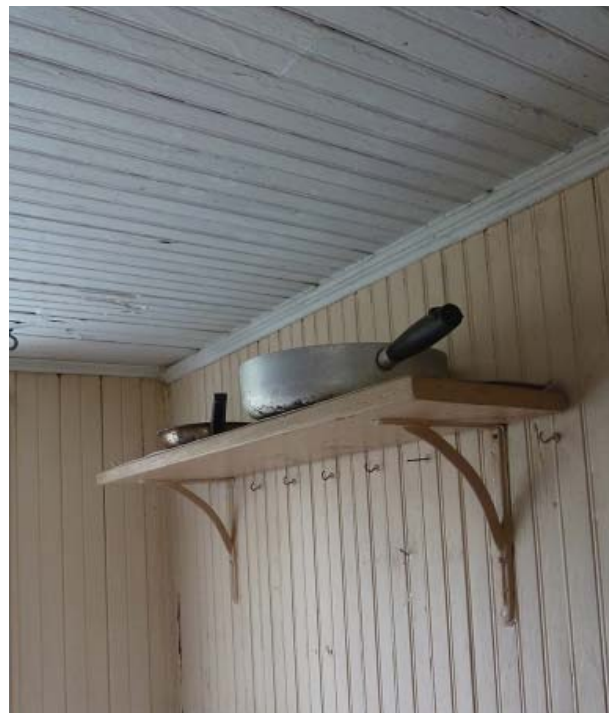
Figure 117. Shelf on west wall.

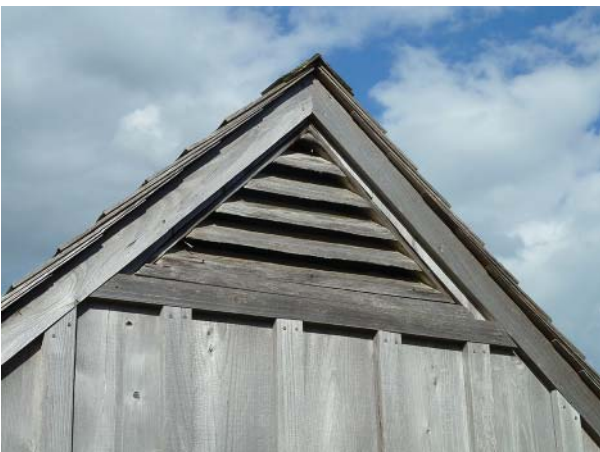
Figure 122. Gable vent.

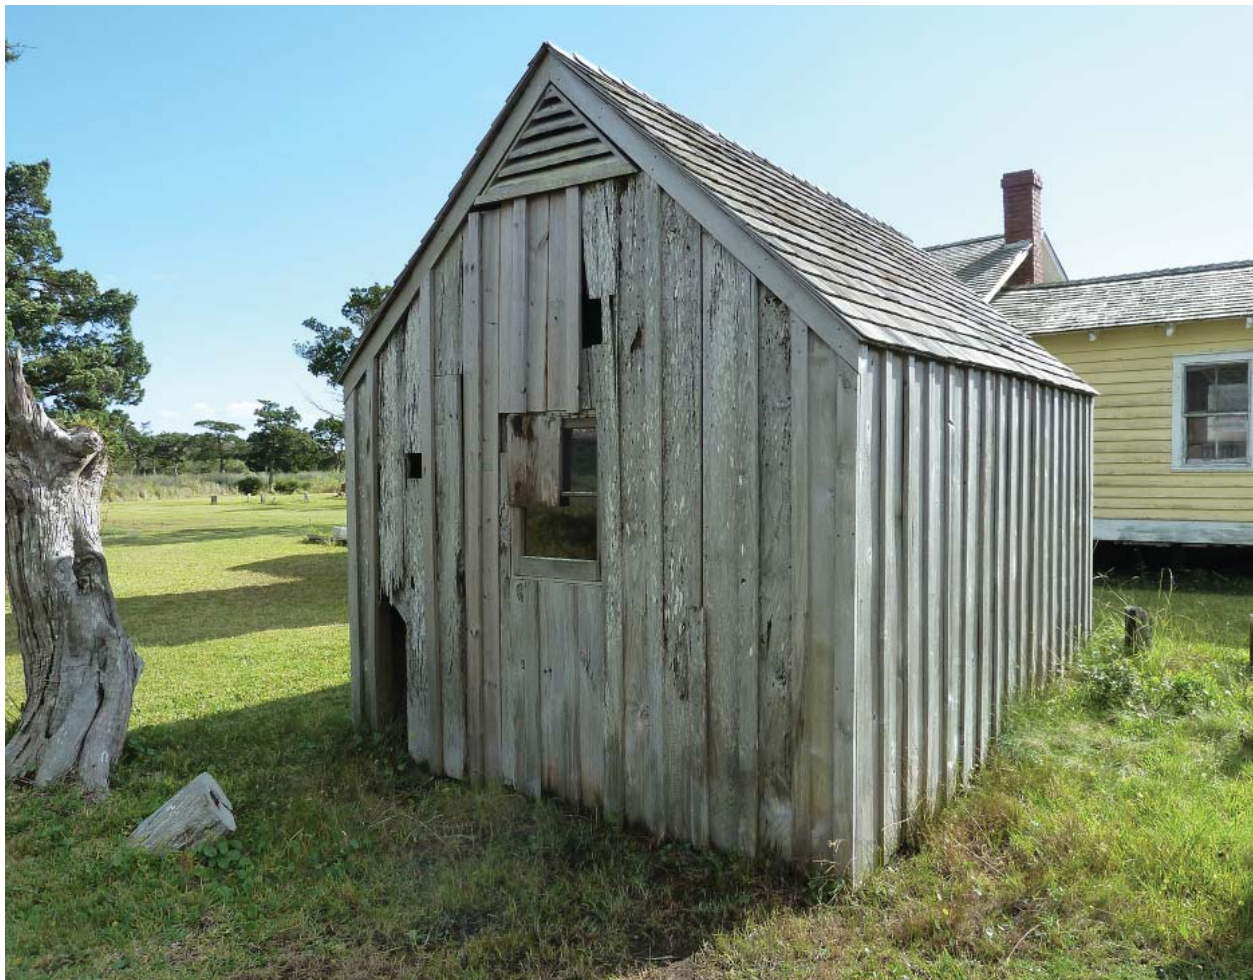
Figure 123. Southeast oblique.

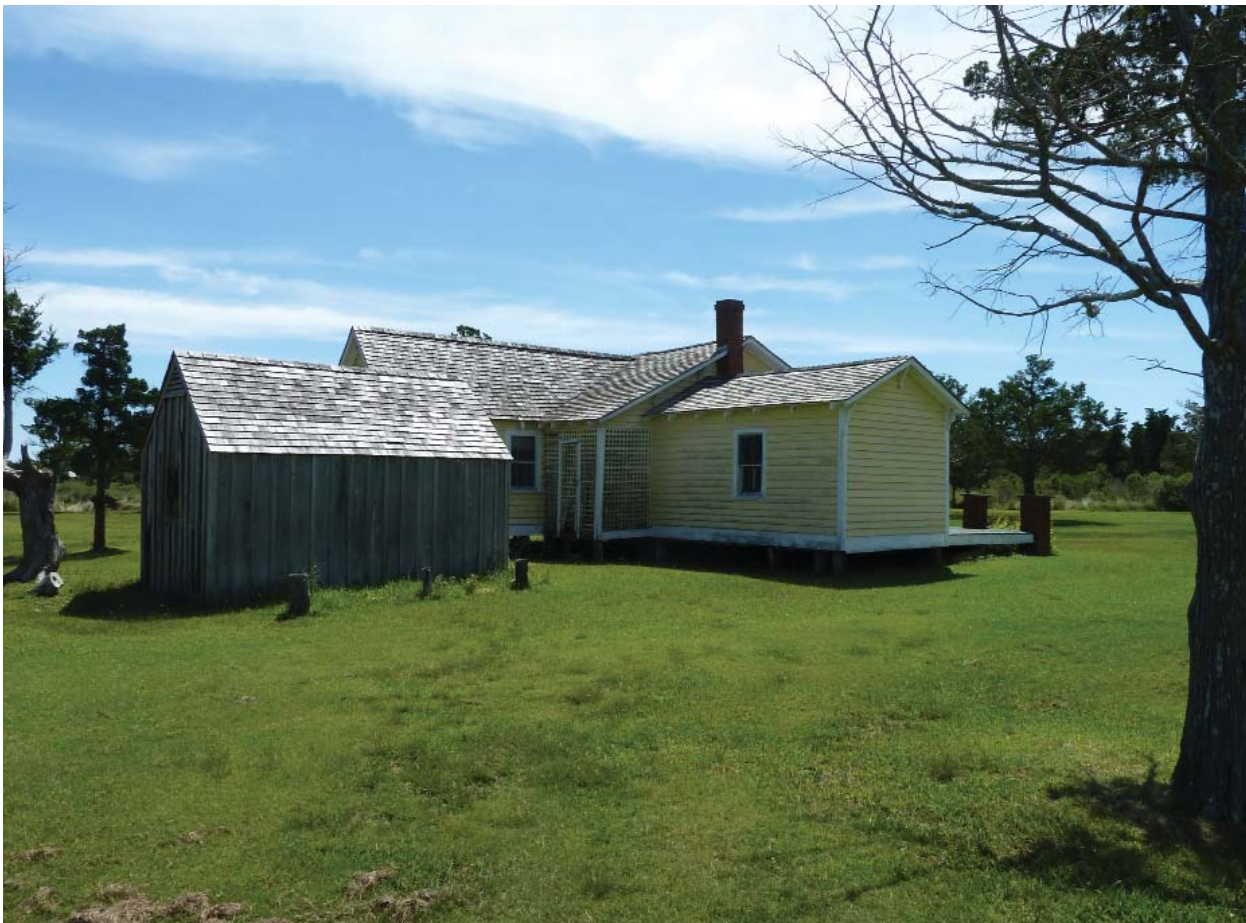
Figure 128. Northwest oblique.

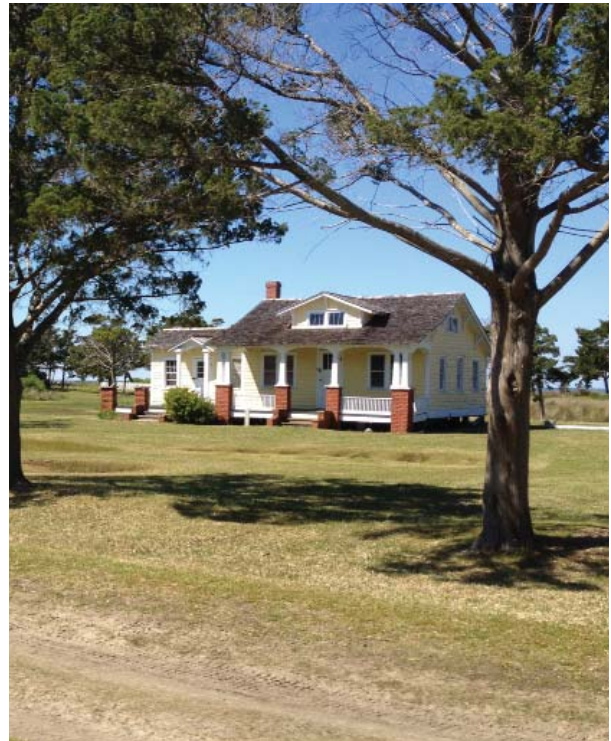
Figure 129. Mason-Willis-Dixon House seen from Village Road.
