# Postearthquake Reconnaissance Report on Transportation Infrastructure Impact of the February 27, 2010, Offshore Maule Earthquake in Chile

PUBLICATION NO. FHWA-HRT-11-030

OCTOBER 2011

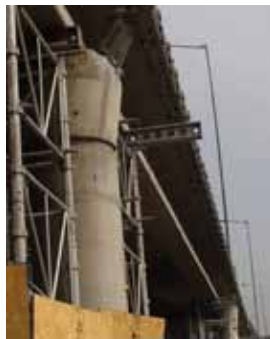
Two bridges oriented in the east-west direction and two ramps connected to westbound traffic were inspected at this site. The eastbound bridge, built in 2004, is a four-span structure with five discontinuous precast prestressed girders and a continuous deck. It almost collapsed during the earthquake, experiencing a lateral offset of greater than 1.6 ft (0.5 m), as indicated by the use of temporary heavy supports shown in figure 23 through figure 25. The superstructure had steel stoppers but no intermediate or end diaphragms. As shown in figure 24 and figure 25, both the curtain wall of the abutment and the steel stoppers were significantly damaged. Each stopper was anchored with two bolts embedded in the cap beam at a depth of 35 inches (900 mm), as shown in figure 26. Steel stoppers were mainly used to restrain the vertical movement of girders.

**Figure 23. Photo. Damage to eastbound Independencia bridge.**

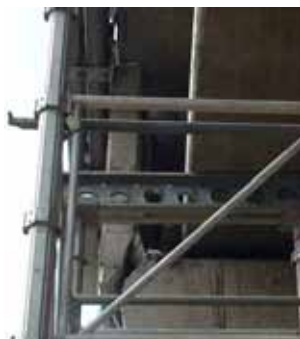
**Figure 24. Photo. Curtain wall at east abutment of eastbound Independencia bridge.**

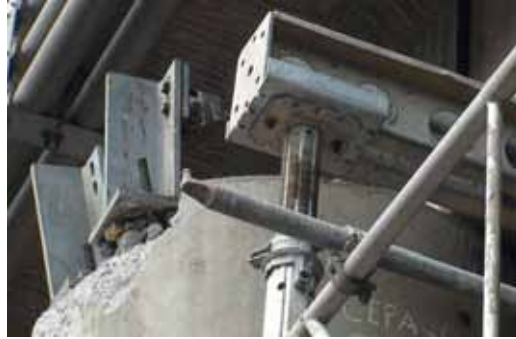
**Figure 25. Photo. Damage to steel stoppers on eastbound Independencia bridge.**

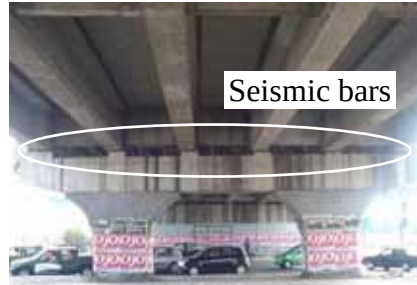
The westbound bridge, built in 1997, is a four-span structure with six discontinuous precast prestressed girders and a continuous deck. Each bent has two flared wall piers, as shown in figure 27. The bridge was designed with both intermediate and end diaphragms. The bridge survived the earthquake with excessive deformations in the seismic bars and damage to concrete shear keys at abutments and intermediate bents (see figure 28 through figure 30).

**Figure 27. Photo. Typical flared wall pier of westbound Independencia bridge.**

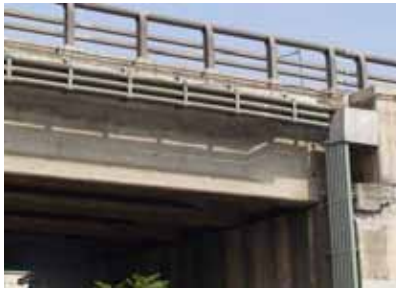
**Figure 29. Photo. Shear key damage at abutment of westbound Independencia bridge.**

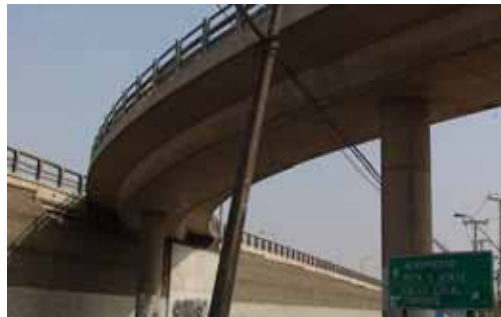
**Figure 32. Photo. Entrance ramp to westbound Independencia bridge.**

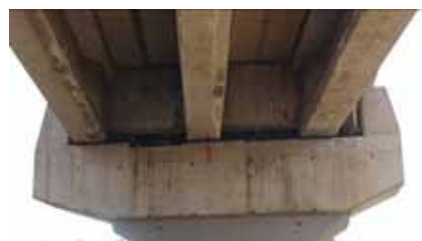
The exit ramp for westbound traffic remained in service after the earthquake. Minor damage due to pounding in the corner of the beam recess was observed on a flared wall pier close to the westbound bridge, as shown in figure 34 and figure 35.

**Figure 34. Photo. Flared wall pier of exit ramp from westbound Independencia bridge.**

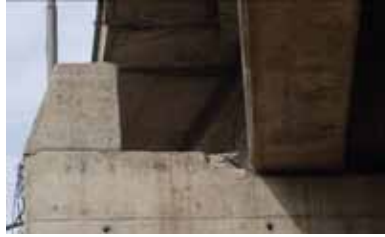
**Figure 35. Photo. Close-up of damage to exit ramp from westbound Independencia bridge.**

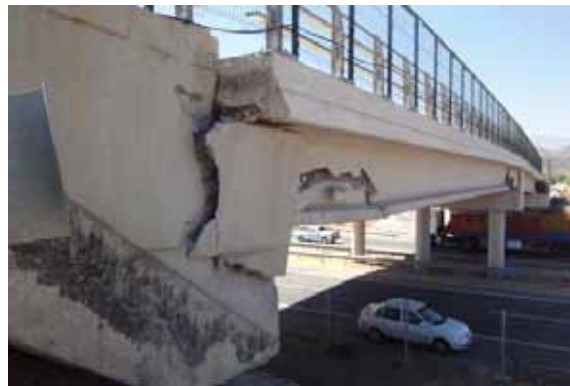
The two-span Chada overpass, shown in figure 36 through figure 39, is oriented approximately east-west. The bridge superstructure was displaced significantly and rotated counterclockwise in plan during the earthquake. The transverse offset between the deck and abutment seats ranged from 25 to 30 inches (640 to 780 mm). The longitudinal gap between the end of girders and the abutment was 3.5 inches (90 mm). The bottom flange and web of the exterior precast girder that hit the curtain walls at each abutment failed in shear, as shown in figure 36. The failure of the bottom flange can be seen in figure 37. The two curtain walls at the intermediate bent were both damaged, as shown in figure 38. The bridge experienced strong shaking, indicated by an induced gap around the columns, as shown in figure 39. No structural damage was observed in the bridge columns.

**Figure 36. Photo. Curtain wall shear failure at abutment of Chada bridge.**

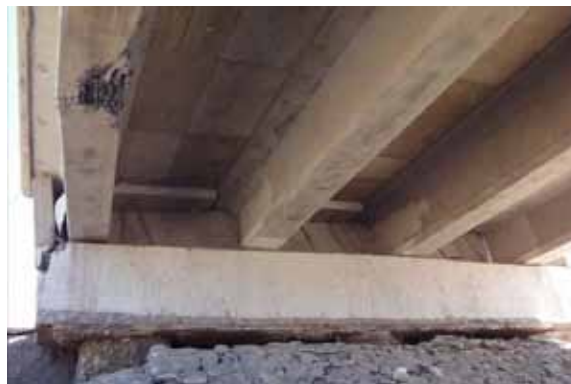
**Figure 37. Photo. Bottom flange damage to Chada bridge.**

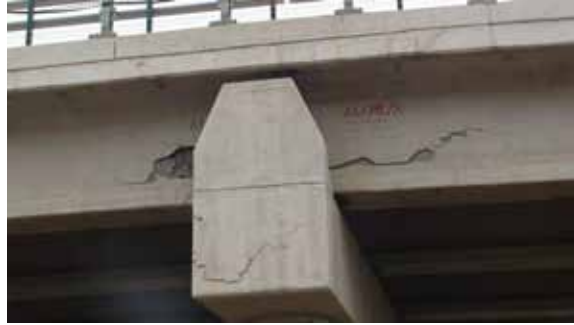
**Figure 38. Photo. Curtain wall damage at bent of Chada bridge.**

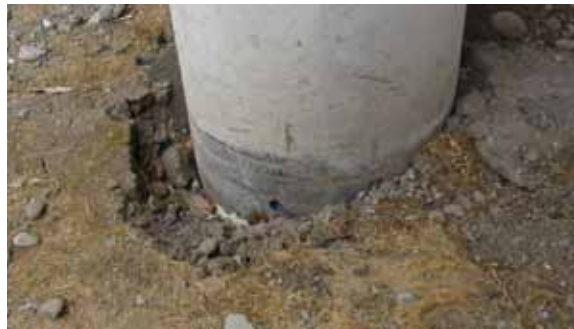
**Figure 39. Photo. Soil separation from column of Chada bridge.**

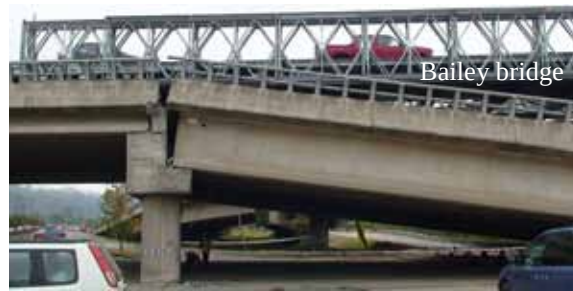
As shown in figure 43, a simply supported span in the eastern approach to the bridge dropped from its seat at the river end of the span, and a temporary Bailey bridge was erected to give traffic access to the main crossing. As shown in figure 44, the end bent supporting the unseated span remained intact except for concrete spalling underneath the cap beam, as shown in figure 45. The seismic bars shown in figure 44 were deformed almost 180 degrees as the span collapsed and they were

**Figure 43. Photo. Unseated simply supported span in eastern approach to Llacolen bridge.**

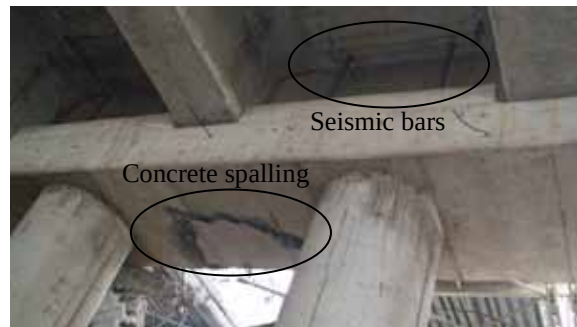
**Figure 45. Photo. Concrete spalling beneath cap beam of eastern approach to Llacolen bridge.**

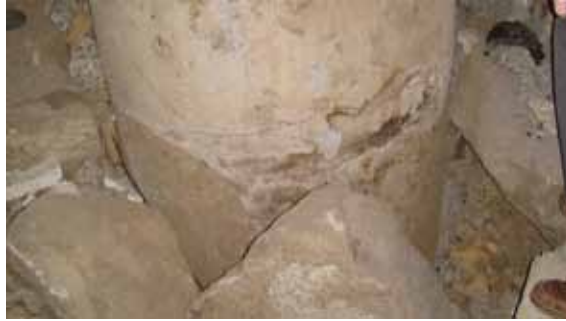
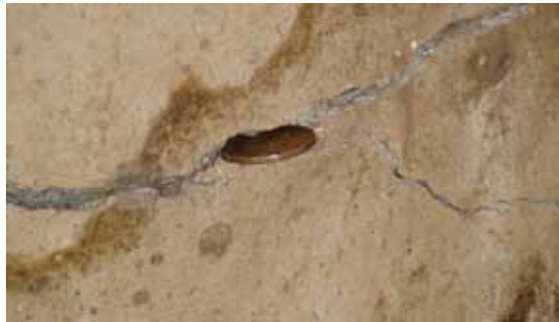
pulled from the diaphragms. The columns supporting the cap beam experienced flexural cracks at the level of the rock rip rap on the bank below the bridge (see figure 46 and figure 47). The cracks appeared on the river side of the columns, where tension developed as the superstructure held the columns against the lateral movement imposed on the foundations by liquefaction-induced lateral spreading of the banks. The bent and columns at the opposite end of the unseated span were undamaged. However, as shown in figure 48, the nearby ground settled up to 1.3 ft (0.4 m) and experienced significant shaking, resulting in a 0.82-ft (0.25-m) separation between the columns and their surrounding ground.

**Figure 46. Photo. Flexural cracks at the level of rip rap on eastern approach to Llacolen bridge.**

**Figure 47. Photo. Close-up view of cracks at the level of rip rap on eastern approach to Llacolen bridge.**

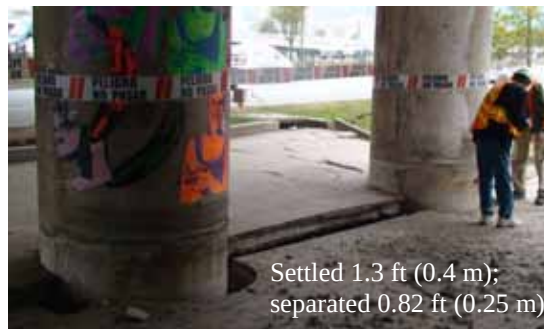
**Figure 48. Photo. Ground settlement and lateral movement of eastern approach to Llacolen bridge.**

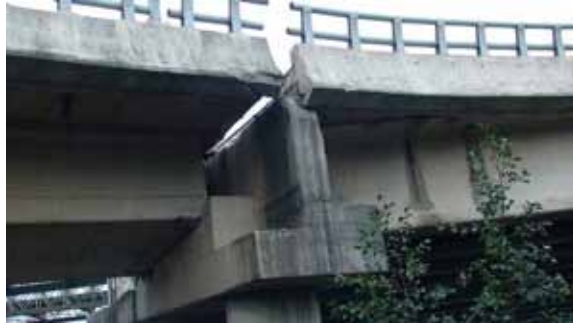
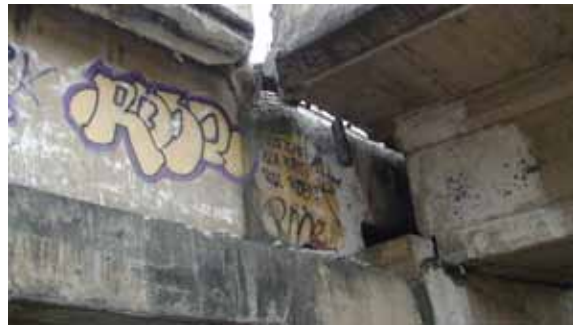
The entrance ramp for westbound traffic is a three-span simply supported box girder bridge. The girders are supported on wall piers with neoprene pads and fitted with seismic bars. The ramp was almost unseated at the river end of the last span, as shown in figure 49 and figure 50. At one intermediate bent, the seismic bars were rusty and the neoprene pads had degraded, as shown in figure 51 through figure 53.

**Figure 49. Photo. Exterior face of westbound ramp to Llacolen bridge at the river end.**

**Figure 50. Photo. Interior face of westbound ramp to Llacolen bridge at the river end.**

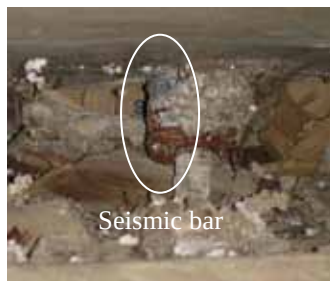
**Figure 52. Photo. Seismic bar condition on westbound ramp to Llacolen bridge.**

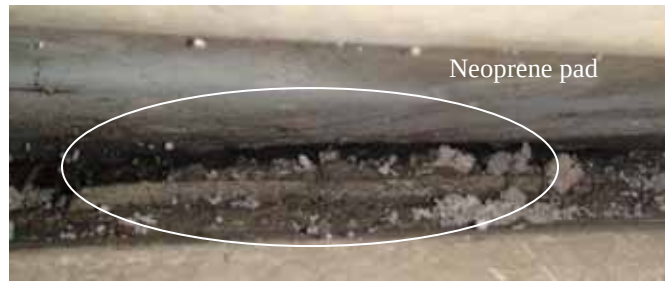
**Figure 53. Photo. Neoprene pad degradation on westbound ramp to Llacolen bridge.**

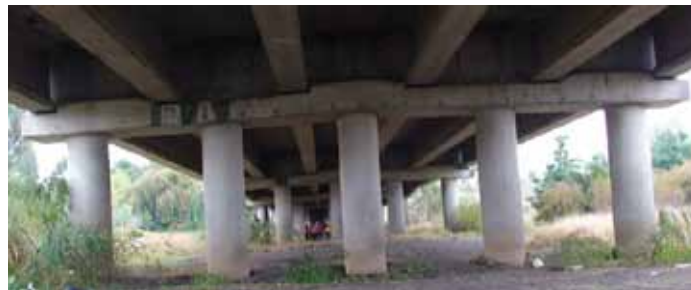
At the west end of the Llacolen bridge, soil settlement and liquefaction were observed at multiple locations near the bridge bents, as shown in figure 54 and figure 55. Pounding-induced damage was also observed at the supports of precast girders, as shown in figure 56 and figure 57. Minor damage also occurred when the girders engaged the concrete keys on the west abutment (see figure 58).

**Figure 54. Photo. Columns with soil marks indicating ground settlement at west end of Llacolen bridge.**

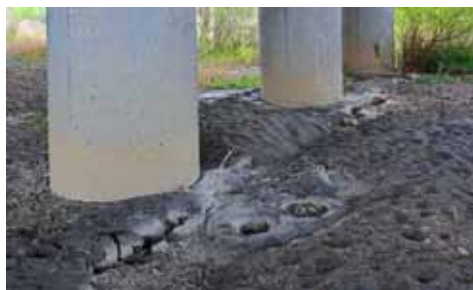
**Figure 55. Photo. Sand boils near columns at west end of Llacolen bridge.**

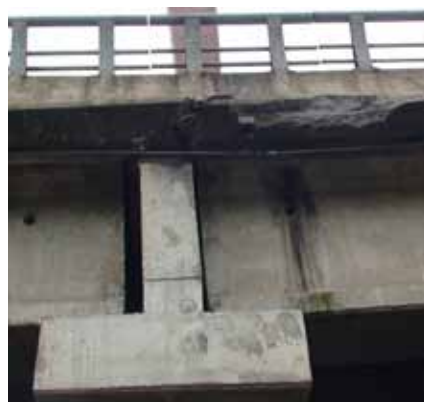
**Figure 56. Photo. Spalling in deck slab at west end of Llacolen bridge.**

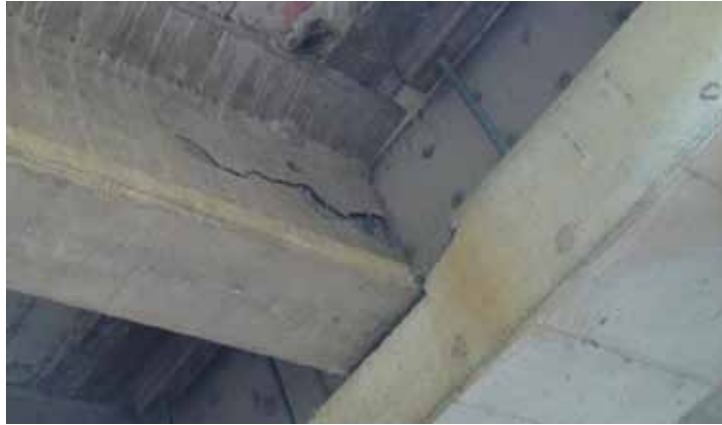
**Figure 57. Photo. Horizontal crack in web of end girders at west end of Llacolen bridge.**

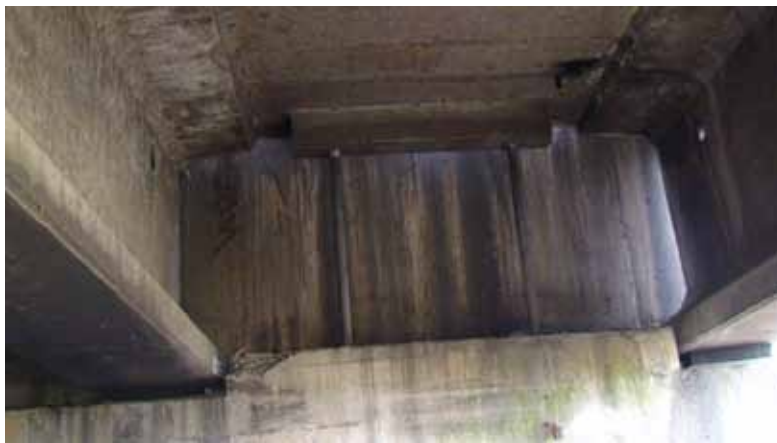
**Figure 58. Photo. Spalling of shear key at southwest abutment of Llacolen bridge.**

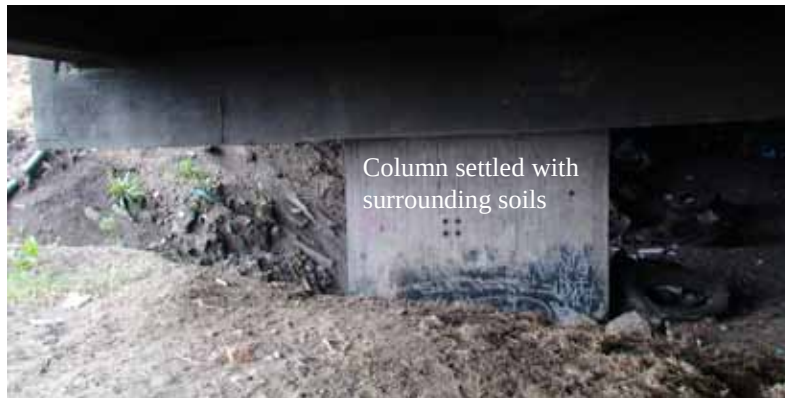
**Figure 63. Photo. Column settlement under approach to Juan Pablo II bridge (cracks on far side).**

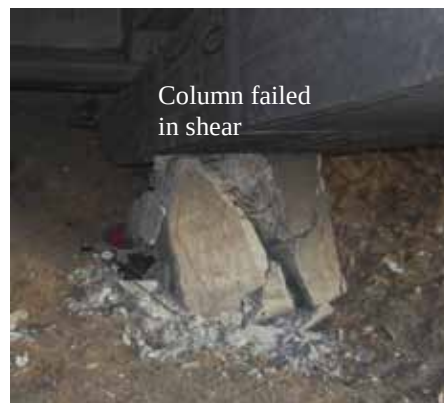
**Figure 64. Photo. Reduced column height due to shear failure under approach to Juan Pablo II bridge.**

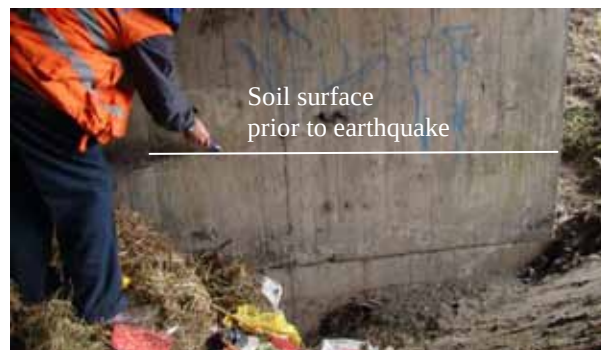
**Figure 65. Photo. Soil surface on far side of undamaged column under approach to Juan Pablo II bridge.**

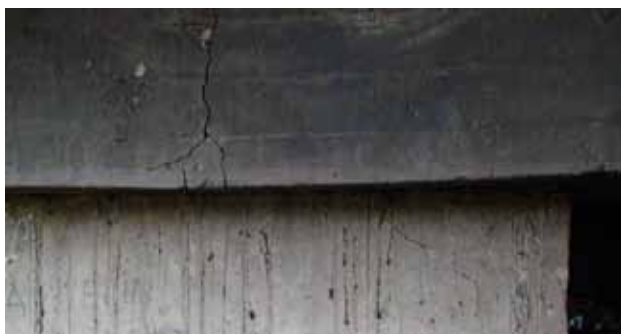
**Figure 66. Photo. Cracks on far side of undamaged column under approach to Juan Pablo II bridge.**

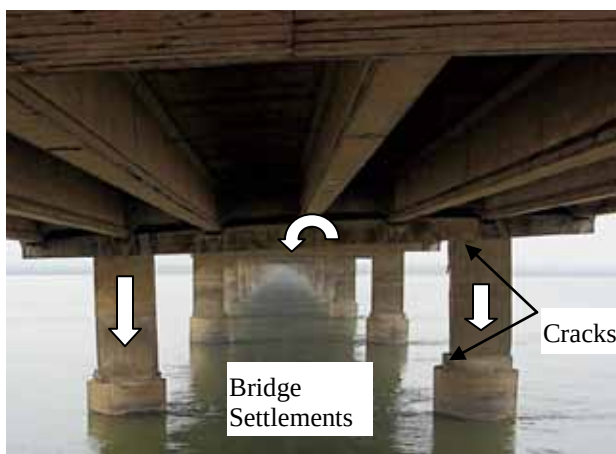
Consistent with the behavior of the approach structure, the spans of the main bridge also appeared to have experienced uneven support settlement, which tilted the columns and rotated the bridge deck about the centerline of the bridge, as seen in figure 67.

**Figure 67. Photo. Differential settlement underneath first span over water at northern end of Juan Pablo II bridge.**

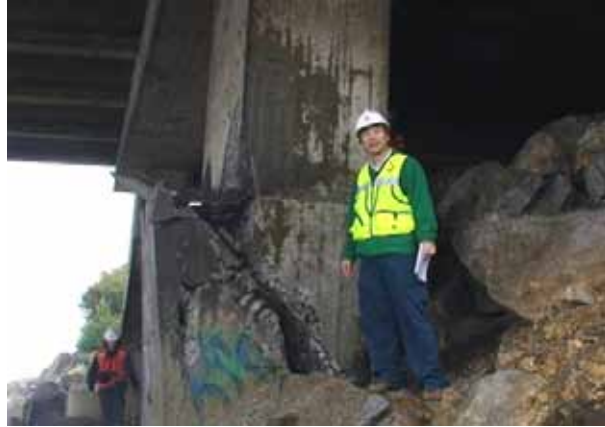
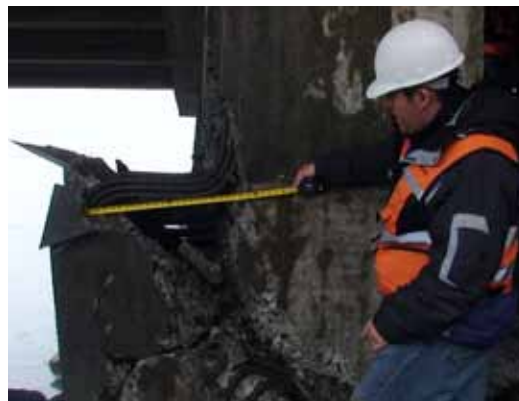
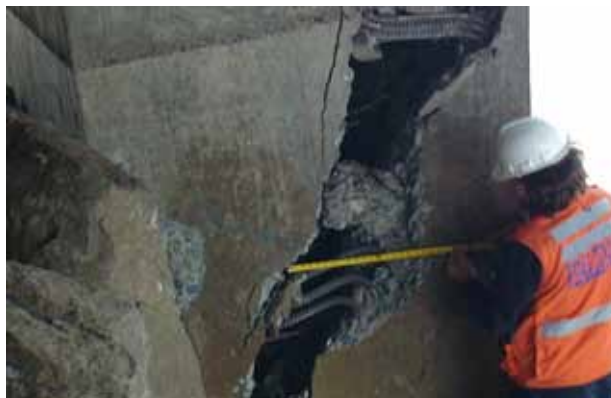
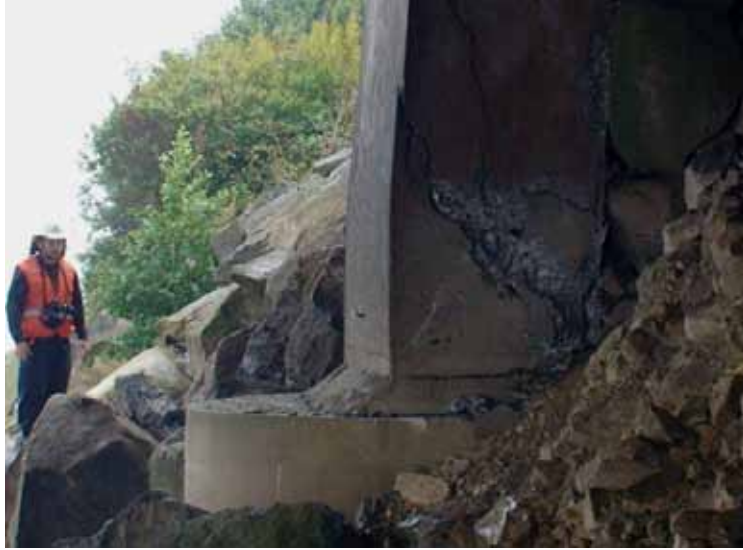
In addition, lateral spreading of the northeast bank pushed the columns of the bent toward the river. However, this movement was restrained by the superstructure, and the columns were consequently placed in single shear. One failed catastrophically (see figure 68 through figure 70), and the other was seriously damaged (see figure 71). The difference in behavior between the two columns might have been due to the uneven settlement and rotation of the bridge deck. The longitudinal movement of the first column was approximately 21.8 inches (559 mm) at the top of the shear plane and 15.8 inches (406 mm) at the bottom. Similar behavior was also observed in the Llacolen bridge, but the damage to the columns was not as severe.

**Figure 68. Photo. Shear failure in upstream column at northern end of Juan Pablo II bridge.**

**Figure 69. Photo. Front face of failure plane at northern end of Juan Pablo II bridge.**

**Figure 70. Photo. Back face of failure plane at northern end of Juan Pablo II bridge.**

**Figure 71. Photo. Shear failure in downstream column at northern end of Juan Pablo II bridge.**

The mainline Juan Pablo II Bridge abutment at the river bank suffered damage due to the lateral forces caused by liquefaction-induced slope instability. Figure 222 and figure 68 through figure 71 illustrate the damage that occurred. The damage to the column in figure 68 through figure 71 illustrates the severe bending stresses and lateral force to which the column was subjected when the northeast riverbank slope moved laterally due to loss of soil strength caused by liquefaction.

| Site No., Name, and Abutment/Pier Location | Estimated Abutment or Slope Height | Estimated Ground Geometry at Abutment/Pier Vicinity | Observed Abutment/Pier Deformation and Performance |
|---|---|---|---|
| 25. Juan Pablo II bridge, pier on slope below NE abutment | 6 to 7 m | Pier is located mid-slope; slope drops steeply to river (~ 30 degrees) (see figure 222 and figure 68 through figure 71) | Pier column on river bank slope moved laterally 0.3 m or more and column failed, but span did not collapse. Interior piers suffered severe differential settlement of up to 1 m. |

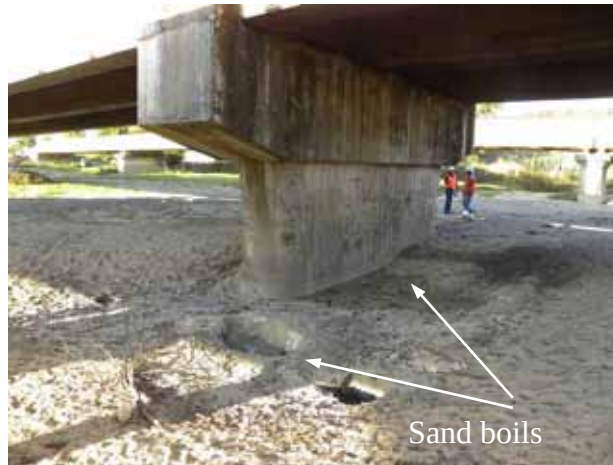
During the earthquake, the piers near the river settled due to liquefaction, causing vertical misalignment of the deck, as shown in figure 75. Sand boils appeared at the bottom of some piers, as shown in figure 76.

**Figure 76. Photo. Sand boils close to pier under east Ramadillas bridge.**

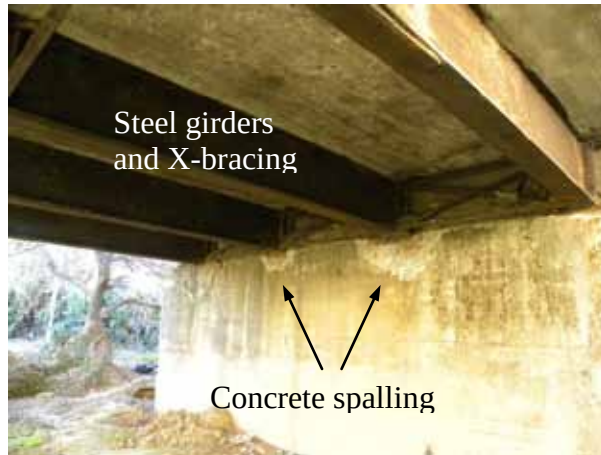
**Figure 78. Photo. Abutment damage beneath west Ramadillas bridge.**

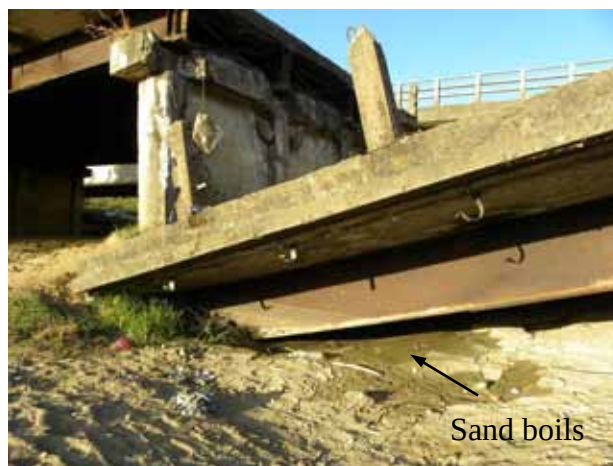
In addition to large inertial forces, significant settlement and lateral flow occurred due to liquefaction during the earthquake. As a consequence, one of the wall piers tilted significantly, and the adjacent span was unseated, as shown in figure 79 and figure 80.

**Figure 80. Photo. Sand boils near collapsed span in west Ramadillas bridge.**

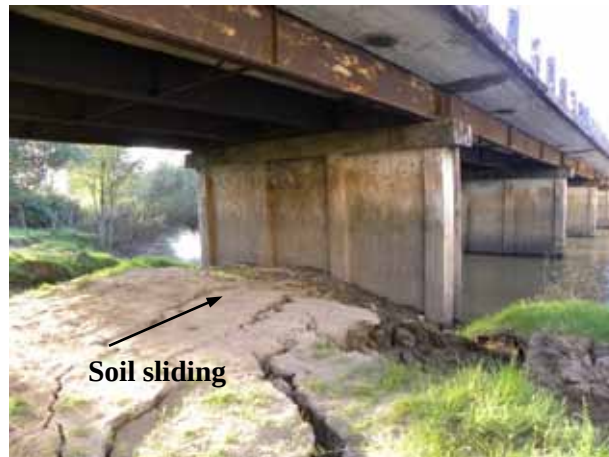
The largest settlements and lateral flows were observed in the river bank under the south abutments of both bridges. Figure 81 through figure 83 show the extent of these effects.

**Figure 82. Photo. Sliding at south abutment under west Ramadillas bridge.**

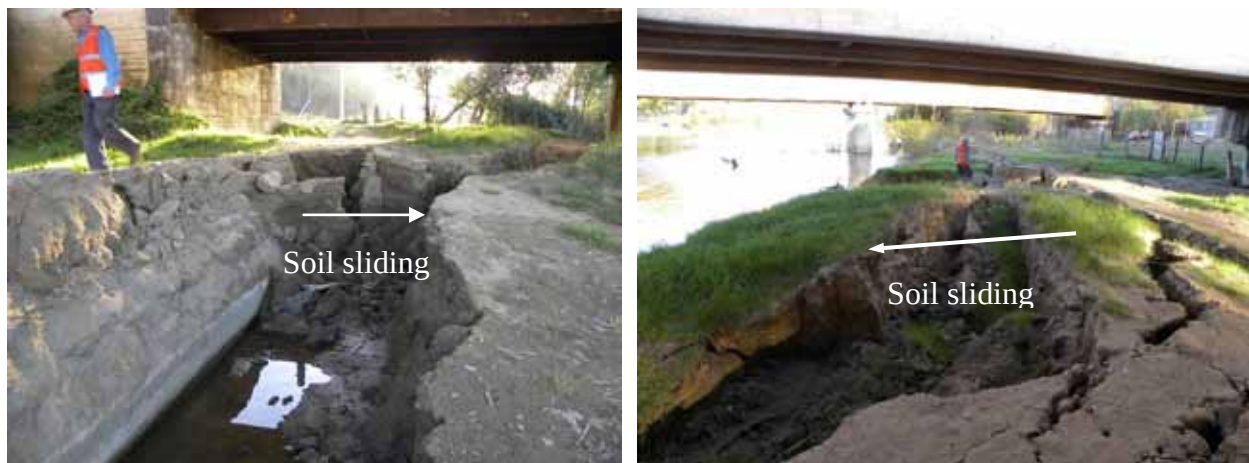
**Figure 83. Photo. Block flow toward river due to liquefaction on south bank of Ramadillas bridges.**

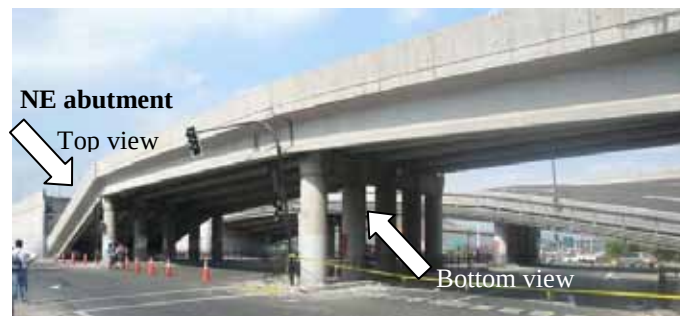
At the Miraflores bridge site, two parallel bridges collapsed, as shown in figure 84 through figure 88. These bridges for southwest-bound and northeast-bound traffic did not have end diaphragms and appear to have had an S-shaped superelevation. Each three-span precast prestressed girder bridge had five discontinuous girders and a continuous deck slab. The abutments and two intermediate piers were skewed to approximately 20 degrees. Each girder was supported on a neoprene pad and a concrete pedestal at both ends. The girders were restrained by a pair of steel stoppers with 0.4- and 2-inch (10- and 50-mm) gaps for vertical and horizontal motions. Details of the steel stoppers are shown in figure 26.

**Figure 84. Photo. Northeast end of Miraflores bridge.**

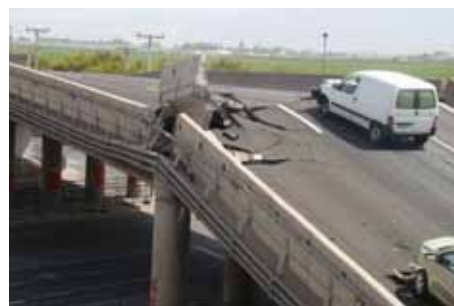
**Figure 86. Photo. Top view of Miraflores bridge from far side**

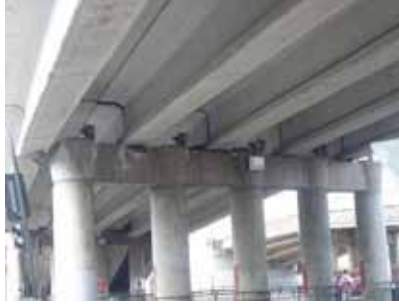
**Figure 87. Photo. Bottom view of Miraflores bridge from near side.**

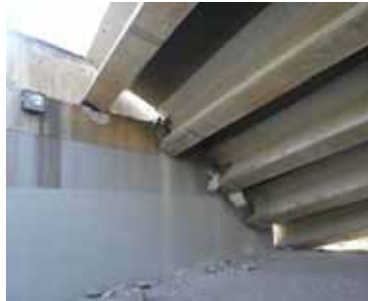
**Figure 88. Photo. Collapsed span of Miraflores bridge.**

During the earthquake, one end span of each bridge fell from its seat-type abutment support. The other end span of one bridge was partially unseated. After the spans were removed, it was clear that the entire bridge superstructure rotated clockwise in plan as the acute corner of the bridge moved away from its supporting abutment (see figure 89 through figure 91). As a result, the curtain walls on all abutments suffered damage in the acute corners. The steel stoppers experienced little bending deformation, but their anchor bolts were either substantially deformed or sheared off.

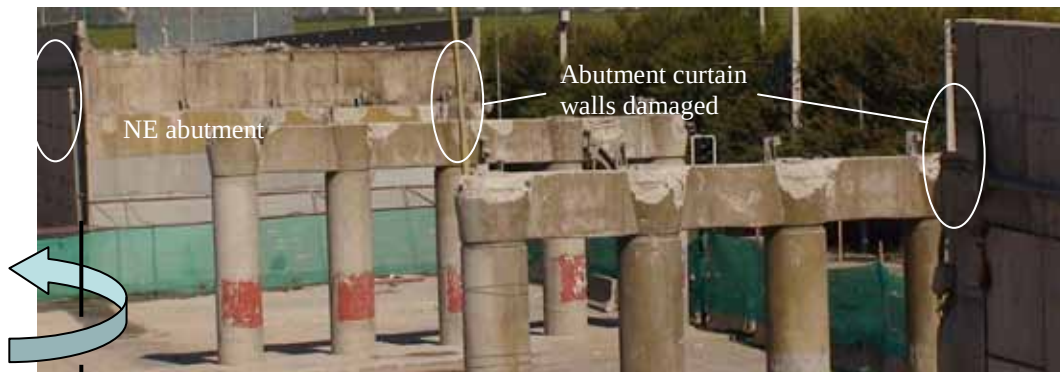
**Figure 89. Photo. Miraflores bridge after removal of superstructure.**

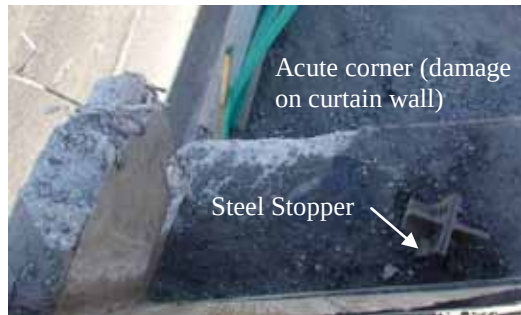
**Figure 90. Photo. Acute corner of southwest abutment of Miraflores bridge.**

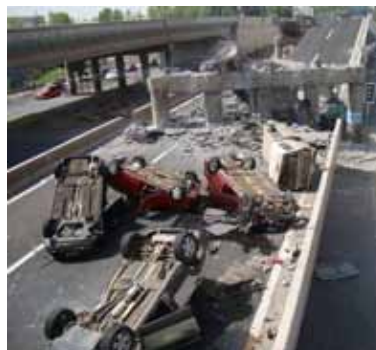
At the Lo Echevers bridge site, two parallel bridges had spans of 91.3, 119.1, and 91.3 ft (27.84, 36.32, and 27.84 m). As shown in figure 92 and figure 93, the southwest-bound bridge suffered minor damage while the northeast-bound bridge collapsed. The bridges did not have end diaphragms and appeared to have had an S-shaped superelevation. Each three-span precast prestressed girder bridge had five discontinuous girders and a continuous deck slab. The abutments and two intermediate piers were skewed approximately 33 degrees. Each girder was supported on a neoprene pad and a concrete pedestal at both ends. The girders were restrained by a pair of steel stoppers with 0.4- and 2-inch (10- and 50-mm) gaps for vertical and horizontal motions. Details of the steel stoppers are shown in figure 26.

**Figure 92. Photo. Collapsed northeast-bound Lo Echevers bridge.**

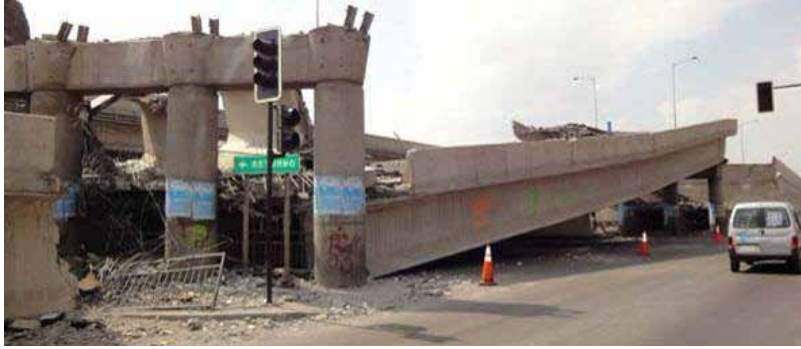
**Figure 93. Photo. Three unseated spans of northeast-bound Lo Echevers bridge.**

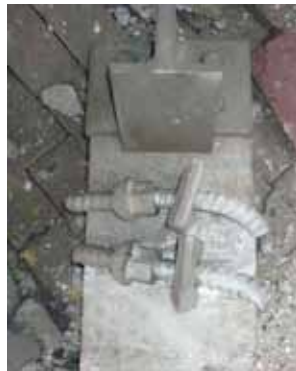
During the earthquake, the bridge superstructure rotated clockwise in plan as the acute corners of the bridge moved away from their supporting abutments. Some of the anchor bolts fractured, as shown in figure 94, and the elastomeric bearings seemed to have been displaced during the earthquake, as shown in figure 95. These bearings showed significant lateral bulging and may have been overstressed under gravity loads.

**Figure 94. Photo. Failure of a steel stopper on Lo Echevers bridge.**

Steel stoppers used in several bridges (e.g., Independencia, Miraflores, and Lo Echevers bridges) failed prematurely. The Independencia bridge with steel stoppers was taken out of service following the earthquake, but the parallel bridge with concrete shear keys and diaphragms survived the earthquake with repairable damage. It was concluded that the two-bolt connections from each steel stopper to the cap beam was too weak to resist any significant bending moment. However, once welded to steel girders, the steel stoppers prevented lateral movement of girders, as observed in the Quilicura railway bridge shown in figure 112.

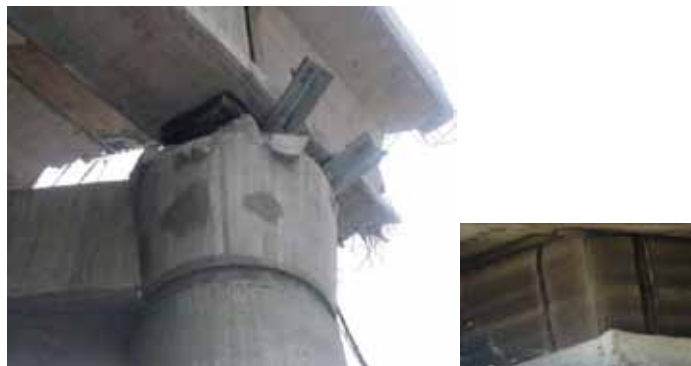
**Figure 95. Photo. Displaced elastomeric bearing on Lo Echevers bridge.**

In general, bridge bearings functioned well during the earthquake. Several of them were displaced significantly, such as in the Lo Echevers bridge shown in figure 95 and in the Cardenal Raúl Silva Henríquez bridge shown in figure 125.

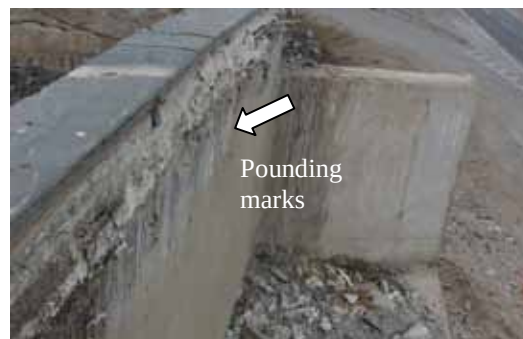
**Figure 100. Photo. Pounding at west abutment of Romero bridge.**

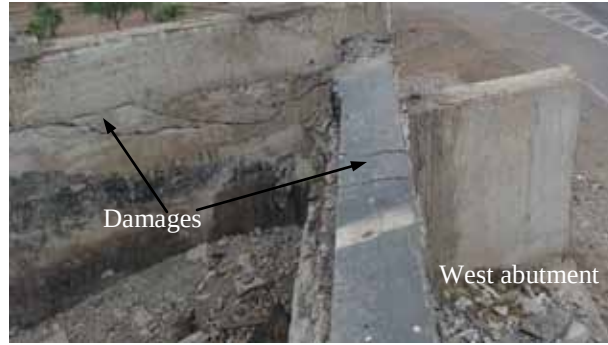
**Figure 101. Photo. Back wall and wing wall damage at west abutment of Romero bridge.**

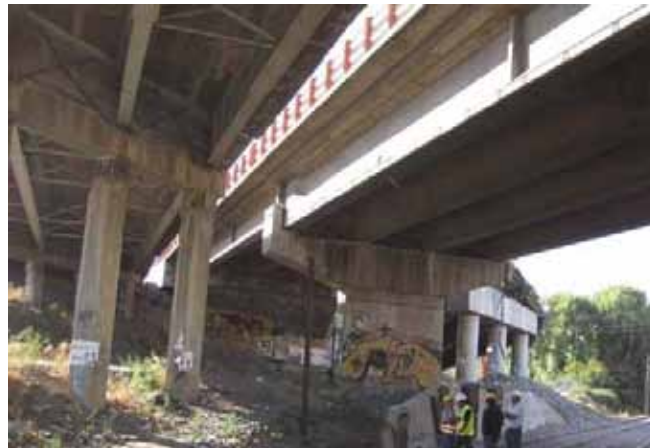
The Route 5 railway overcrossing at Hospital comprised three parallel bridges over two railway tracks and a local road. The bridges were oriented northwest-southeast. One bridge had a steel plate girder superstructure, and the other two had precast prestressed girders. The two concrete bridges carried northbound and southbound traffic on Route 5. During the earthquake, the southbound bridge collapsed, as shown in figure 102 and figure 103.

**Figure 102. Photo. Three bridges (one demolished) at Route 5 overcrossing at Hospital.**

As shown in figure 102, plastic hinges appear to have developed at the top of the columns of the steel plate girder bridge with cross frames and shear keys. The fact that hinges formed at the top of the columns implies that strong shaking occurred transversely (i.e., in the direction of the skew). This is one of the few bridges for which column damage was observed, but field data is minimal because the bridge was demolished for safety reasons soon after the main shock. The only bridge to remain standing at this site after the earthquake had diaphragms but no skew.

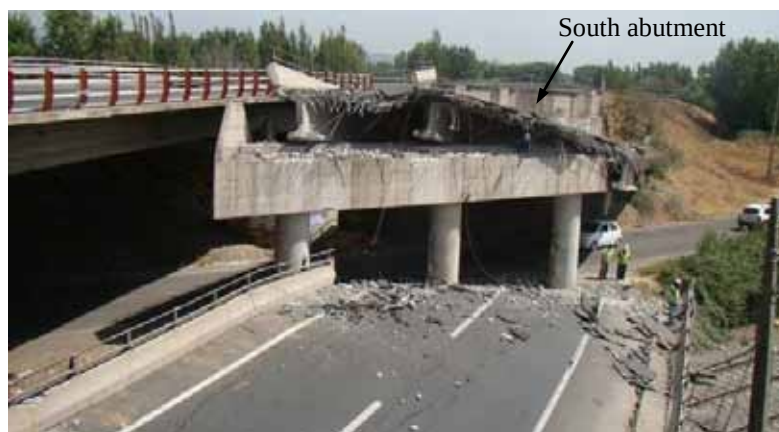
**Figure 103. Photo. Collapse of bridge at Route 5 overcrossing at Hospital.**

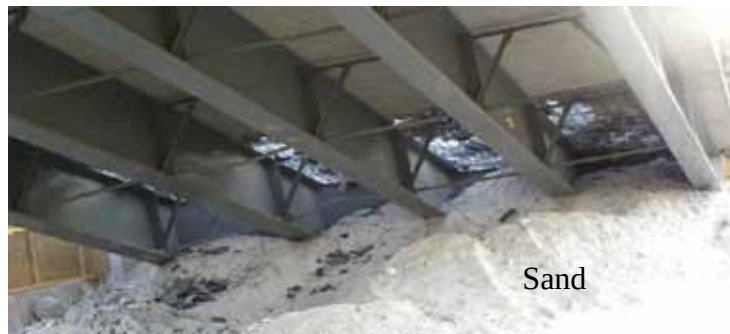
**Figure 111. Photo. West span of Quilicura railway overcrossing lowered onto sandbank.**

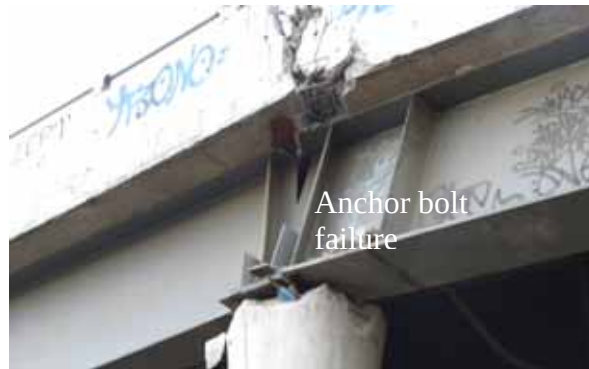
Due to the transverse displacement and rotation of the superstructure, the curtain walls at the acute corners of the bridge sustained pounding damage. In addition, the lateral forces on the superstructure damaged the girder anchor bolts and buckled some cross frames, as shown in figure 112 and figure 113.

**Figure 112. Photo. Damage to anchor bolts on Quilicura railway overcrossing.**

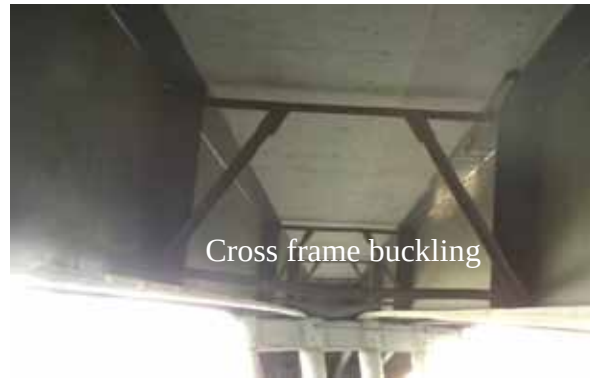
**Figure 113. Photo. Damage to cross frame on Quilicura railway overcrossing.**

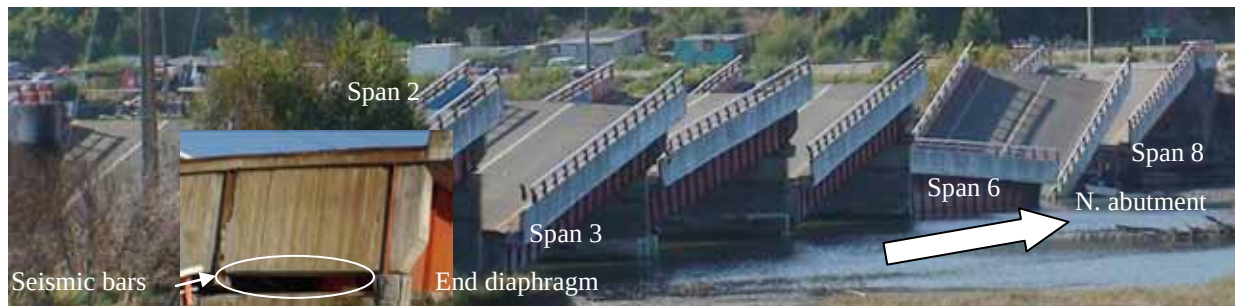
The Tubul bridge is an eight-span simply supported steel girder bridge oriented north-south with a span length of approximately 92 ft (28 m). Each span consists of three steel girders with concrete end diaphragms, as shown in figure 114. Shown in the inset of figure 114 are four seismic bars between the end diaphragm and the wall pier. The bridge is most likely supported on pile foundations. All the spans were unseated at their south end, resulting in the northern-most span punching into the north abutment and in the buckling of nearby pavement, as shown in figure 115 and figure 116. With the exception of span 6, all the spans were in general alignment in the north-south direction.

**Figure 114. Photo. Unseating at southern ends of each span of Tubul bridge.**

Local damage to the various piers and spans was inspected by boat. As shown in figure 114, span 6 lost support at its north end. Local residents confirmed that this span was like the others immediately after the main shock, but the north end collapsed during an aftershock during the first week, probably due to rigid body rotation of the wall pier. This difference in span 6 may be attributable to the fact that the span rotated from the north to the northeast, creating load concentration on the north support. Figure 117 shows watermarks on one of the wall piers. The concrete below the high watermark showed signs of deterioration, probably due to wet and dry cycles, particularly in the mid-height of the wet area at the average watermark.

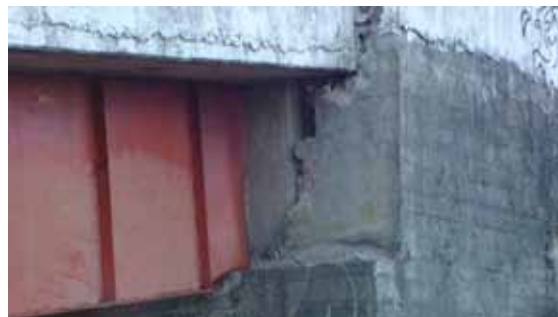
**Figure 115. Photo. Punching of Tubul bridge deck into back wall**

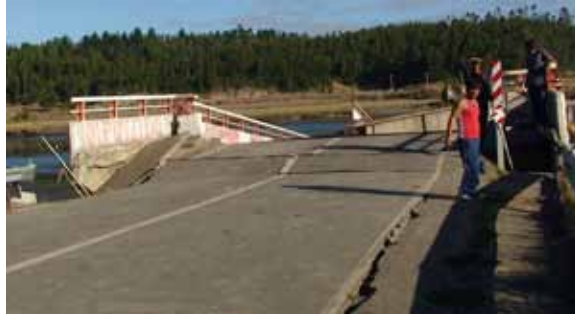
**Figure 116. Photo. Buckling of pavement at north abutment of Tubul bridge.**

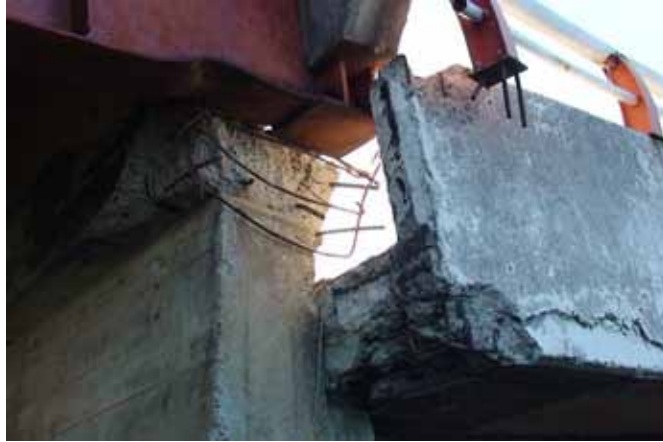
In general, the bottom flange of the girders buckled, as shown in figure 115 and figure 118, and the tops of the wall piers were damaged locally, as shown in figure 118 and figure 119. All of the piers were tilted toward the north abutment and were significantly damaged either by flexural effects at the top of the footing due to the maximum moment as the bridge deck pushed against the wall during the earthquake or by shear effects around the average watermark where the concrete was severely deteriorated (see figure 119 and figure 120). Concrete spalling associated with both a shear crack and a vertical crack on the wall pier are shown in figure 121. The pile cap holding the dropped span was cracked, as shown in figure 122, probably due to the impact of the falling span.

**Figure 118. Photo. Bottom flange buckling and concrete spalling on Tubul bridge.**

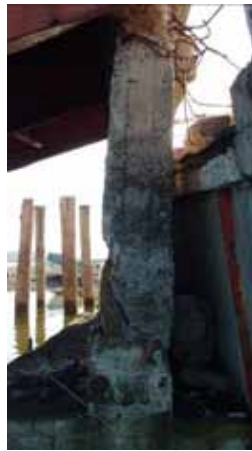
**Figure 119. Photo. Shear crack in Tubul bridge.**

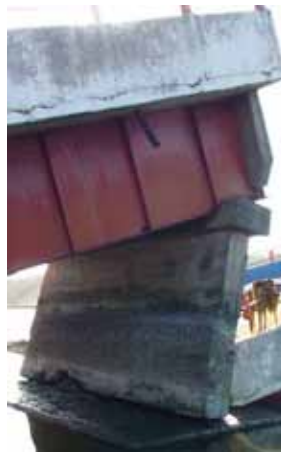
**Figure 120. Photo. Tilting wall pier on Tubul bridge.**

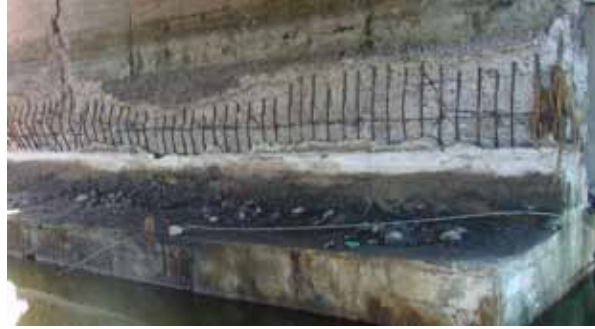
**Figure 121. Photo. Spalling due to shear action and vertical crack in Tubul bridge.**

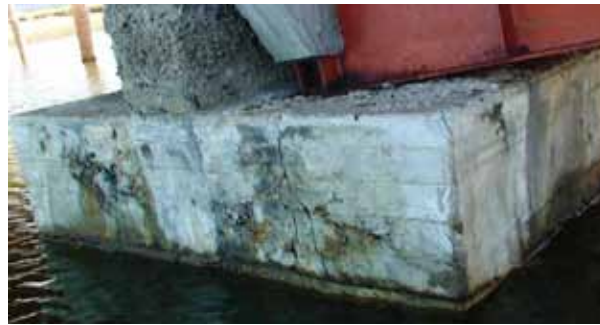
**Figure 122. Photo. Crack in footing of Tubul bridge.**

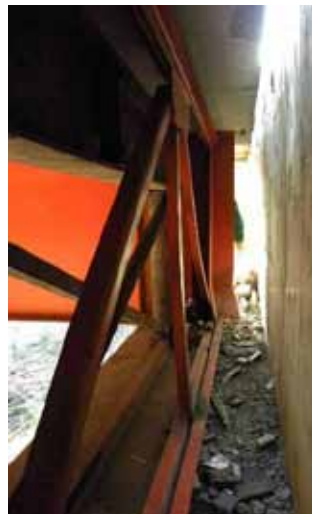
**Figure 126. Photo. Cross frame buckling on Cardenal Raúl Silva Henríquez bridge.**

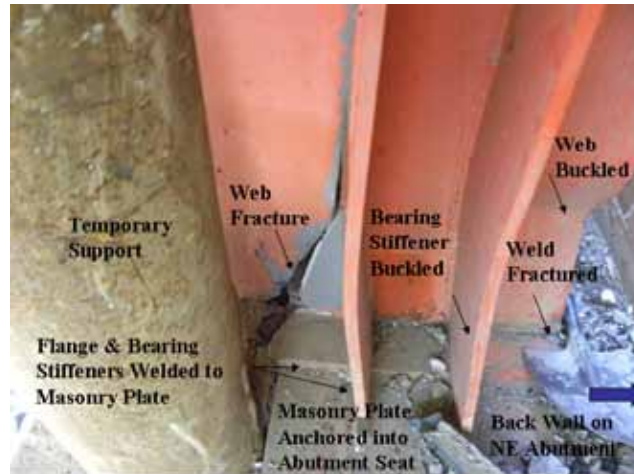
**Figure 127. Photo. Girder damage at northeast abutment of Cardenal Raúl Silva Henríquez bridge.**

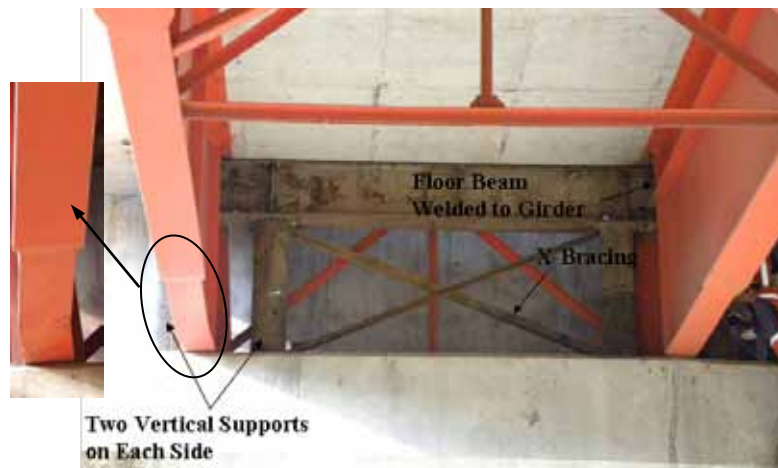
**Figure 128. Photo. Temporary repair at northeast abutment of Cardenal Raúl Silva Henríquez bridge**

To maintain traffic on the bridge, a temporary cross frame was installed at the northeast abutment, as shown in figure 128. Due to severe damage in the girder webs and flanges, a steel beam was used to transfer loads from the girder flanges to the abutment seat, bypassing the webs.

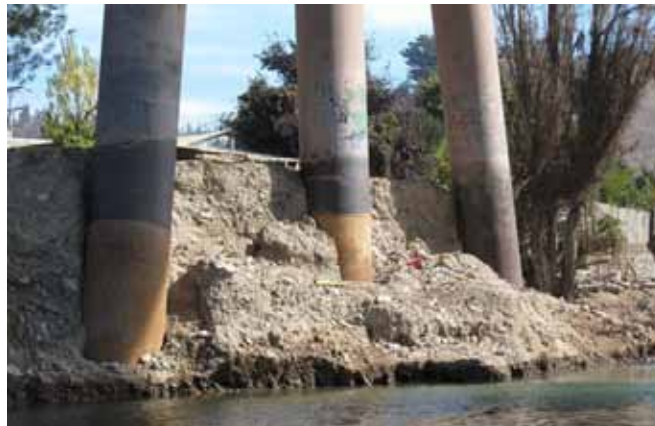
As previously noted, nine spans of the southwest portion of the bridge are supported on tall steel pile bents, as shown in figure 129. The legs of these bents are fabricated from 4.9-ft (1.5-m)-diameter tubes with a wall thickness of 0.55 inches (14 mm). Their overall heights from pile tip to soffit range from 146 to 169 ft (44.5 to 51.5 m). The maximum clear height above water is about 82 ft (25 m). This portion of the structure appeared to have performed well during the earthquake but suffered local damage at several locations due to tsunamis. Four major waves were recorded nearby, with arrival times ranging from 4 to 5.5 h after the earthquake. Wave heights ranged from 22.6 to 36.7 ft (6.9 to 11.2 m), passing under the superstructure. Nevertheless, the waves eroded river sands and gravels from around the piles to a depth of about 15 ft (4.5 m), and waveborne debris punctured a hole in the wall of one of the legs of one of the bents (see figure 130 and figure 131).

**Figure 130. Photo. Erosion of alluvial material around bent legs of Cardenal Raúl Silva Henríquez bridge.**

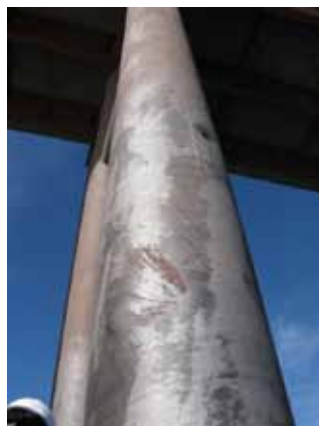
**Figure 131. Photo. Debris-impact hole in bent leg of Cardenal Raúl Silva Henríquez bridge.**

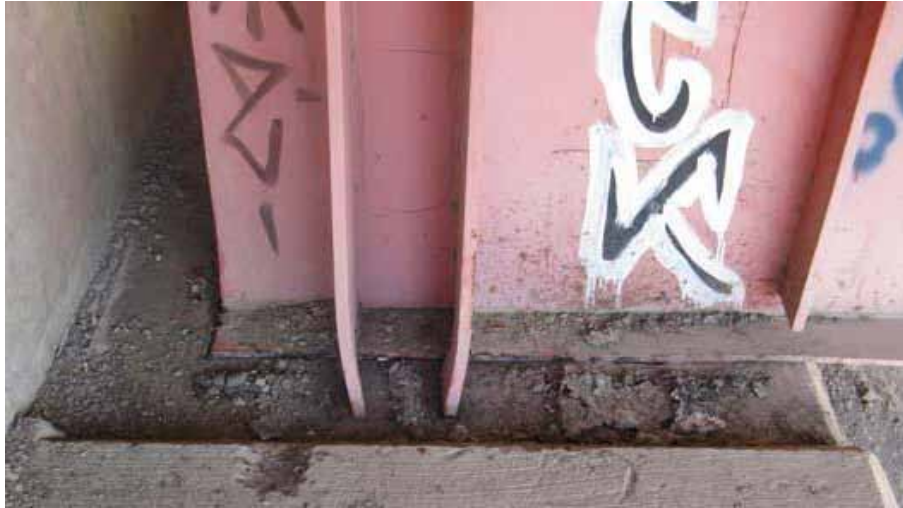
Although the details are similar, the damage to the girders at the southwest abutment was not as severe as at the northeast abutment and was limited to the buckling of the bearing stiffeners. The reason for this difference is probably that the fillet welds connecting the girder flanges and bearing stiffeners to the masonry plates failed during the earthquake and large longitudinal loads were not attracted to this abutment (see figure 132 through figure 134).

**Figure 132. Photo. Fillet weld fractures at the girder-to-abutment connection on the Cardenal Raúl Silva Henríquez bridge.**

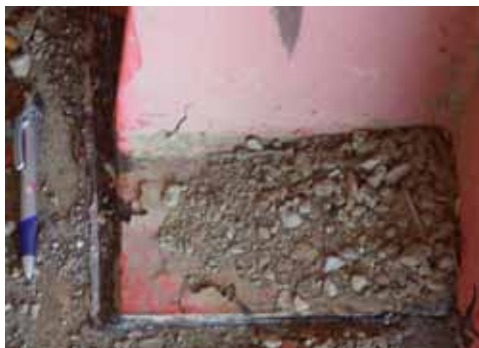
**Figure 133. Photo. Close-up of girder end on Cardenal Raúl Silva Henríquez bridge.**

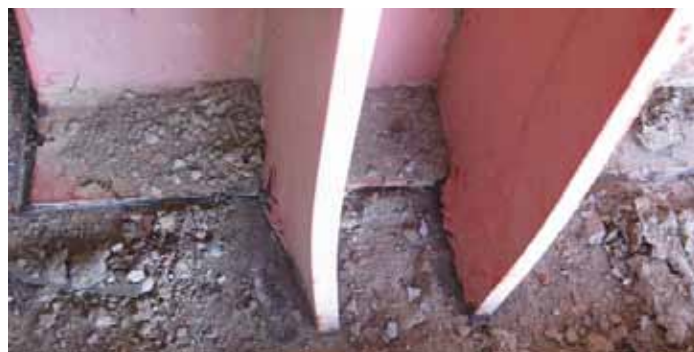
**Figure 134. Photo. Close-up of transverse stiffeners on Cardenal Raúl Silva Henríquez bridge.**
