# Postearthquake Reconnaissance Report on Transportation Infrastructure Impact of the February 27, 2010, Offshore Maule Earthquake in Chile

PUBLICATION NO. FHWA-HRT-11-030

OCTOBER 2011

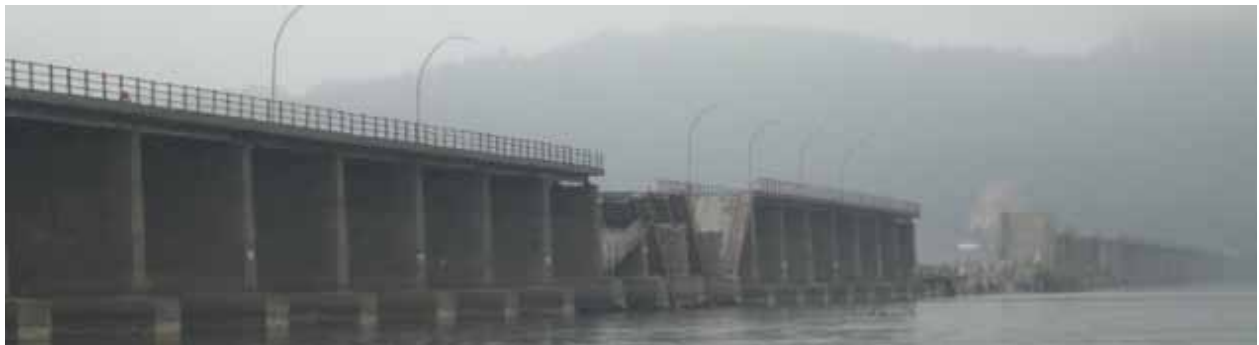
The historic multispan bridge over the Biobío River is oriented approximately east-west. As seen in figure 135 and figure 136, the bridge superstructure consists of multiple simply supported spans with four steel girders and a concrete deck. Intermediate and end X-braced cross frames were provided in each span. Each end of a steel girder was restrained by two anchor bolts through the bottom flange, one on either side of the web. As shown in figure 137, lateral spreading due to liquefaction was observed near the north end of the bridge approaches. Many spans moved longitudinally and fell from their seats after shear failure of the anchor bolts. Some piers also collapsed in the longitudinal direction, as shown in figure 138, possibly due to liquefaction-induced vertical settlement in combination with longitudinal seismic forces. These movements may have caused the multiple cracks visible in the pile caps (see figure 139).

**Figure 135. Photo. Collapsed spans in Biobío River bridge.**

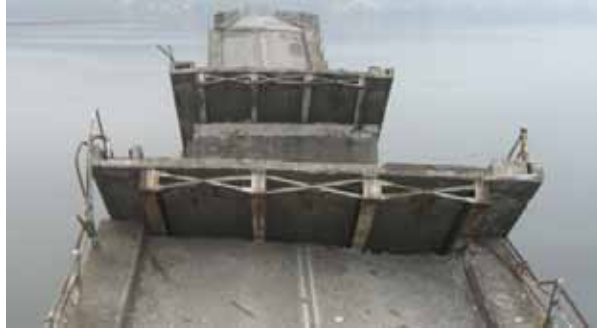
**Figure 136. Photo. Unseated spans in Biobío River bridge.**

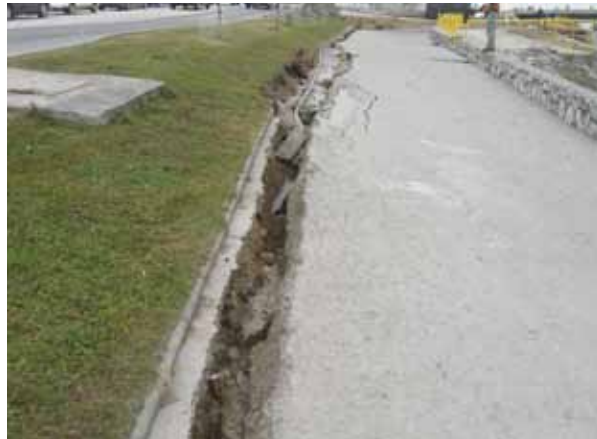
**Figure 137. Photo. Lateral spreading near east end of Biobío River bridge.**

**5.2.2.3.6 Old Biobío River Bridge (Site 26):** The old Biobío River bridge was built in the 1920s, replaced in 1943, and no longer in service at the time of the earthquake. Spans and some of its substructure units collapsed in the earthquake, probably due to a combination of inadequate structural resistance and shallow foundations (see figure 138, figure 223, and figure 224). Various types of deep foundations were used in various sections of the bridge. It appeared that pile foundations were used for the northeast half of the bridge, although it was not clear if all the original timber pile foundations used to support the 1920s structure were replaced with steel pipe piles in the 1943 replacement structure. Therefore, the northeast portion of the bridge could be supported by both timber and steel pipe piles. Based on input from a Chilean consultant, the piers near the southwest end of the bridge appeared to be supported by twin shaft foundations or twin hand-dug oval caissons (33 to 39 ft (10 to 12 m) deep, although it is possible that the foundations were tipped in relatively dense soils). Scour problems and deep liquefaction or soft soils that allowed more foundation movement during shaking may have contributed to the weakening and collapse of the structure, though the specific role of liquefaction in this collapse cannot be confirmed until more subsurface data becomes available. However, ground failure and lateral soil movement were observed at the bridge abutment for this structure on the northeast bank of the Biobío River, and the abutment pier wall appeared to be tilted toward the river (see figure 137, figure 225, and figure 226).

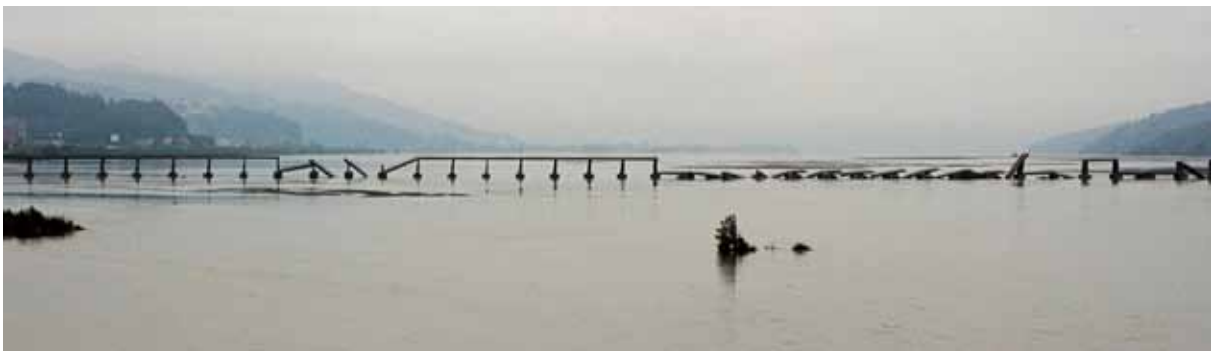
**Figure 138. Photo. Collapsed spans and piers of Biobío River bridge.**

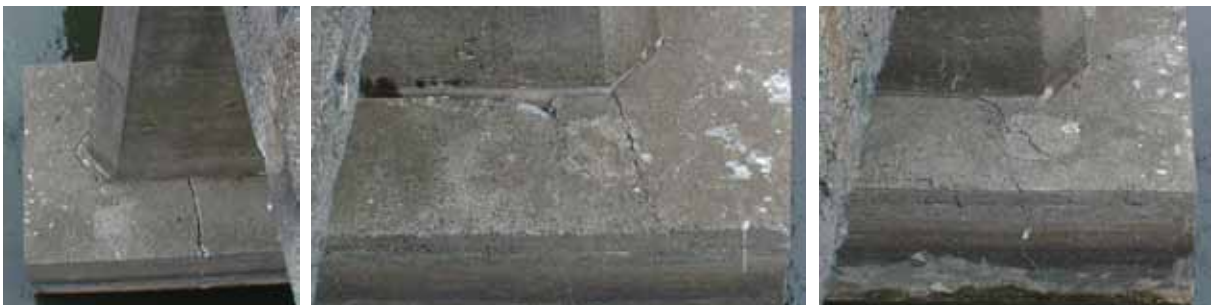
**Figure 139. Photo. Cracks in pile caps of Biobío River bridge.**

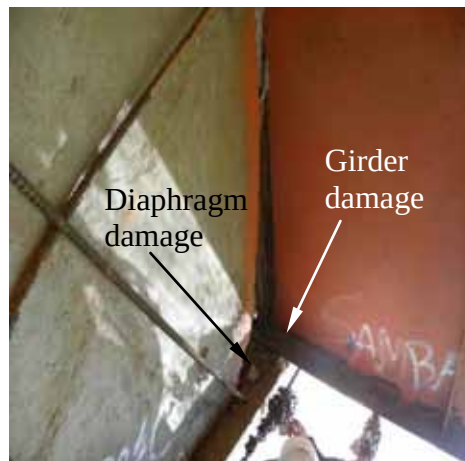
At the same location, damage was also found in the concrete diaphragm and bracing system, with tension rupture in one bar and compression buckling in the other one (see figure 145 and figure 146).

**Figure 146. Photo. Diaphragm crushing in south abutment of Pichibudis bridge.**

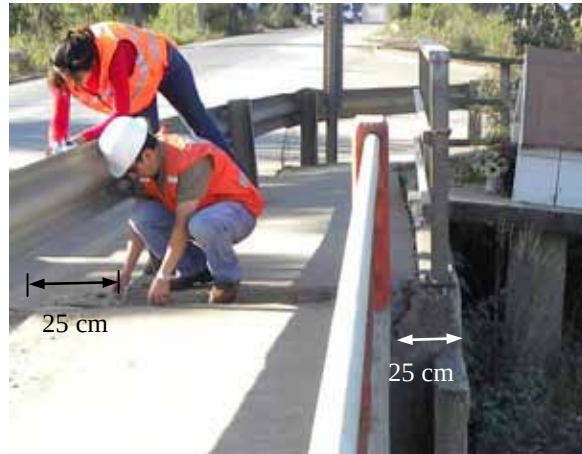
Earthquake damage at the south abutment included a lateral permanent deformation of 9.8 inches (250 mm), girders dislodged from their neoprene pads, and damage to the concrete back wall (see figure 152 and figure 153). When the bridge was retrofitted after the 2006 floods, a rebar X-brace system and a new concrete diaphragm were added at the north abutment. The diaphragm was

**Figure 152. Photo. Lateral deformation at south abutment of El Bar bridge.**

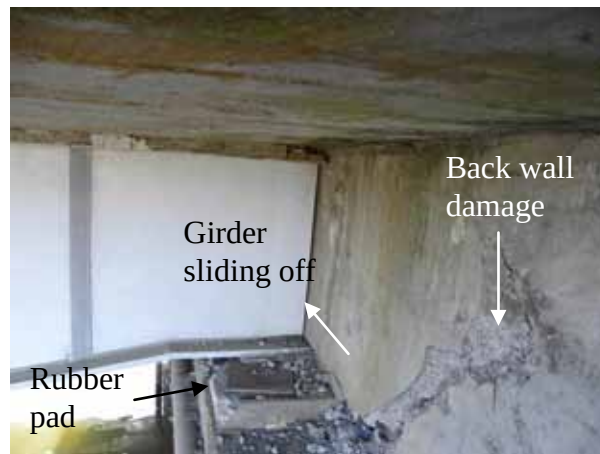
**Figure 153. Photo. Damage at south abutment of El Bar bridge.**

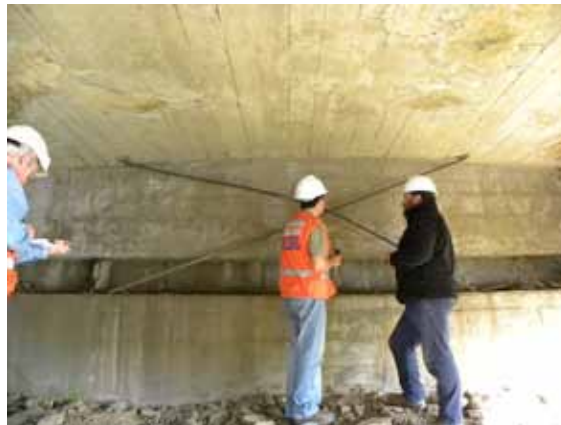
anchored to the abutment seat using vertical restraining bars (seismic bars). Earthquake damage observed at this support included large deformations in the rebar of the X-brace system (tension yielding and compression buckling), lateral deformation of the seismic restrainers, and concrete crushing of the original abutment back wall (see figure 154 and figure 155).

**Figure 154. Photo. Damage to rebar X-brace system on north abutment of El Bar bridge.**

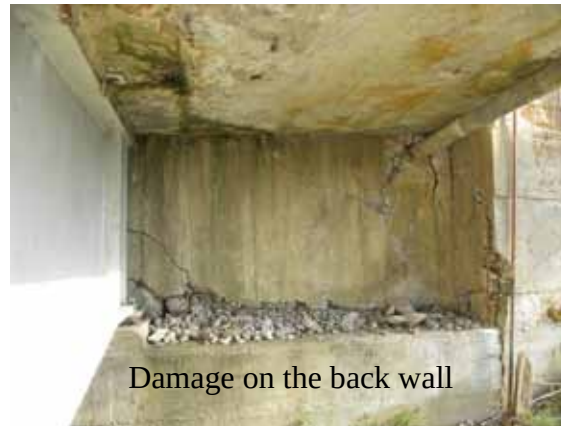
**Figure 155. Photo. Damage to north abutment back wall of El Bar bridge.**

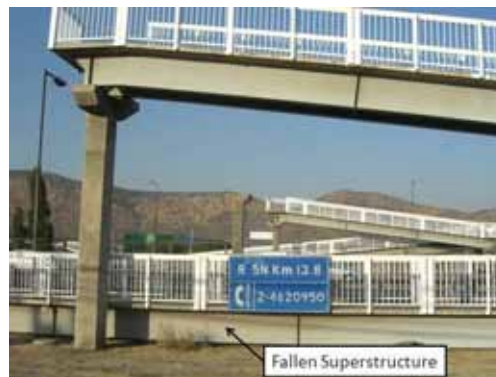
Several pedestrian bridges over Route 5 collapsed during the earthquake. All appeared to have similar details and to have failed in a similar manner. The collapse of the pedestrian bridge at KM 13.8 of Route 5 North is described in this section. The bridge consisted of two approach ramps on each side of the highway and a two-span overpass oriented approximately east-west. As shown in figure 160, the two spans fell from their supports during the earthquake and were subsequently moved to the sides of the highway. Each 70.1-ft (21.4-m)-long span consisted of a concrete deck supported by two steel plate girders and four uniformly spaced cross frames. The end of each girder rested on a neoprene pad, as shown in figure 161. Each cross frame was composed of X-bracing, a top chord, and a bottom chord, as shown in figure 162. The main span was anchored at each end to a hammerhead pier by two 1-inch (25-mm)-diameter bolts through the flange of the bottom chord. Failure occurred when the anchor bolts pulled out of the bottom chord and there was insufficient seat width to prevent the girders from collapsing (see figure 163).

**Figure 160. Photo. Damaged Route 5 pedestrian bridge.**

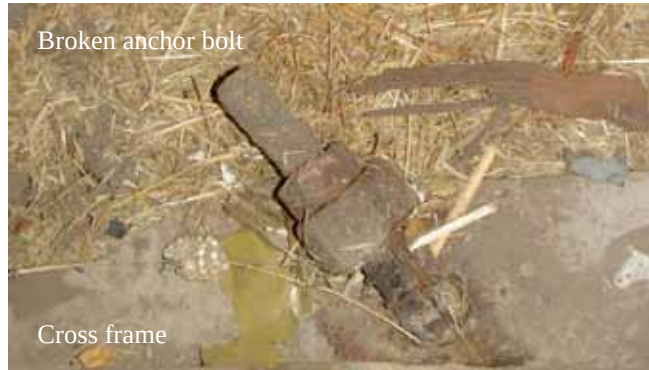
**Figure 163. Photo. Anchor bolt failure (shear and pull out) on Route 5 pedestrian bridge.**

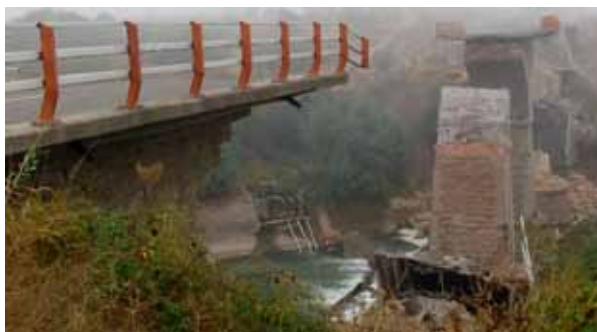
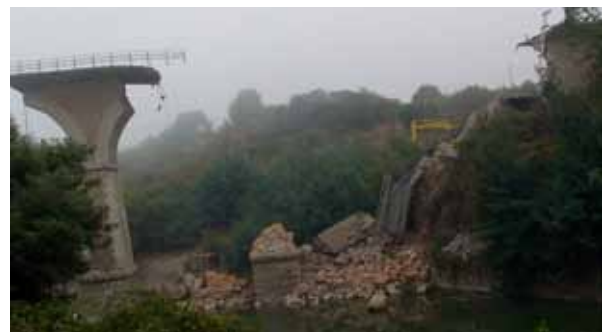
The masonry bridge consisted of a set of seven back-to-back arches oriented approximately northeast-southwest. Two piers survived the earthquake, and all foundations appeared to be intact, as shown in figure 165 and figure 166.

**Figure 166. Photo. Close-up view of collapsed bridge at Claro River.**

As shown in figure 166, the collapsed spans and other debris, including arches and piers, fell directly into the river below the bridge and were not thrown sideways, upstream, or downstream. Therefore, one scenario is that the collapse was caused by the failure of a pier with deteriorated masonry during strong shaking along the axis of the bridge. Another scenario is that the elevation difference between the end support of the arch bridge and its nearby pier caused stress concentration in two end spans along the axis of the bridge, resulting in cracks in the ribs and falling of various pieces. The collapse of two end spans reduced the inward thrust of each intermediate arch span and triggered progressive collapse. Since no deterioration of the masonry was observed in the rubble in the river bed, the second scenario is most likely.

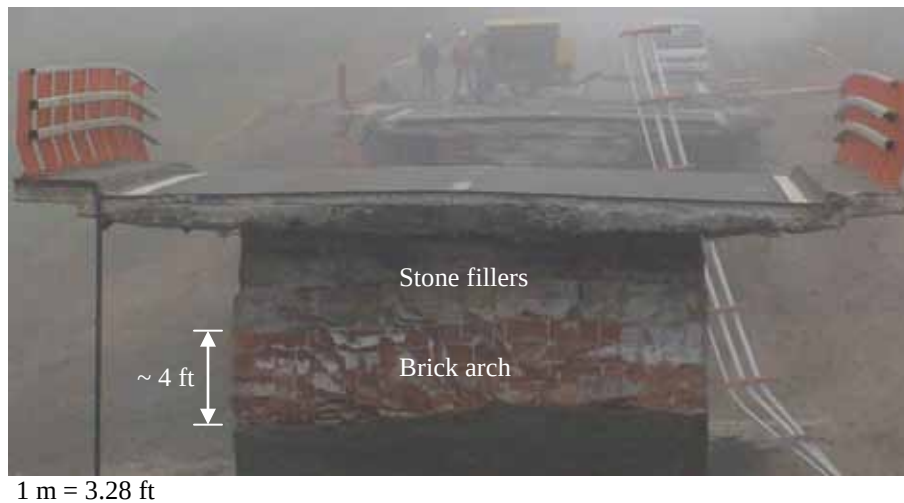
Figure 167 through figure 169 show details of various components of the bridge. The deck slab was approximately 8 to 10 inches (203 to 254 mm) thick, and the arch crown was approximately 4 ft (1.2 m) thick. The ribs and piers were constructed from solid brick with some stone fill above the brick ribs, as shown in figure 167 and figure 168, and faced with stone blocks or plastered with cement to give the appearance of stonework. Close inspection of the piers found some cracks between the bricks and stone facades, possibly due to shaking, but, in general, the masonry was in excellent condition. The foundations of the bridge were most likely made of stone blocks and seemed to have experienced little or no damage during the earthquake (see figure 169).

**Figure 167. Photo. Deck slab and crown of arch on Claro River bridge.**

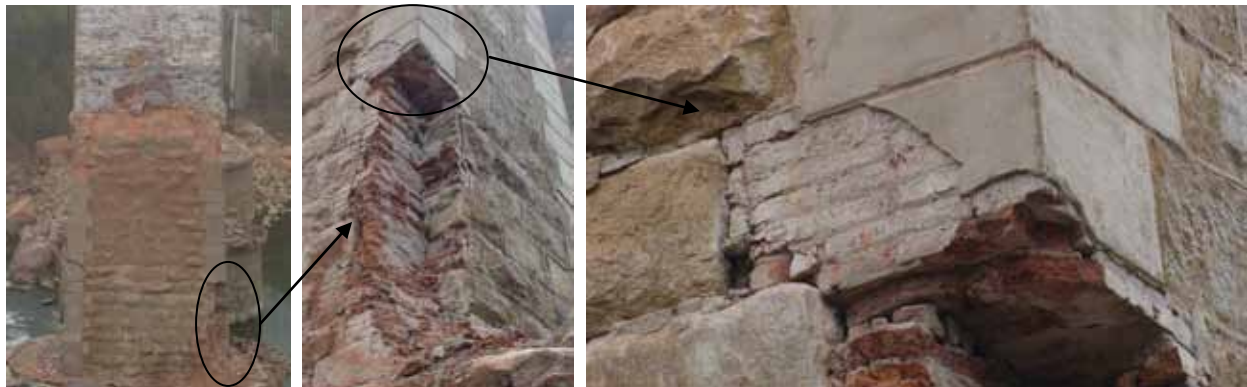
**Figure 168. Photo. Pier of Claro River bridge.**

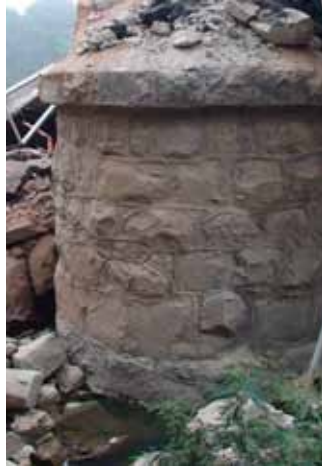
**Figure 169. Photo. Foundation of Claro River bridge.**

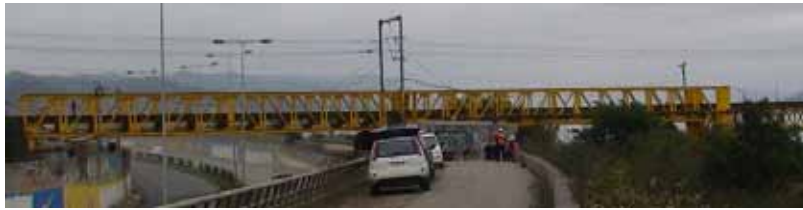
**Figure 171. Photo. North end of Chepe railroad bridge over roadway.**

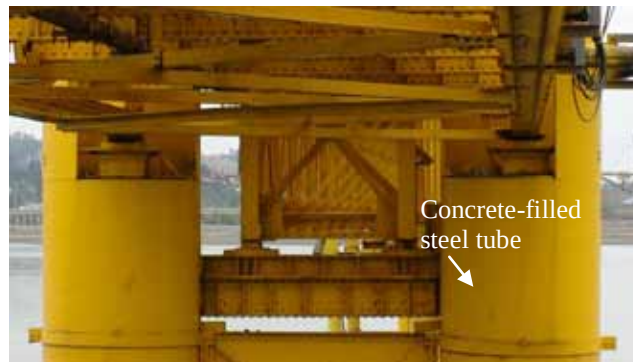
**Figure 174. Photo. Bottom view and cross section on north end of Chepe railroad bridge.**

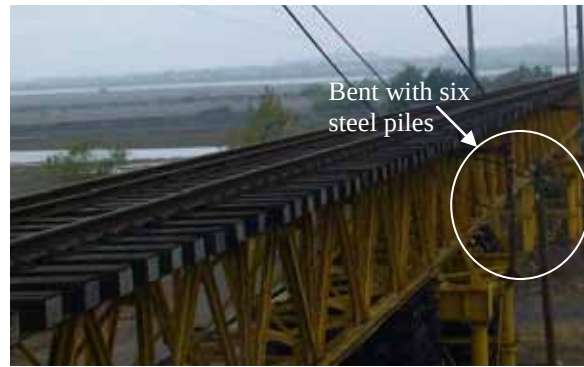
**Figure 175. Photo. Section on south end of Chepe railroad bridge.**

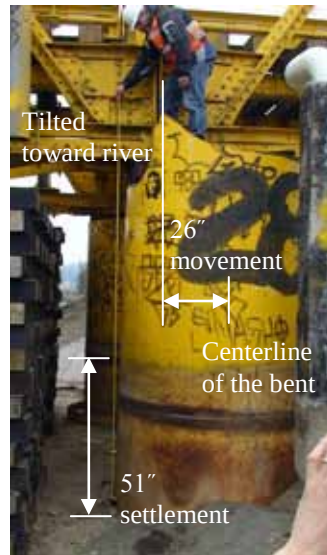
**Figure 177. Photo. Settlement and tilting of bent on Chepe railroad bridge.**

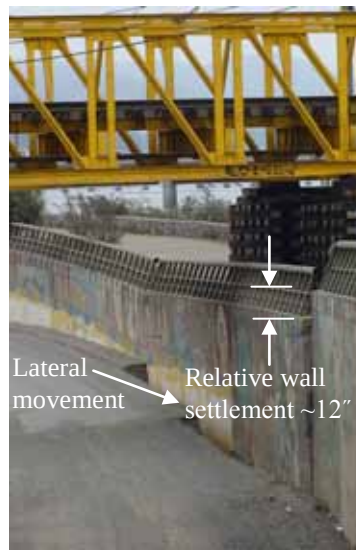
**Figure 178. Photo. Settlement behind retaining wall on Chepe railroad bridge.**

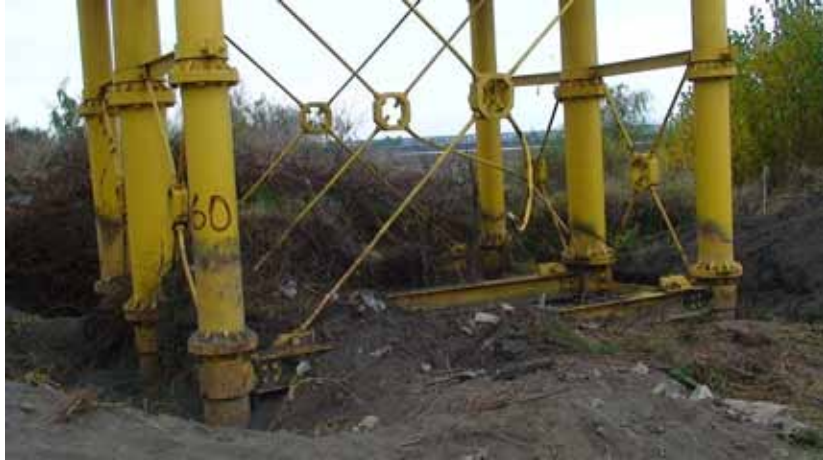
At the south end of the bridge, several bracing rods were broken, and at least two steel piles were fractured, possibly due to ground spreading, as shown in figure 179 and figure 180. A temporary support comprising a stack of timber ties had been erected near the damaged bent, as shown in figure 173.

**Figure 179. Photo. Ruptured cross bracing at south end of Chepe railroad bridge.**

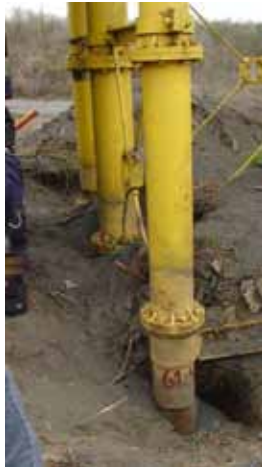
**Figure 180. Photo. Fractured steel piles at south end of Chepe railroad bridge.**

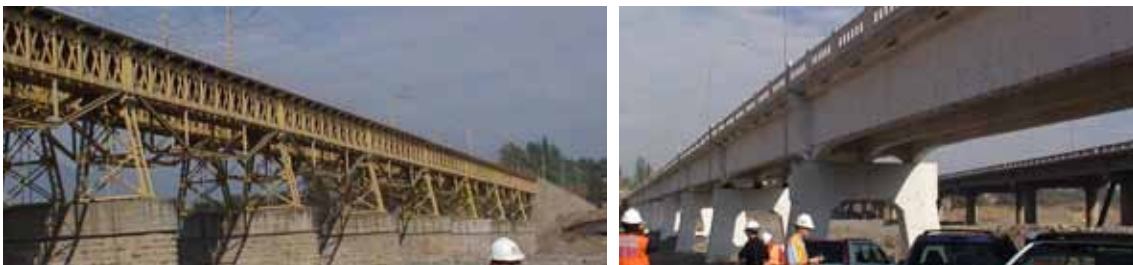
**Figure 181. Photo. Three parallel bridges crossing Maipú River south of Santiago.**

The railway bridge seemed to be undamaged by the earthquake. Likewise, the Route 5 bridge sustained only minor damage despite being built in 1970. However, the Route 5 bridge is susceptible to scour, and the foundations were being retrofitted at the time of the reconnaissance visit. The local access road bridge was severely damaged in the earthquake.

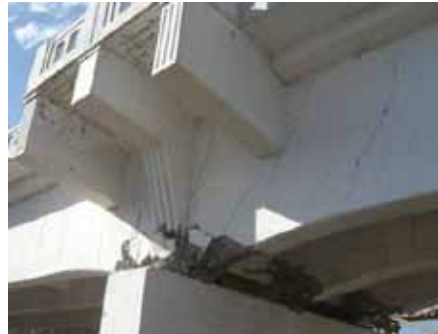
**Figure 182. Photo. Crushing of haunches at pier 3 of Maipú River bridge.**

During the earthquake, the haunches of three girders over pier 3 were severely crushed, as shown in figure 182. Some concrete diaphragms, such as those at piers 2 and 3, were also cracked significantly, as shown in figure 184. After the earthquake, two temporary frames were installed underneath span 1, and lightweight traffic was permitted on the bridge. Most likely, the crushing of the girder haunches was mainly due to a combined effect of seismic-induced longitudinal shear force and vertical load, as shown in figure 184.

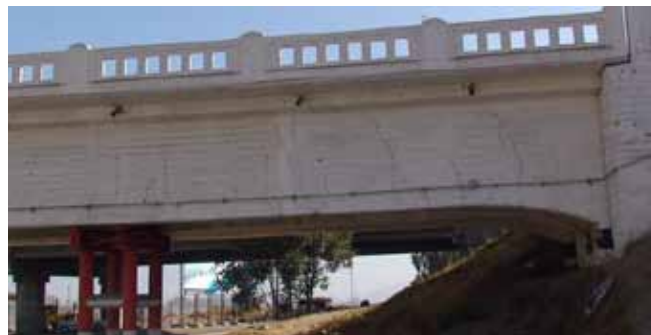
Oriented approximately north-south, the bridge was used to carry trucks loaded with gravel dredged from the river. Field observations indicated the existence of shear cracks near the ends of many of the girders, probably caused by heavy truck loading (see figure 182 and figure 183). Some of these cracks appeared to have been repaired prior to the earthquake.

**Figure 183. Photo. Shear cracks at span 1 of Maipú River bridge.**

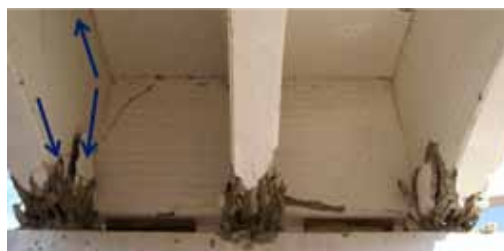
**Figure 184. Photo. Longitudinal and vertical seismic forces in haunches at pier 3 of Maipú River bridge.**

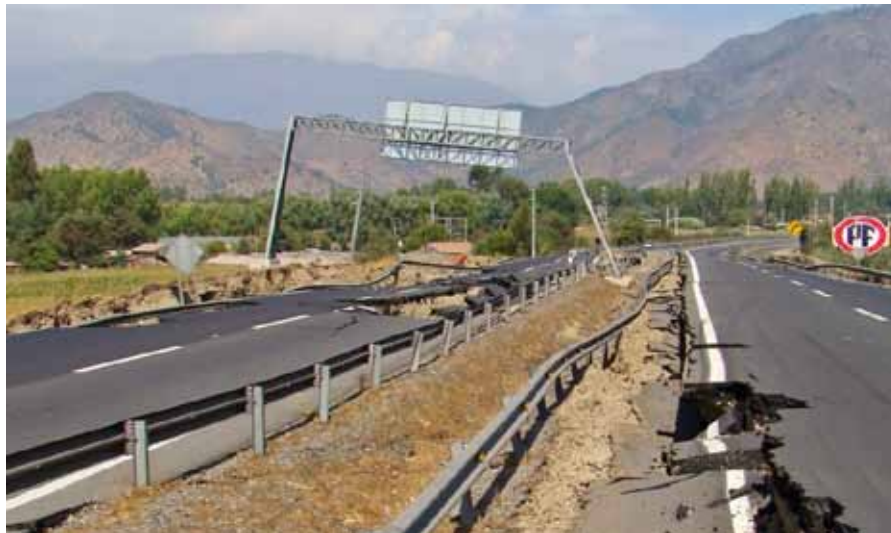
**Figure 191. Photo. Close-up of approach fill failure and damaged sign bridge.**

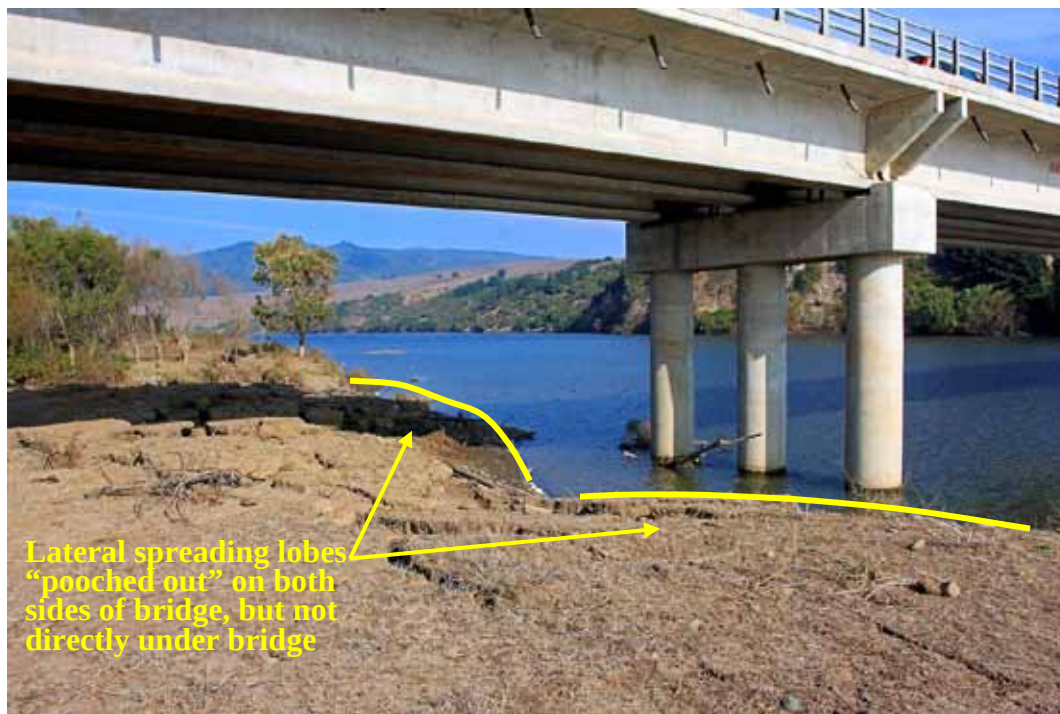
**Figure 193. Photo. Lateral spreading at Mataquito bridge with lateral movement beneath and around bridge.**

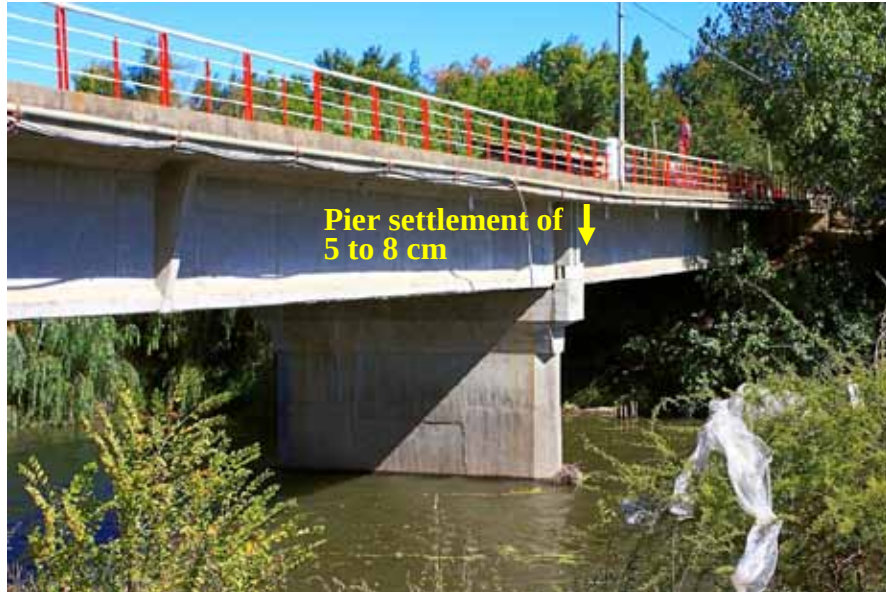
Figure 199 shows an example in which a center pier in the middle of the river settled (about 1.9 to 3.1 inches (50 to 80 mm)), but, because of the water in the river, no specific evidence of liquefaction could be observed. It is likely that liquefaction is the cause of this kind of effect on the bridge, although it is also likely that the liquefied layer is not extensive because the amount of deformation in the foundation is relatively small.

**Figure 199. Photo. San Nicolás bridge center pier settlement probably due to liquefaction of soil layers beneath river.**

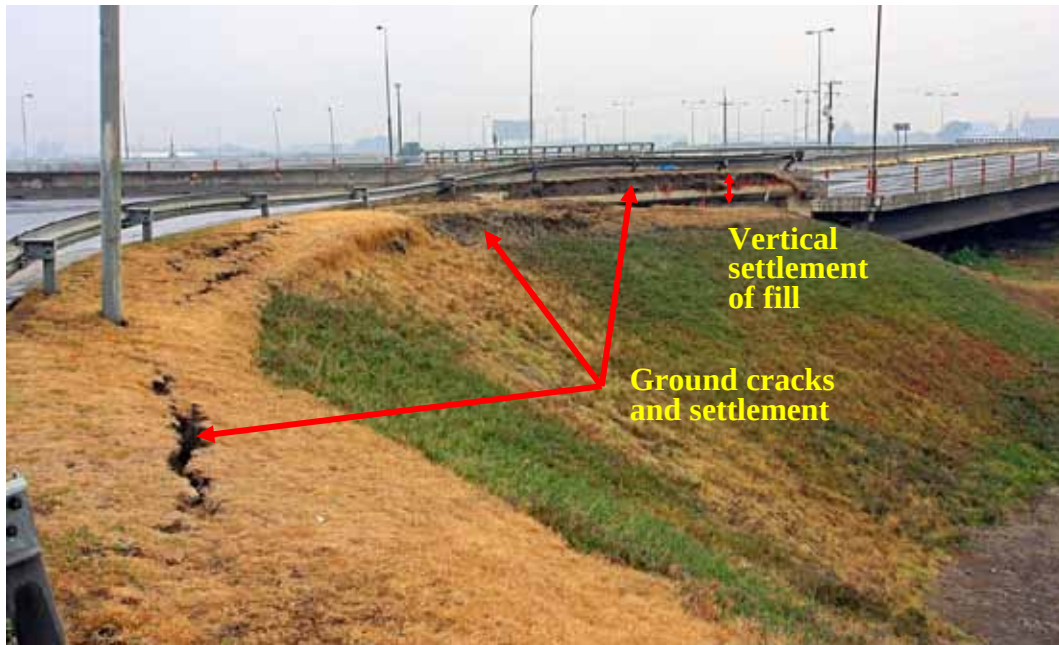
The only ground improvement the team was made aware of to address liquefaction was deep dynamic compaction (DDC) conducted beneath some of the approach fills near the north end of the Juan Pablo II bridge in Concepción. Based on field observations at that site, the ground improvement was only partially successful, as shown in figure 200 and figure 201. DDC is generally not very effective for stabilizing deeper liquefaction in soils below the water table (i.e., water is virtually incompressible, and, in finer sandy or silty soils, the water does not have time to escape during DDC impacts, preventing reduction of pore volume). However, the specific limits of the DDC and the subsurface conditions are not known, so the apparent lack of success of the DDC cannot be fully investigated at this time.

**Figure 200. Photo. Ramps at Juan Pablo II bridge where existing ground was improved with DDC.**

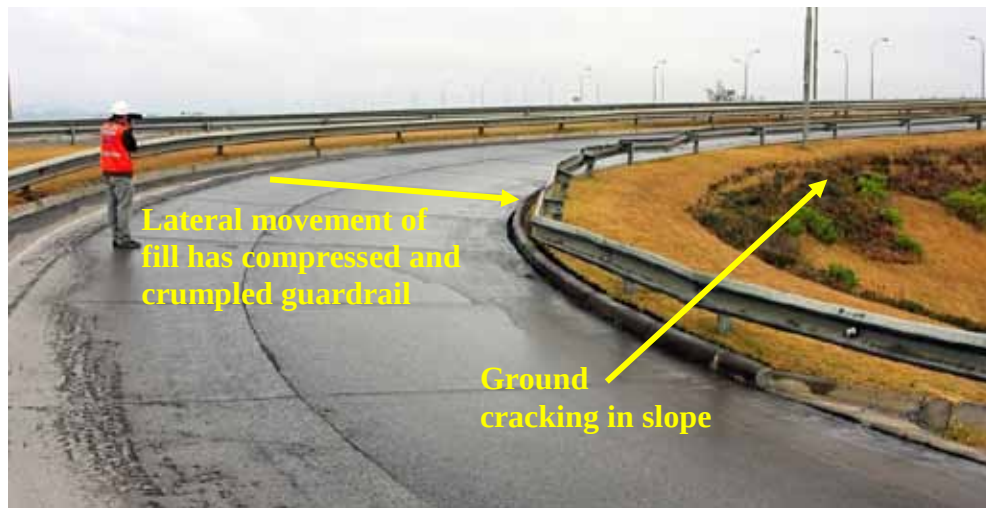
**Figure 201. Photo. Lateral movement of fill in ramps at Juan Pablo II bridge.**

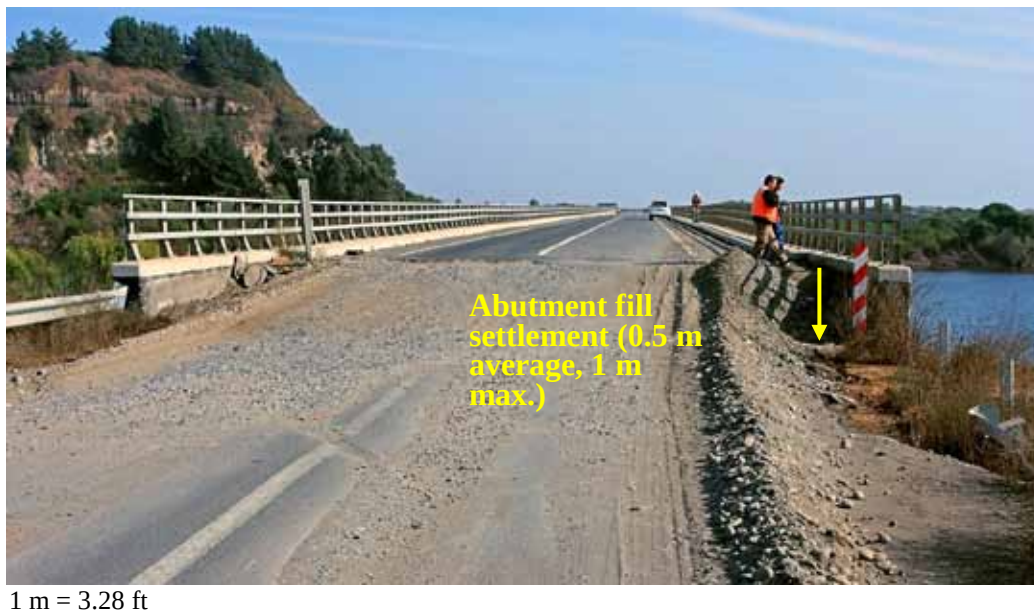
For the Mataquito bridge, it appears that the abutment fill primarily moved parallel to and around the abutment wall rather than applying the full lateral force of the soil directly into the abutment. Ridging along the approach fill slope toe and longitudinal roadway pavement cracking appear to confirm that most of the soil movement was perpendicular to the roadway centerline (also identified in GEER).<sup>(2)</sup> Significant abutment fill settlement (approximately 1.6 to 3 ft (0.5 to 1 m)) also occurred, requiring some easily accomplished repair to the bridge approach fill (see figure 202 and figure 203). It also appeared that the soil was able to partially flow around the pier and foundation elements, possibly reducing the lateral loads enough that the foundations could resist them (see figure 192 and figure 193). As shown in figure 202 and figure 203, the bridge itself was virtually unaffected by the lateral spreading other than some minor abutment wall crushing where the abutment and bridge deck were shoved together either during shaking or as a result of very small lateral movement of the abutment. There was not enough movement or damage to affect bridge operation. Settlement of the soil around the interior piers was also observed (see figure 204) and appeared to be partly due to lateral spreading of the soil down slope as well as to possible deeper liquefaction-induced settlement that contributed only to downdrag forces on the foundations.

**Figure 203. Photo. Soil settlement without bridge settlement at northeast abutment of Mataquito bridge.**

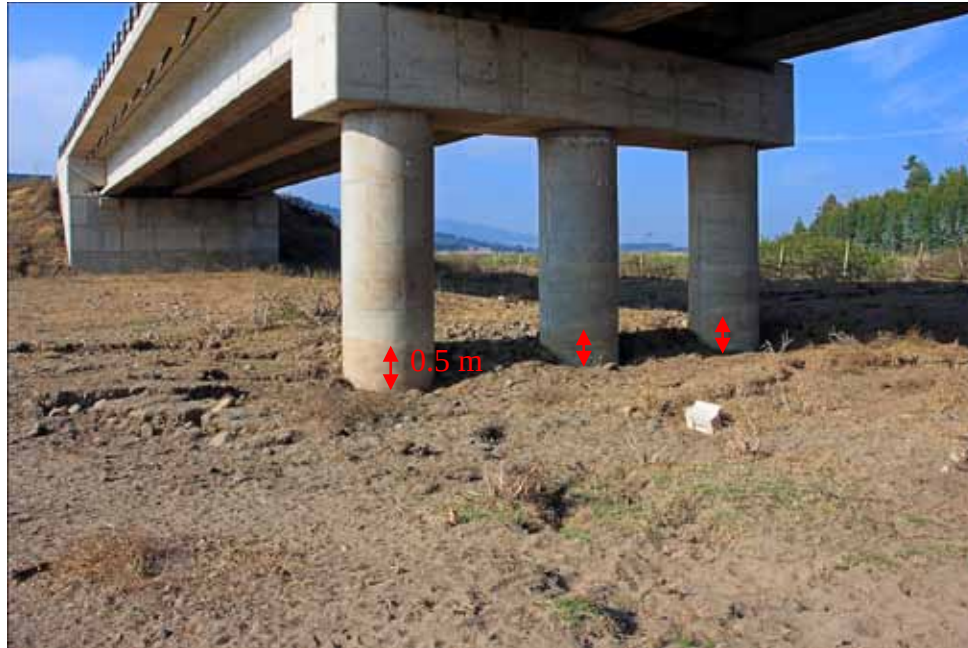
**Figure 204. Photo. Soil settlement at interior pier at northeast abutment of Mataquito bridge.**

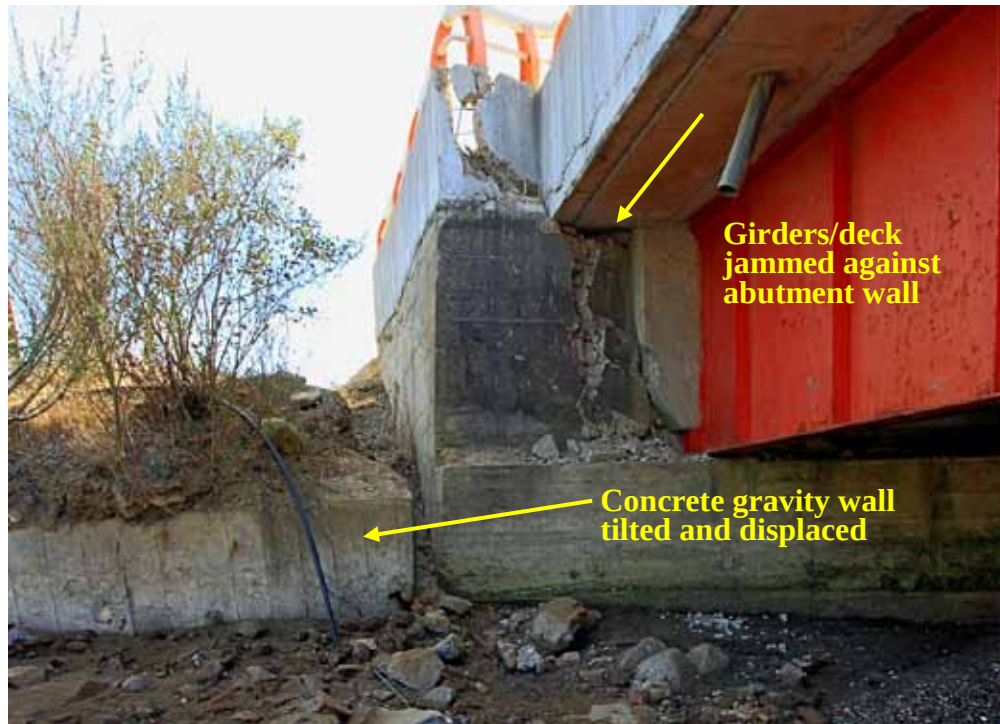
**Figure 206. Photo. Abutment and girders shoved into each other and deck at the northwest abutment of the Raqui 1 bridge.**

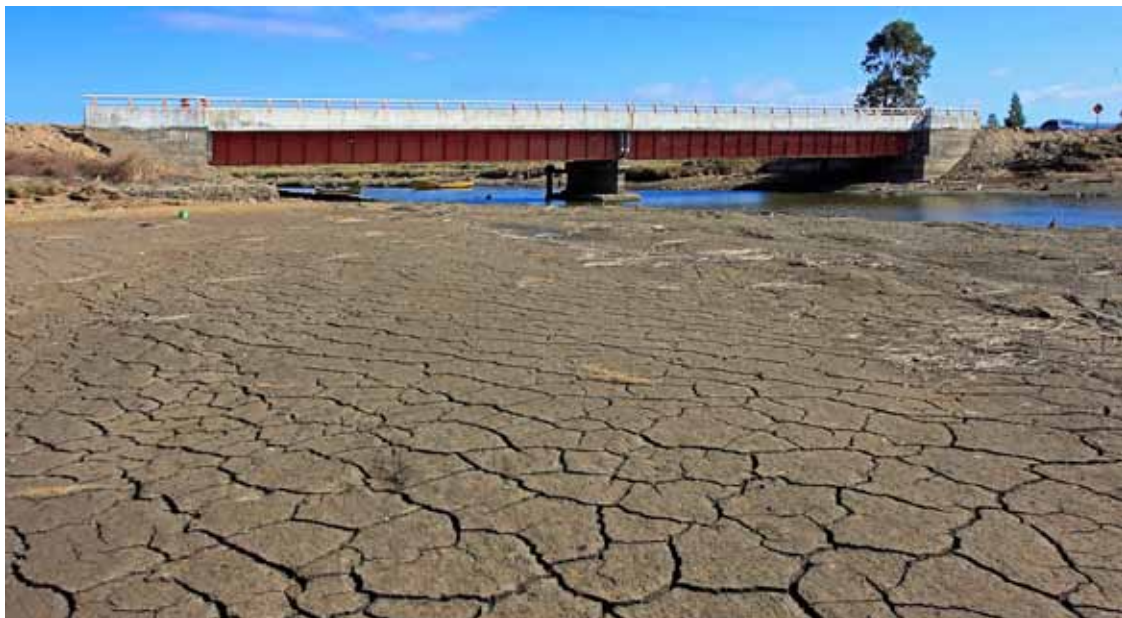
**5.2.2.3.2 Raqui 1 bridge (Site 20):** The Raqui 1 bridge is somewhat transitional with regard to the effects of liquefaction. The primary impact of liquefaction for this bridge was abutment fill settlement, though evidence of relatively minor lateral spreading below the abutment fills was present. Figure 205 shows approximately 3 ft (1 m) of fill settlement at the northwest abutment. The southeast abutment shows a similar amount of settlement. However, figure 206 shows that some lateral movement of the northwest abutment may have occurred (approximately 2.9 to 3.9 inches (75 to 100 mm)), severe enough to cause crushing of the abutment wall against the bridge girders and deck but not to shut down the bridge once the abutment approach fills were rebuilt to match the bridge deck elevation. A small concrete gravity wall adjacent to the abutment also displaced and tilted laterally down slope toward the river (see figure 206). It also appeared that more lateral movement occurred on one edge of the northwest abutment than on the other, indicating that some twisting of the abutment occurred. The abutment wall crushing could be partially due to strong shaking of the superstructure, forcing the bridge girders and deck into the abutment. However, the abutment wall crushing, signs of abutment fill displacement, twisting of the abutment, and lateral movement of the gravity wall adjacent to the abutment indicate that abutment movement toward the river occurred, likely due to liquefaction. It appeared that the southeast abutment did not move due to the liquefaction and lateral spreading. The difference in the liquefaction effects at the two abutments may be due to the presence of more gently sloping ground around the approach fill for the southeast abutment than for the northwest abutment (see figure 207). There was some evidence

**Figure 207. Photo. Raqui 1 bridge viewed from north side.**

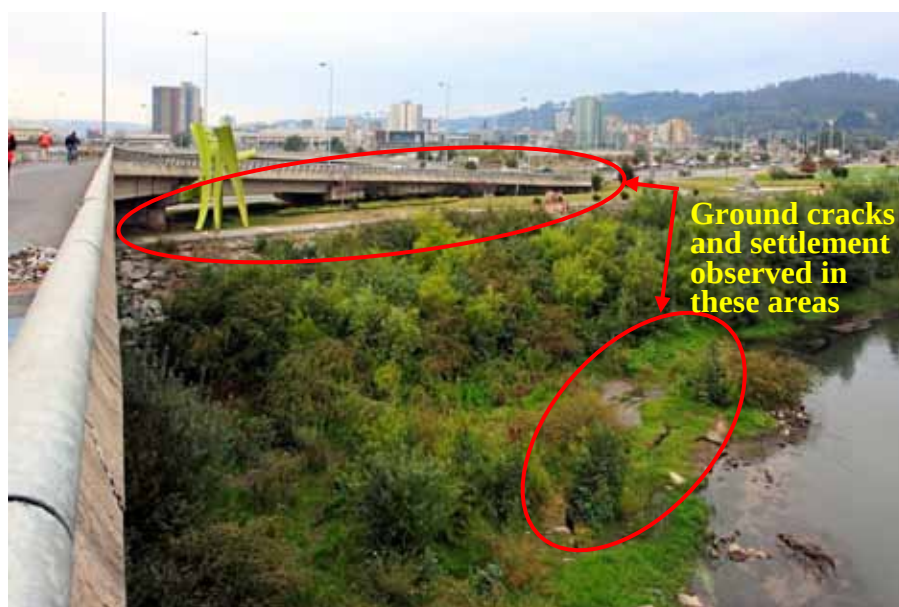
At the northeast end of the Llacolen bridge, the liquefaction impacts were far worse. The biggest problem for the Llacolen bridge, as well as for other Biobío River crossings and structures, was lateral movement of the foundations within the liquefaction-induced slope failure areas (see figure 209 for an overview of the river crossings and figure 210 through figure 213 for the Llacolen bridge). In general, most of the liquefaction-induced slope failure problems occurred along the northeast side of the river, where the river channel is incised more steeply. Very few liquefaction-induced problems occurred along the southwest side of the river even though there was clear evidence that liquefaction had occurred, probably due to the very flat ground conditions on that side of the river (see figure 195).

**Figure 210. Photo. Evidence of slope instability due to liquefaction at northeast abutment and approaches of Llacolen bridge.**

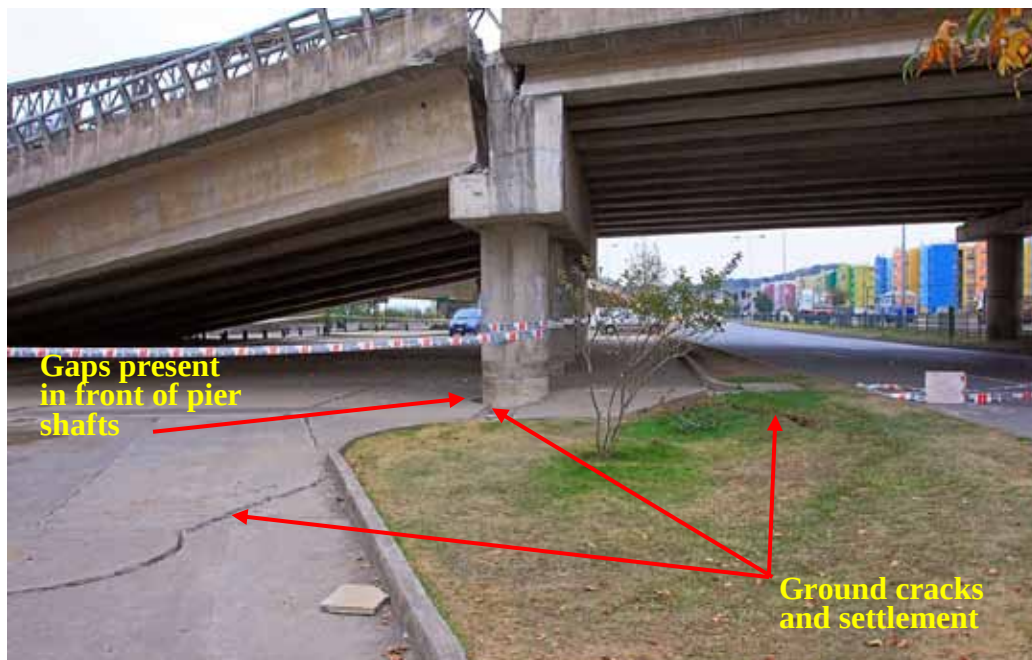
**Figure 212. Photo. Settlement due to liquefaction-induced slope instability at northeast end of Llacolen bridge.**

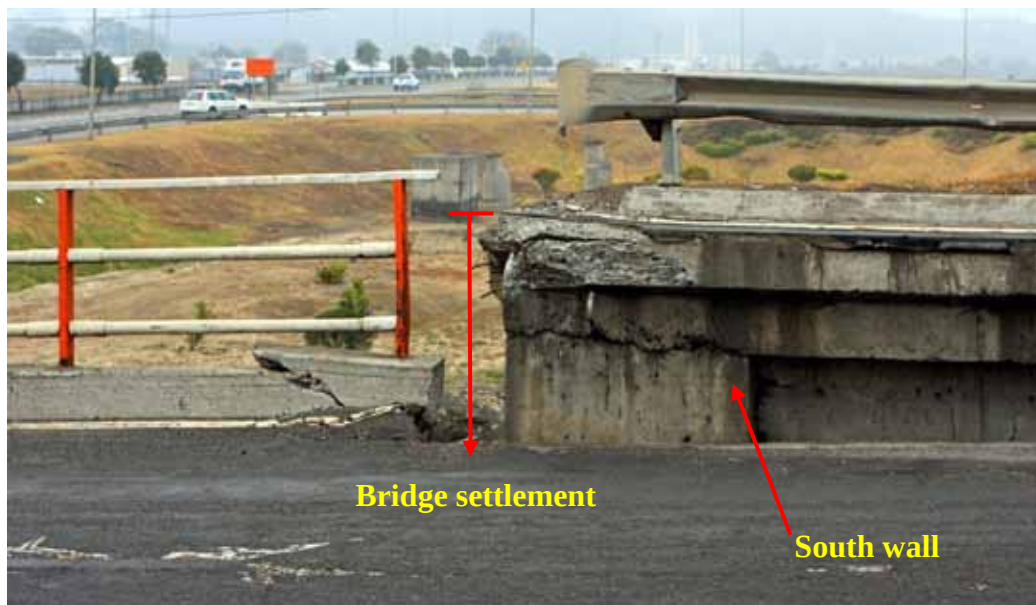
Notably, a shaft-supported wall supporting fill between the approach bridge and the main river-crossing structure settled very little, whereas the bridge approach pier settled more than 3 ft (1 m), and the soil surrounding the end of the wall and the bridge pier also settled more than 3 ft (1 m) (see figure 217 and figure 218). This difference is likely due to differences in the two structures and the amount of load they carry. It was noted that the shaft-supported wall is much newer than the bridge ramp structure and therefore may be designed to more stringent standards, as it is unlikely that the soil would be so vastly different over such a short distance. Figure 219 through figure 221 show the bridge settlement.

**Figure 218. Photo. Close-up of settlement of approach structure for Juan Pablo II bridge.**

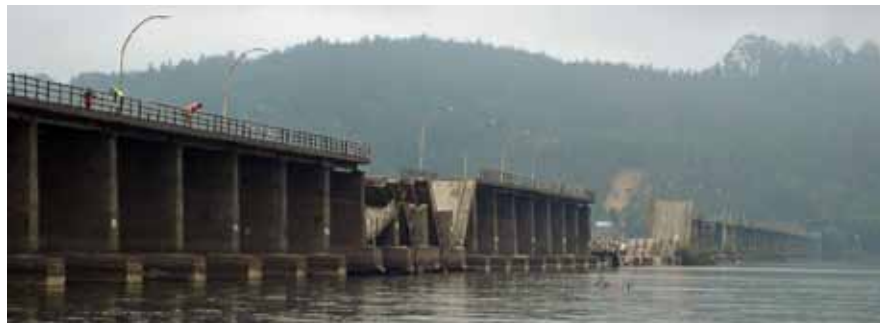
**Figure 223. Photo. View of collapsed spans from northeast river bank of Biobío River.**

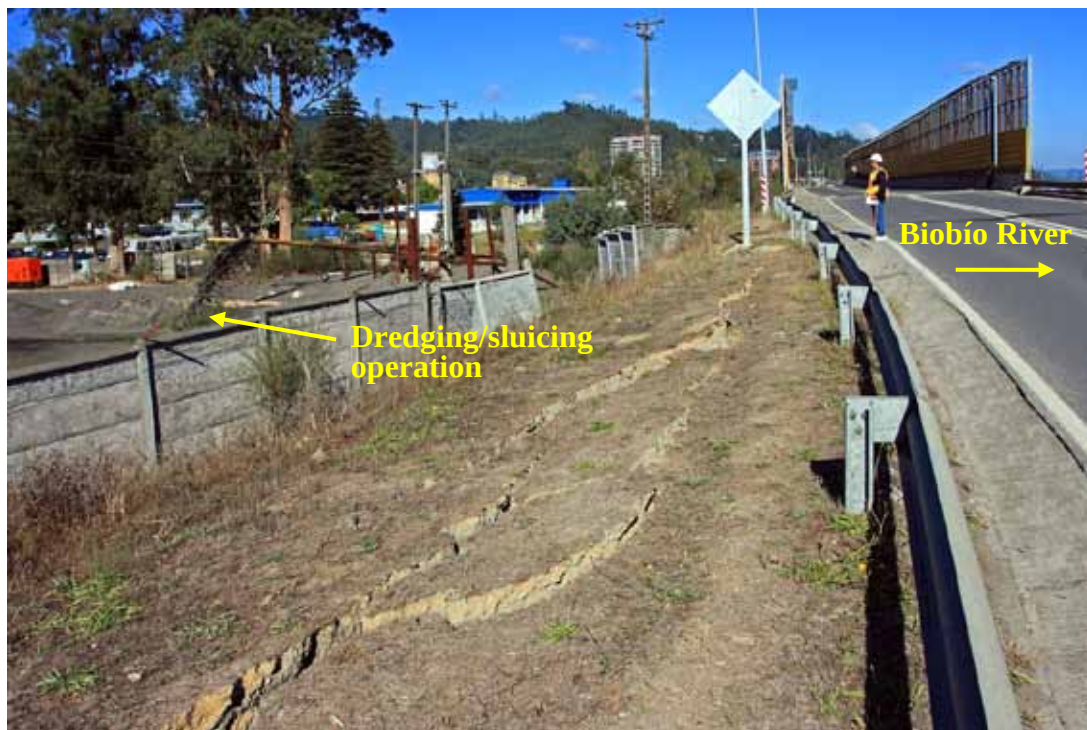
north approach fill damage, and figure 196 and figure 197 show ground failure at the interior piers. The presence of ground water is a key ingredient for liquefaction to occur, and the ground water regime at this site was complicated by the presence of a dredging operation that pumped water from the river into a pit adjacent to the north approach fill, possibly raising the ground water levels in that approach fill (see figure 229). Seepage, possibly from water in the dredging spoils pit, was observed in the riverbank slope about 7 to 10 ft (2 to 3 m) above the river level in this area. This may have increased the severity of the ground failure observed in the north approach fill. However, the severity of the ground failure did not seem to be as great at the bridge abutment as it was 82–660 ft (25–200 m) north of the abutment (see figure 227 and figure 228). This may have been one of the reasons why the north bridge abutment was not significantly displaced due to this liquefaction-induced soil movement.

**Figure 229. Photo. La Mochita bridge north approach fill and edge of dredging pit.**

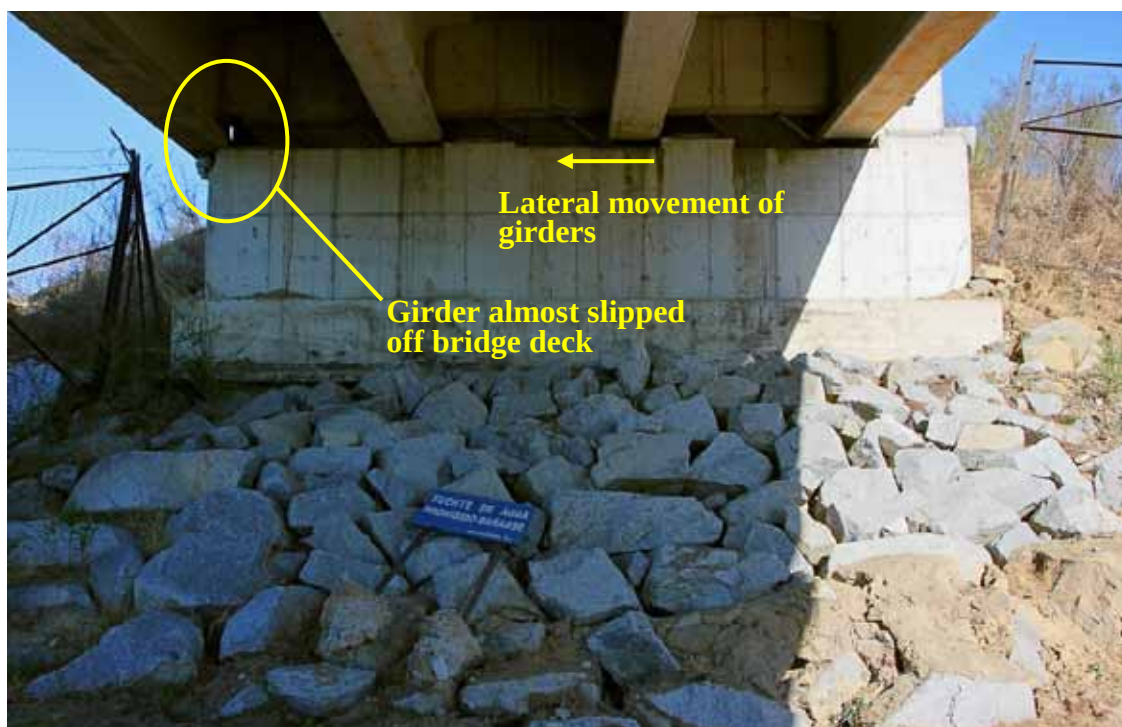
The bridge superstructure (girders and deck) also slid laterally toward the east up to 1 ft (0.3 m), with more movement at the south abutment than at the north abutment, possibly due to a combination of strong shaking and the tilting of the interior pier (see figure 230 through figure 232). It appeared that the abutments did not move. Note that one of the outside bridge girders almost slipped off the abutment seat (see figure 232). Overall, while the ground failure was significant (lots of movement with a thick non-liquefied crust), this bridge did not collapse. However, it was laterally displaced and suffered damage.

**Figure 232. Photo. La Mochita bridge lateral bridge deck and girder at south abutment.**

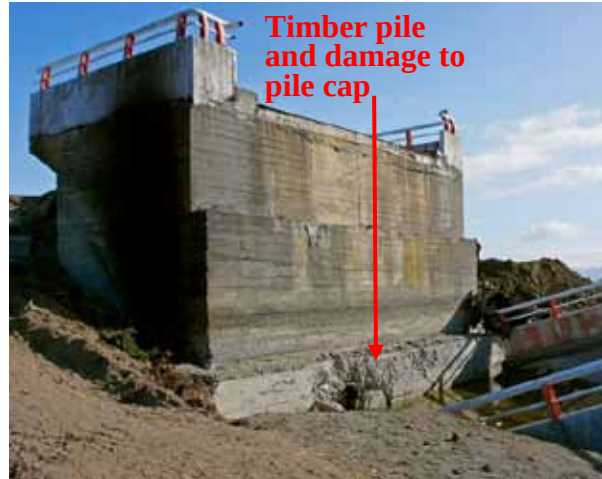
was observed at both ends of the bridge. Damage observed included liquefaction-induced ground failure, large-scale settlement of the approach fills (see figure 236 through figure 240), and shoving of the bridge girders approximately 5.9 inches (150 mm) into the north abutment, resulting in some crushing of the abutment wall at the girder locations (see figure 240 and figure 115). The south abutment pile cap was also damaged (see figure 239). It is possible that the north abutment was pushed into the girder to cause the abutment wall crushing. Alternatively, the girders supported by the interior piers could have been shoved into the north abutment due to a combination of lateral movement of the south abutment and strong shaking (see chapter 4).

**Figure 238. Photo. Overview of damage to south abutment of Tubul bridge.**
