# Postearthquake Reconnaissance Report on Transportation Infrastructure Impact of the February 27, 2010, Offshore Maule Earthquake in Chile

PUBLICATION NO. FHWA-HRT-11-030

OCTOBER 2011

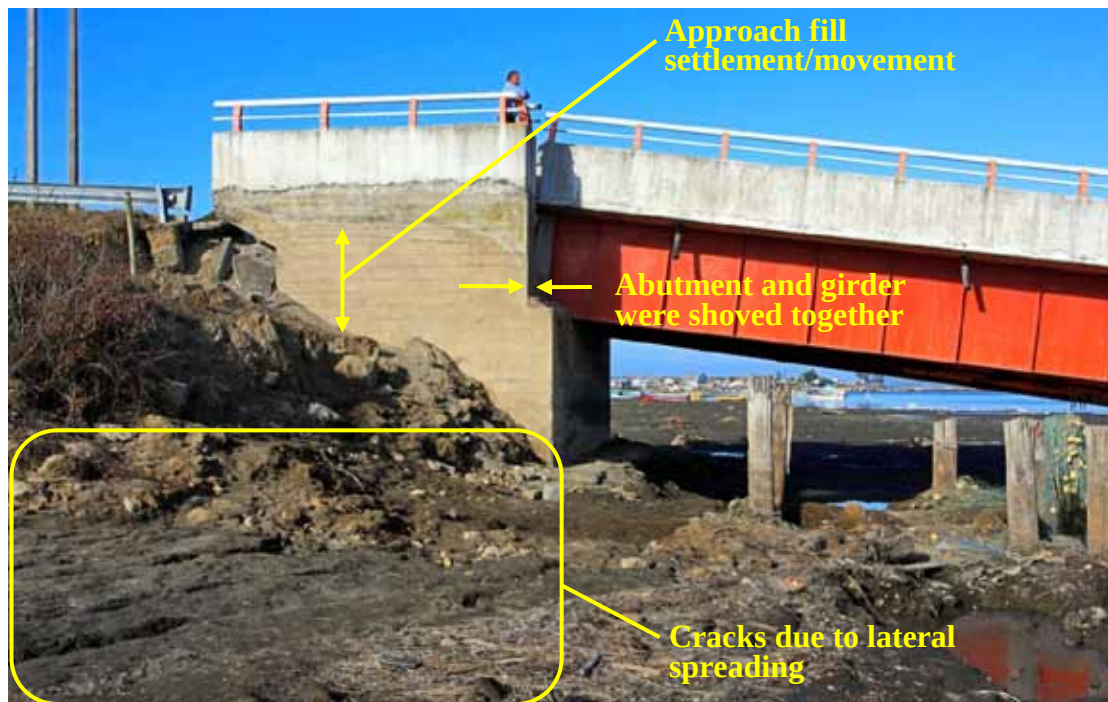
**Figure 240. Photo. Overview of Tubul bridge north abutment.**

| Site No., Name, and Abutment/Pier Location | Estimated Abutment or Slope Height | Estimated Ground Geometry at Abutment/Pier Vicinity | Observed Abutment/Pier Deformation and Performance |
|---|---|---|---|
| 22. Tubul bridge, north abutment and interior piers | 4.5 to 5 m | Fill behind abutment extends out from edges of bridge (wider than needed for two lanes); slope is 25 to 30 degrees (estimated) then flattens to 10 degrees or less in short section to river (see figure 240) | Abutment may have moved laterally about 150 mm, but it is also possible that girders were shoved into abutment due to a combination of pier wall failures, strong shaking, and lateral movement of south abutment. Approach fill settled over 1 m. Interior piers collapsed. |

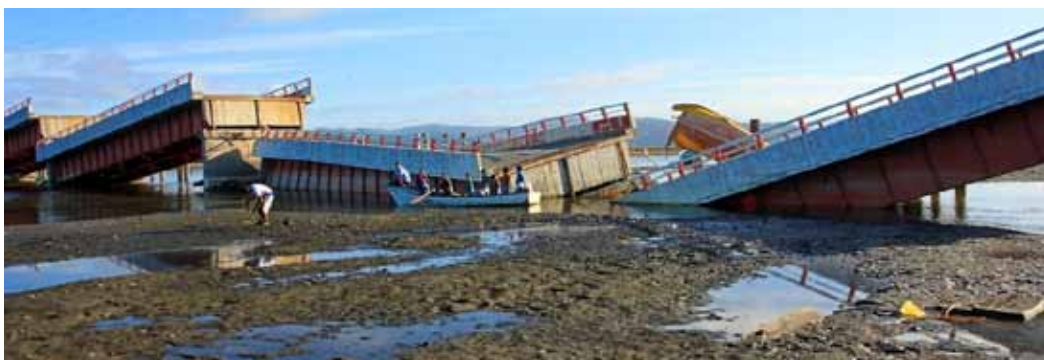
The exposed pile cap of the Tubul bridge south abutment was obviously damaged, possibly due to lateral movement toward the north (see figure 239). It is not clear if the exposed timber pile was embedded in the pile cap as part of the abutment foundation or was a remnant of a foundation from an older bridge that ended up getting included in the pile cap when it was constructed. Specific foundation details for this bridge were not available, although it is likely that this bridge was supported on piles. In any case, it appears that the presence of the timber pile in combination with lateral movement of the abutment due to lateral spreading forces may have forced the exterior concrete pile cap to break and come loose. Additionally, the approach fill settlement and lateral movement appeared to be more severe at the south abutment than at the north abutment, providing further support that the collapse may have initiated at the south end of the bridge. Regarding the interior piers of the Tubul bridge, damage or collapse of the pier walls appeared to be the primary problem. The pile caps appeared to not have moved, at least in the lateral direction. However, some of the pile caps were not visible (they were under water or mud) and therefore could have settled or moved laterally (see figure 241).

**Figure 241. Photo. Tubul bridge collapsed spans and substructure.**

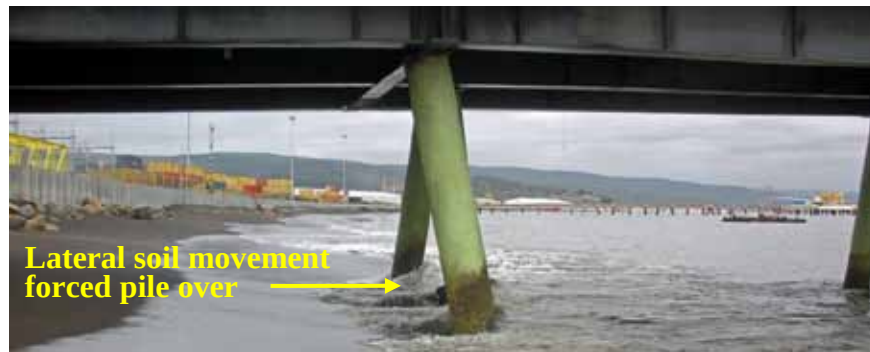
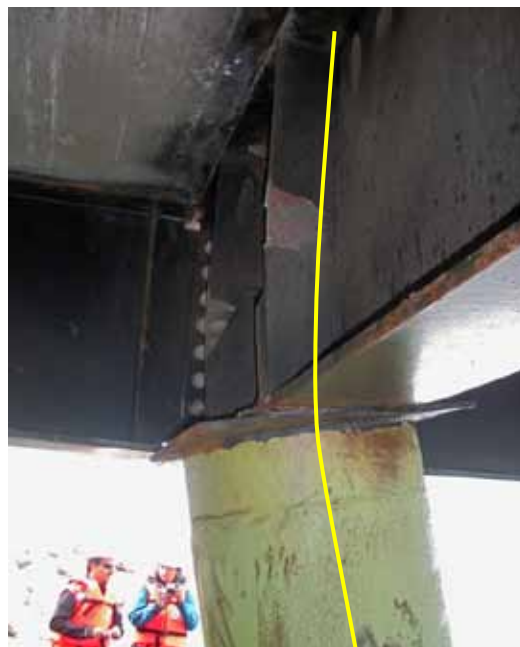
**5.2.2.3.9. Puerto de Coronel Muelle (Site 19):** Deep liquefaction combined with lateral soil movement can cause severe foundation element bending. This was exemplified at the Puerto de Coronel Muelle, located south of Concepción but north of Arauco. The foundations supporting the pier (wharf) structure were pushed laterally and displaced (see figure 242 and figure 243). Since the foundations were deep (steel 28- to 40-inch (711 to 1,016 mm) open-ended pipe piles driven to a depth of approximately 160 ft (50 m)), the piles were probably fairly well fixed near the bottom. Based on the boring logs available, loose sands are present in the top 49 to 66 ft (15 to 20 m) below the ground surface. Therefore, liquefaction likely occurred to significant depth and contributed to the foundation displacements and degrees of bending observed. The yellow line in figure 243 traces the bending and twisting observed in the girder that was attached to the pile foundation. See GEER for additional details regarding the effect lateral spreading had on these and similar structures in the vicinity.<sup>(2)</sup>

**Figure 242. Photo. Puerto de Coronel Muelle foundation displacement and bending.**

**Figure 243. Photo. Close-up of Puerto de Coronel Muelle foundation displacement and bending.**

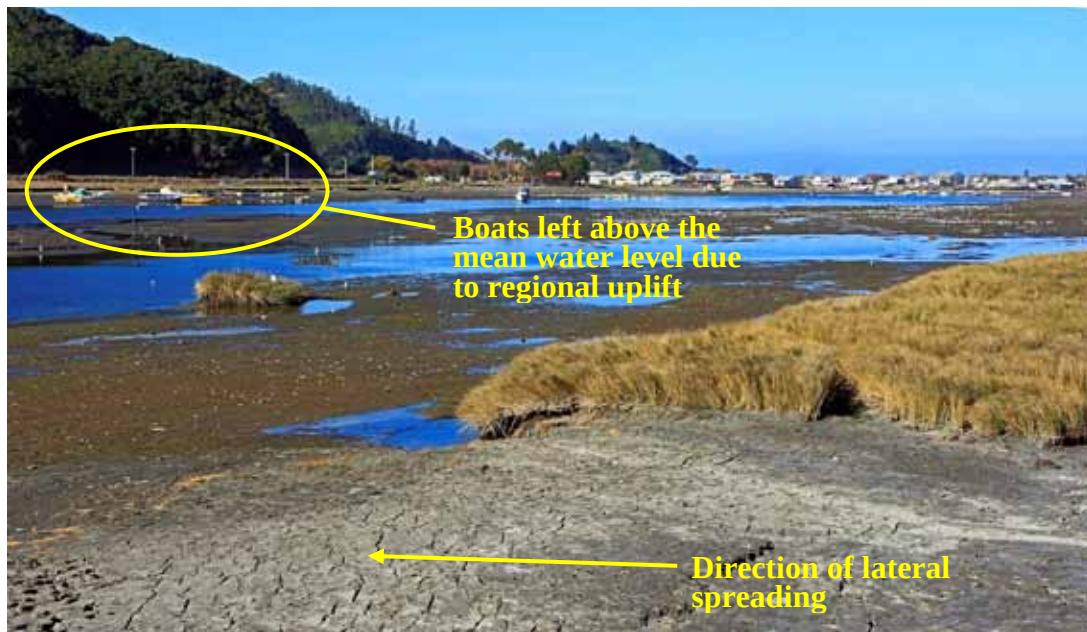
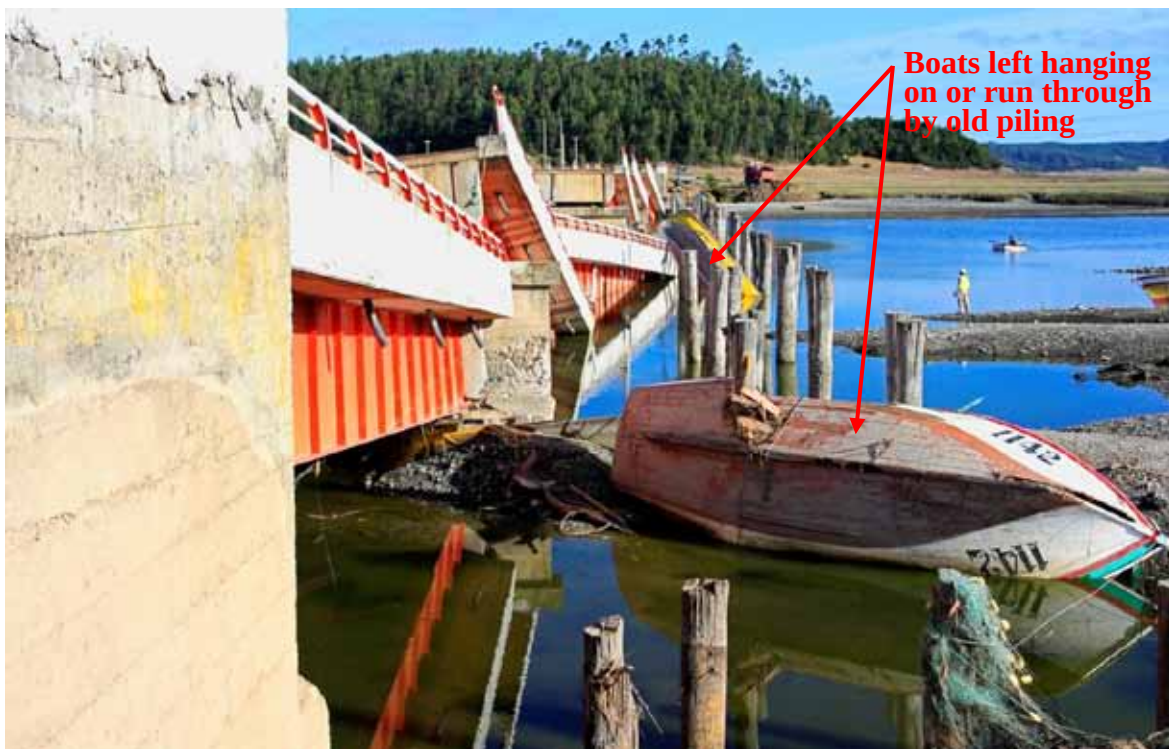
Examples of the impact of rapid uplift are shown in figure 244 and figure 245. These figures show dry ground that was once wet and boats hung up on old timber pilings that were once almost fully submerged. However, the team was not able to confirm that these boats ended up on the pilings as the result of the earthquake. Figure 117 shows additional evidence of the pre-earthquake water level. One possible effect of the rapid uplift was to create rapid drawdown conditions, increasing the instability of sloping ground that was once partially or fully underwater. These remnant pore pressures could have combined with liquefaction effects to further decrease the stability of affected slopes, making them more likely to fail and to experience greater lateral deformations. This scenario needs further study once more subsurface data is obtained. The effect of rapid uplift on the bridge itself is unknown at this point. However, if the rapid uplift created the potential for differential movement between piers, the rapid uplift could have created additional problems for a bridge already in distress due to strong ground motions and liquefaction-induced forces or loss of foundation support. These near-fault effects need further consideration.

**Figure 244. Photo. View northeast from Tubul bridge south abutment showing areas left dry and boats left above the new mean water level.**

**Figure 245. Photo. Tubul bridge with boats run through by old timber pilings.**

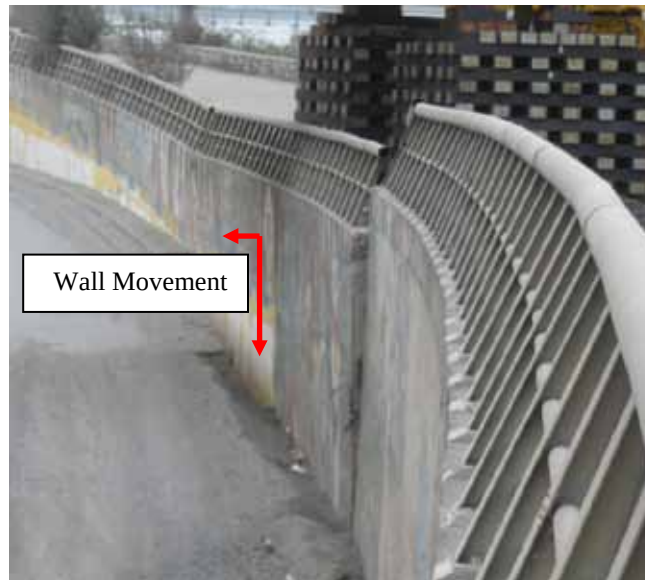
The Chepe railroad bridge over the Biobío River (site 18) is a complex system, as shown in figure 176. A CIP cantilever wall supports a cut to form a depressed roadway. The ground water level is above the depressed roadway elevation at times, depending on the water level in the river. In effect, the roadway and walls in this section form a tub to keep the ground water out of the roadway. The soil below and behind the wall settled and moved toward the river, probably due to liquefaction-induced slope failure (see figure 262 and figure 263). This condition is consistent with observations at other sites along this side of the Biobío River. Due to the liquefaction-induced soil movement, the wall moved downward approximately 1 to 1.3 ft (0.3 to 0.4 m) and the top of wall rotated into the depressed roadway section. Furthermore, the seal between the roadway and wall was broken, which will allow water into the depressed roadway when the river rises.

**Figure 262. Photo. Wall movement near Chepe railroad bridge due to lateral spreading and settlement.**

While the wall was in immediate need of repair, it is notable that the wall was still performing its function of retaining the soil from impacting the depressed roadway despite the severe movement caused by liquefaction. This demonstrates that even in the severe case of liquefaction below the wall, the wall can still function and not collapse. Note that the temporary support of the bridge superstructure placed after the earthquake may be contributing to the lateral loading of the wall. This indicates that even though the wall was damaged, it has some reserve capacity.

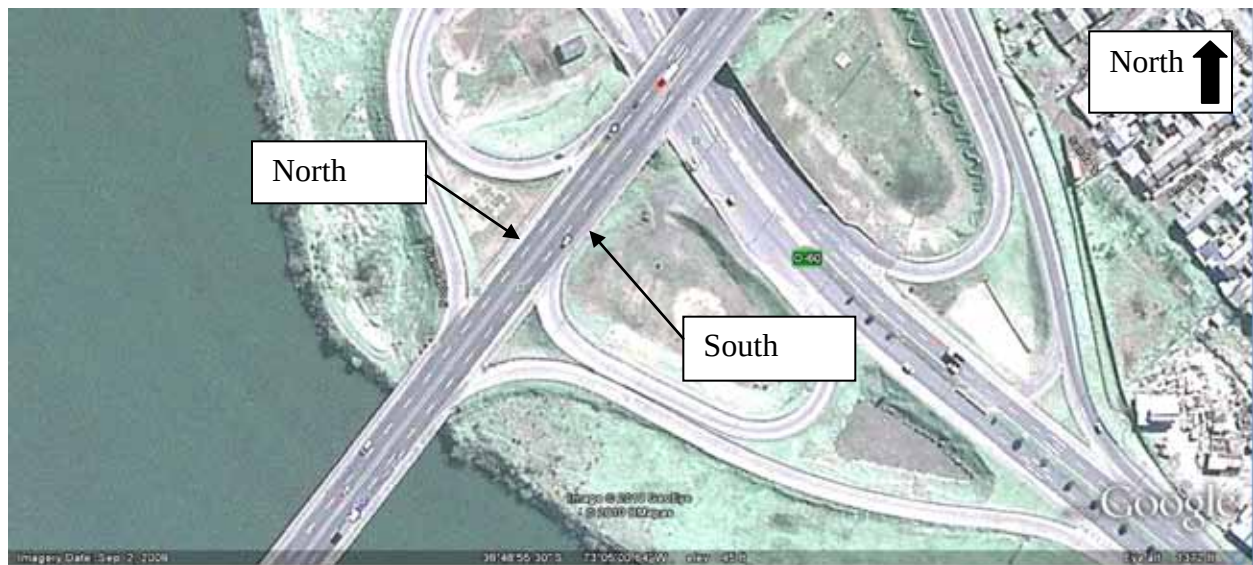
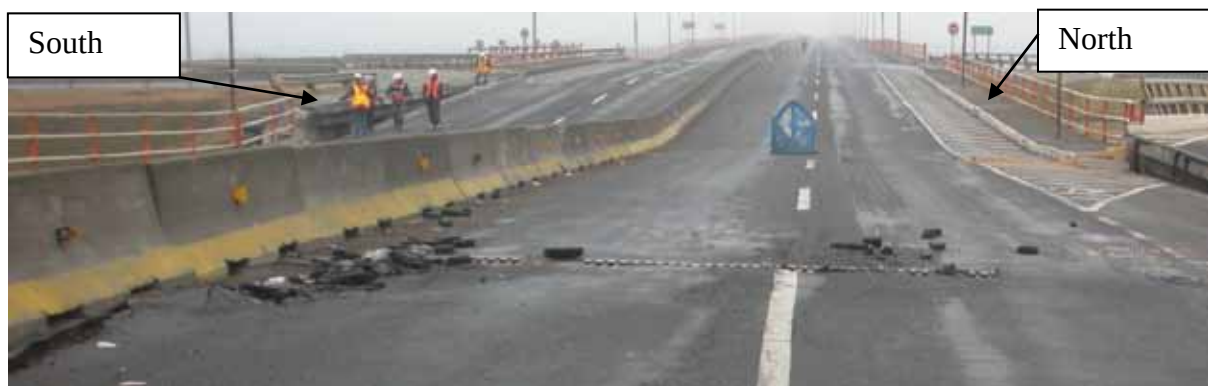
The approach for the Juan Pablo II bridge (site 25) was discussed in section 5.1 and illustrated in figure 217 through figure 219. In addition to bridge damage, there were two CIP walls retaining the embankment fill between bridge spans (identified as north and south walls in figure 256, figure 257, figure 264, and figure 265). The embankment between bridge spans settled due to

liquefaction, and the bridge pier near the south wall also settled approximately 3 ft (1 m). The slopes in front of these walls moved laterally, likely due to liquefaction (see figure 200 and figure 201). It appears that the north wall and the embankment settled together more than 3 ft (1 m). Although the soil in front and behind the south wall settled, the wall itself did not settle because it was founded on deep foundations. This wall was built during a later construction project that added the entrance and exit ramps heading east. The north wall was completed in the original construction. Both walls continue to perform as intended after the earthquake, though the north wall would likely need to be replaced to raise the roadway back to its original grade.

**Figure 264. Map. Retaining walls near Juan Pablo II bridge.**

**Figure 265. Photo. Wall settlement near Juan Pablo II bridge due to liquefaction-induced settlement.**

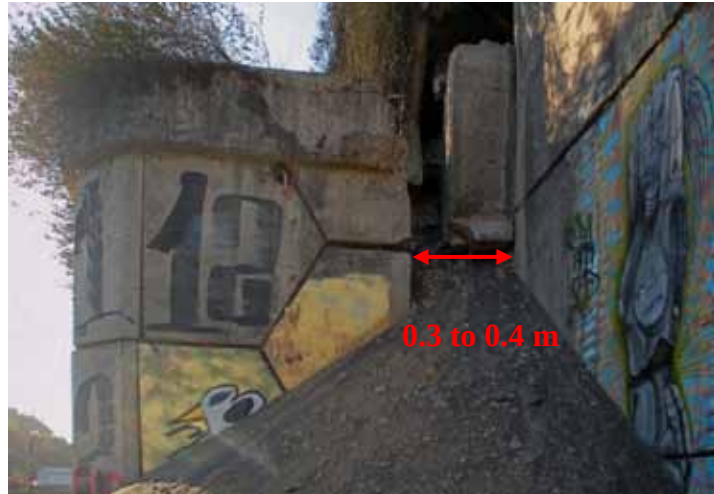
The deformation at wall site 28C was the most severe of the three (see figure 269 through figure 272). Similar to wall site A, the wall is tiered, but instead of rotating, the lower wall slid and rotated, moving laterally outward near the lower wall top approximately 1 to 1.3 ft (0.3 to 0.4 m) (see figure 269) and possibly 0.49 to 0.7 ft (0.15 to 0.2 m) near the wall base (estimated based on tilt of wall face). This is the only wall observed by TIRT that exhibited signs of translational movement, with the exception of the wall at site 18 that moved laterally due to liquefaction-induced lateral spreading of the soil it retained. Because the upper tier was founded on the fill of the lower tier, the upper tier moved downward once the fill retained by the lower wall spilled out through the gap between the lower wall and the curtain wall. Figure 270 shows the back side of the upper wall, where the loss of the fill exposed the soil reinforcement behind the panels. The reinforcement, panel connection, and lack of geotextile between the MSE wall and curtain wall can be seen. The function of the geotextile is to prevent fill from escaping through the joint. In this case, the gap was probably too large for the geotextile to keep the fill from spilling. The geotextile was used at the panel-to-panel joints. The movement of the corner panels was observed at the other corners of these walls, although to a lesser degree.

**Figure 269. Photo. Lateral movement of lower wall top at wall site 28C.**

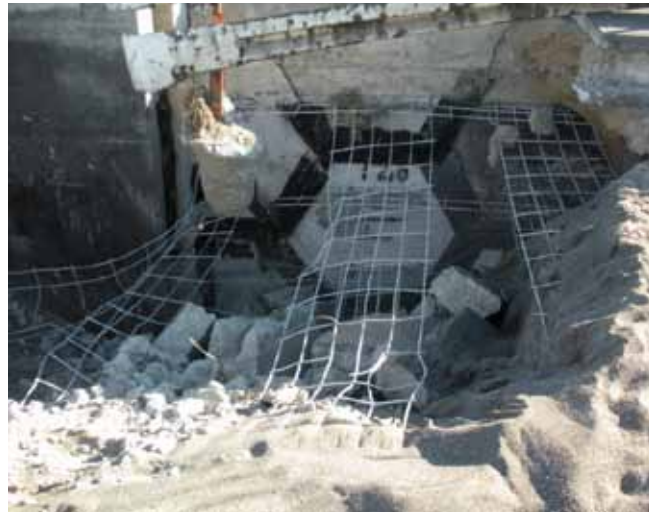
**Figure 270. Photo. Back side of upper wall at wall site 28C.**

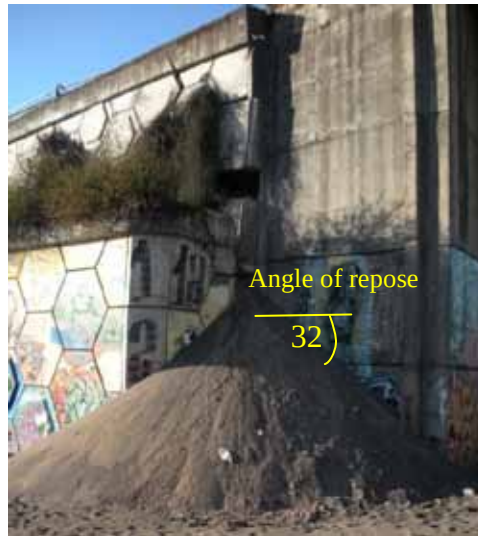
**Figure 271. Photo. Fill material from tiered wall at wall site 28C.**

As shown in figure 271, the fill was a uniform medium-coarse sand with an angle of repose of approximately 32 degrees. This type of material may have contributed to poor soil-structure interaction with the reinforcement. If this was not considered in the wall design, it may have caused a lower pullout resistance than anticipated.

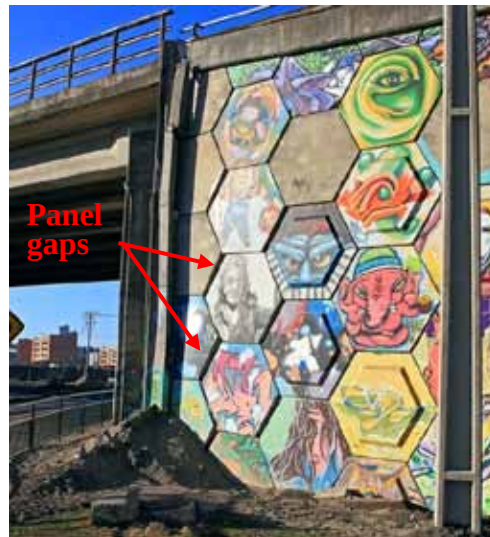
**Figure 272. Photo. Differential settlement at wall site 28C.**

Figure 272 shows the wall at the opposite abutment. In this case, the wall appears to have differentially settled, causing the panels to shift and separate and allowing some backfill soil to spill out.

The specific cause of the excessive lateral movement and differential settlement at this location may have been the liquefaction of the loose sandy soil below the wall. The available borings at the site indicate that the water table is approximately 7 ft (2 m) below the ground surface and loose, liquefiable sand extends to a depth of approximately 16 ft (5 m) (see appendix A). Soft organic silt extends another 3 to 7 ft (1 to 2 m) below the loose sand, below which the sands become dense to

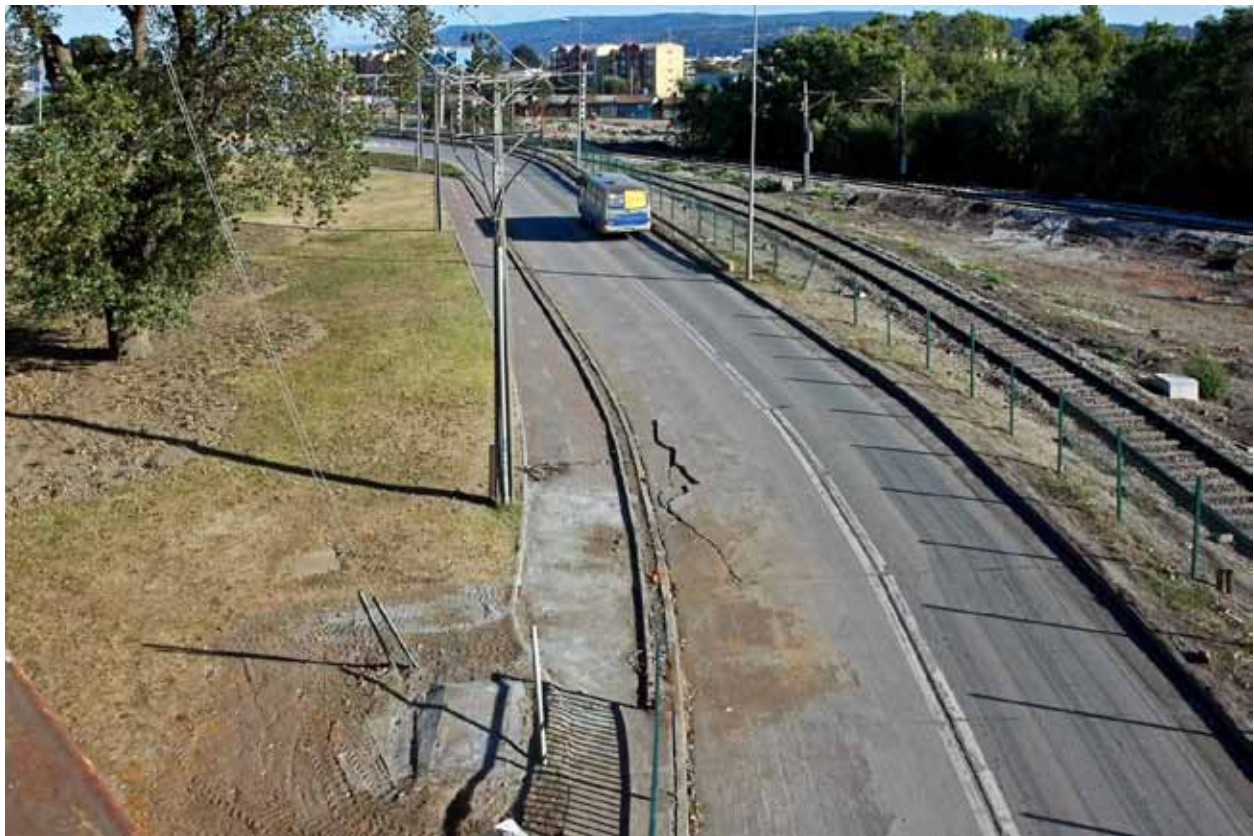
very dense. What appeared to be ejected sand (sand boils) was present near these walls as was some localized ground cracking and cracks in the roadway pavement, as shown in figure 273. With regard to lateral movement on the lower wall, the width of the reinforced soil zone (approaching 100 percent of the wall height) was likely more than adequate to resist the seismically induced lateral earth pressures behind the wall. Therefore, liquefaction is the most likely explanation for the lateral movement. During wall construction, 7.8 inches (200 mm) of settlement of the walls and fill occurred due to the loose sand and organic silt layer below the walls. Construction photos of the walls show what appear to be gaps in the panels that were likely caused by differential settlement that occurred during construction. However, it is also likely that liquefaction settlement below the wall may have worsened the panel distortion.

**Figure 273. Photo. Possible liquefaction features near wall site 28C.**

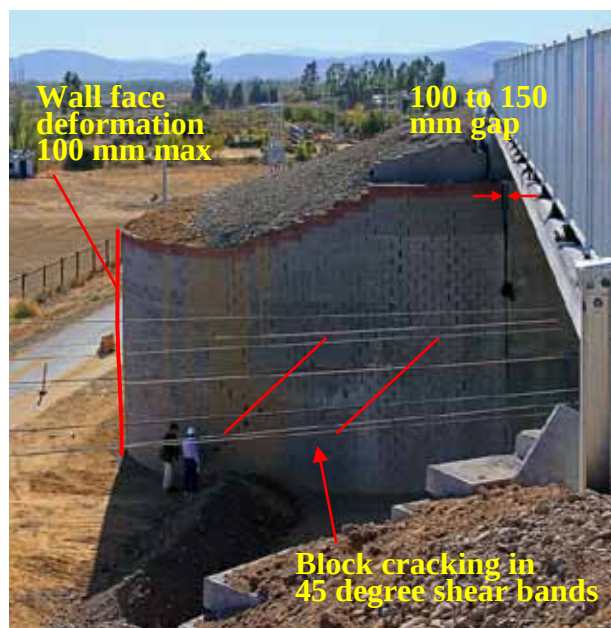
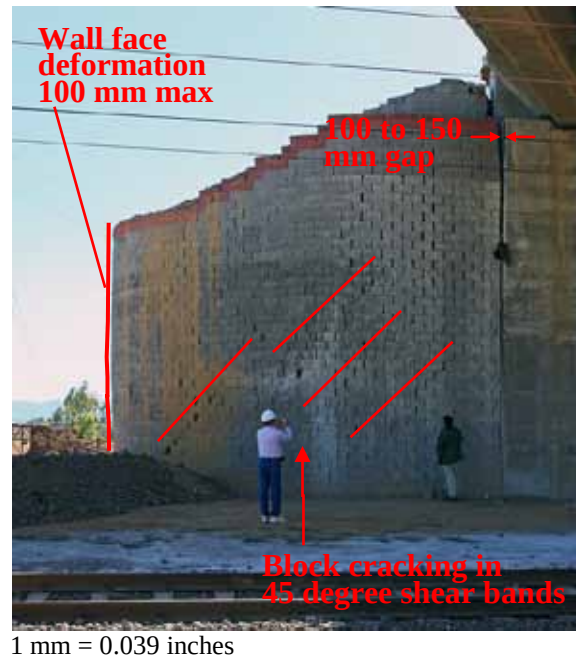
The Muros Talca site (site 32) consists of four geogrid reinforced modular block MSE walls approximately 30 ft (9 m) high with a 1.5H:1V to 2H:1V unreinforced slope on top. The MSE walls abut to a CIP concrete abutment wall. A plan view of the bridge and walls is provided in figure 274. The northeast corner wall experienced severe cracking of the facing blocks and an outward lateral deformation of approximately 4 inches (100 mm). The face block cracking pattern is shown in figure 275 and figure 276, with a linear distribution of the cracks on a 45-degree angle. The southwest corner also had some cracked blocks with a similar pattern but to a much lesser degree. This appears to be another example of a wall corner (or very tight radius in the wall alignment) having problems resisting seismic loading. The significant wall height, especially for a vertical wall, puts a lot of demand on the blocks even for static loading. Combining the wall height plus soil surcharge with a tight radius in the wall alignment and severe seismic loading

**Figure 275. Photo. Wall with steep top slope at Muros Talca.**

**Figure 276. Photo. Wall with cracked block pattern at Muros Talca.**

caused a severe demand on the facing blocks. Some additional evaluation of this wall is needed to fully understand the effect that seismic loading had on this wall and the mode of facing failure. However, even though the wall facing was sheared by the demands placed on it, the wall did not collapse and is still functional, though facing repair will be needed.

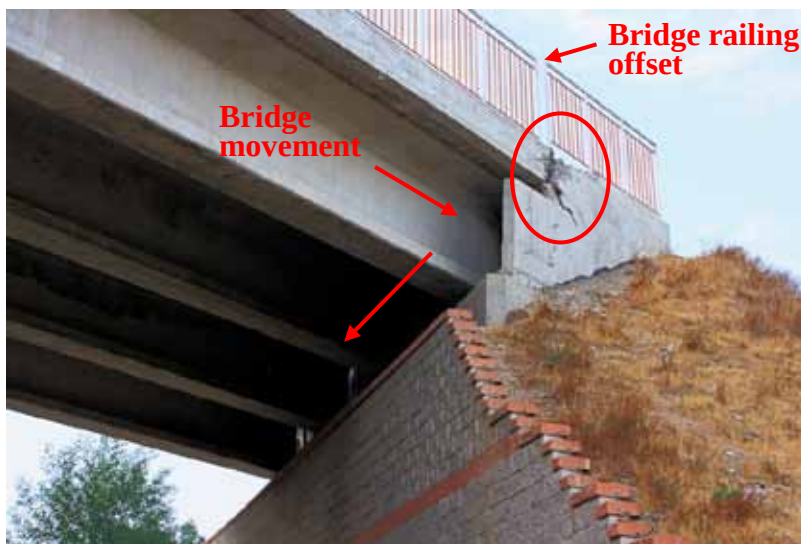
Finally, it should be noted that the wall at Estribo Francisco Mostazal (site 11) is a geogrid reinforced modular block wall directly supporting the abutment and bridge foundation loads (see table 6). This type of abutment wall is what is referred to as a “true” MSE bridge abutment. The MSE abutment walls at site 11 performed very well, exhibiting no signs of lateral or vertical movement due to the earthquake. While the bridge suffered some relatively minor damage (see figure 277), the damage was not caused by the walls but was probably due to the severe bridge skew angle (similar to other bridges observed by TIRT and described in chapter 4) combined with the bridge tending to slide down hill, as it was located on a downhill roadway grade.

**Figure 277. Photo. Bridge supported on footing on top of block-faced geogrid wall at Estribo Francisco Mostazal.**

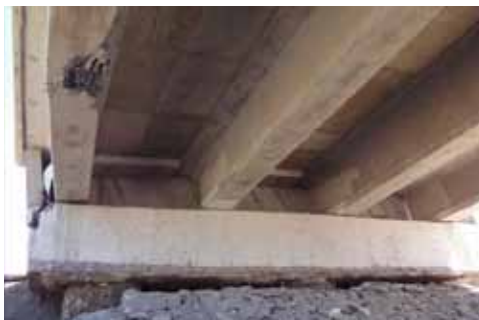
**Figure 281. Photo. Exterior girder damage at Chada bridge, no diaphragms.**

The exterior prestressed concrete girders of the Chada and Romero bridges, which were constructed without diaphragms, experienced out-of-plane block shear failures due to transverse impact loads from shear keys, as shown in figure 281. When partial diaphragms were used between the girders, such as in the San Nicolás bridge, the bottom portion of the exterior girder still experienced significant shear cracking, as shown in figure 282. However, with the use of even partial concrete teeth between girders, as shown in the Llacolen bridge in figure 283, both exterior and interior prestressed concrete girders suffered no visible damage. One interior girder in the west portion of Llacolen bridge experienced a horizontal crack, as shown in figure 57. This was because the concrete teeth provided sufficient lateral restraints on most of the girders, making them work together and share the transverse seismic force.
